Prudhom, A.; Antonino-Daviu, J.; Razik, H.; Climente Alarcon, V. (2017). Time-frequency vibration analysis for the detection of motor damages caused by bearing currents. *Mechanical Systems and Signal Processing*. 84:747-762. doi:10.1016/j.ymssp.2015.12.008

Time-frequency vibration analysis for the detection of motor damages caused by bearing currents

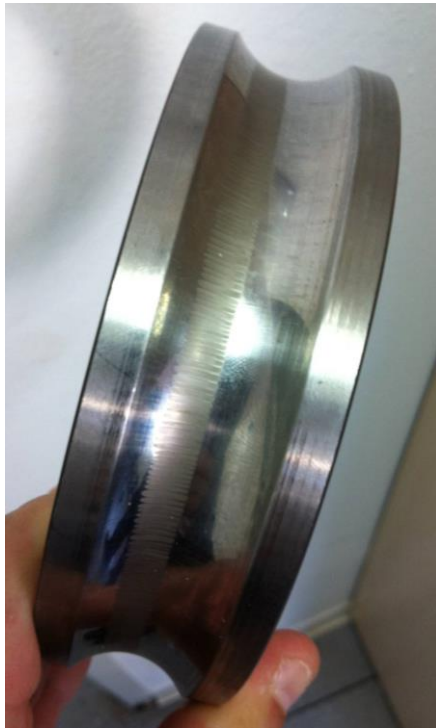
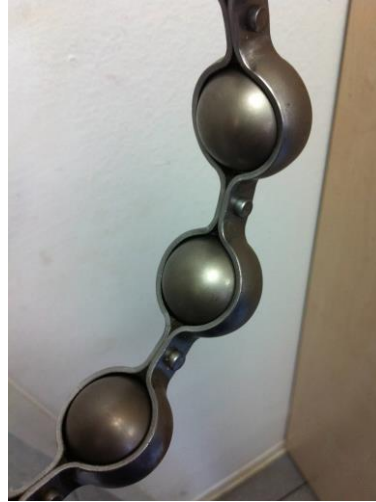
Figure 1. Effects of bearing currents on a real bearing: (a) Surface roughness of a bearing race caused by fluting effect, (b) Matt-grey colour of bearing balls.

The circulation of these currents may lead to shorten the life of the bearings: although failure rates may vary widely depending on many factors, evidence suggests that a significant portion of failures occur only 3 to 12 months after the system starts its operation [4, 6]. Bearing currents may damage the contact surface on the bearing balls as well as the bearing rings. The metal is progressively heated and small craters may appear on the surface of the material (arcing, pitting and fluting of the bearing race). This effect is often accompanied by a discoloration in the balls. Fig. 1 shows the picture of a real bearing that was damaged due to the circulation of bearing currents: note the damaged inner ring with a

characteristic washboard pattern caused by fluting effect [1, 4] (Fig. 1(a)). Note also the characteristic matt grey colour of the balls (Fig.2).

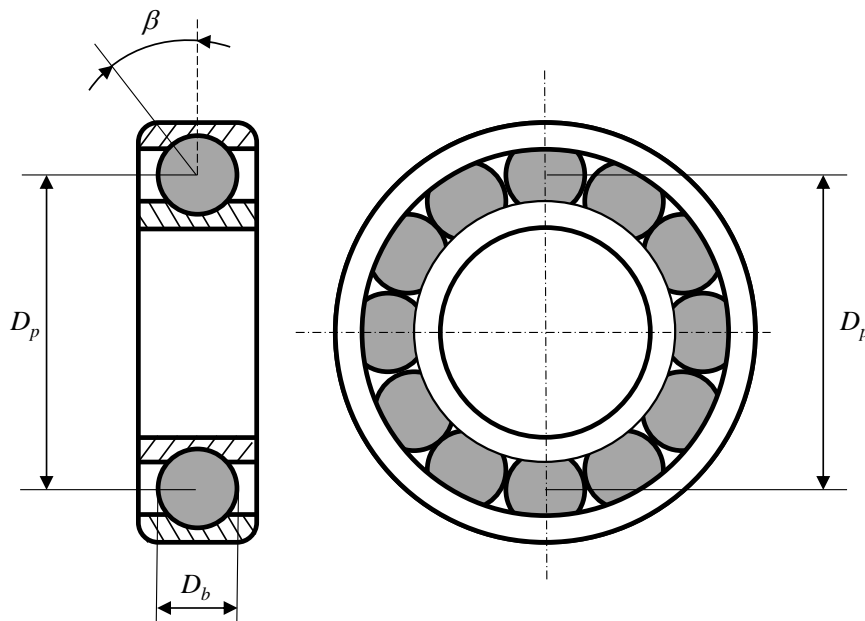
Figure 2. Schematic representation of the ball bearing characteristics used in expressions (1) to (4).

data that depend on the constructive characteristics of the bearing, enables to identify the degradation of a ball bearing. More specifically, expressions (1) to (4) are commonly employed to calculate the frequencies associated to damages in the outer race (1), inner race (2), bearing balls (3) and cage (4) [23-24]. Note that these expressions depend on constructive parameters of the bearings (see Fig. 2), as well as other characteristics: f_C is the cage fault frequency, f_I is the inner raceway fault frequency, f_O is the outer raceway fault frequency, f_B is the ball/roller fault frequency, N_b is the number of rolling elements, D_b and D_c are the diameter of the balls and the pitch diameter, respectively, f_r is the mechanical rotor frequency and β is the ball contact angle (see Fig. 2).

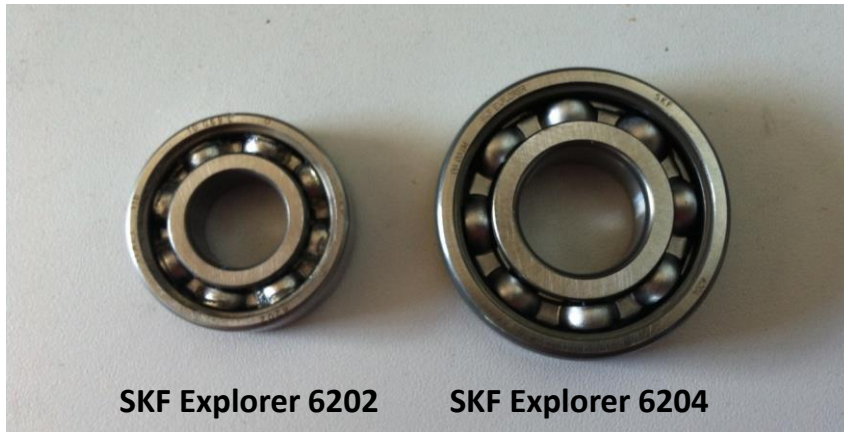
Figure 3. Pictures of the two bearings considered for the tests.

In the present work, two different bearings will be considered (see pictures in Fig. 3). The bearing models are SKF Explorer 6204 and SKF Explorer 6202. These are deep groove, single row ball bearings. The main reason for selecting these models was that they enable a quick and reliable disassembly so that it was possible an easy access to each component. The bearing parameters taken from the data sheet are shown in Table I.

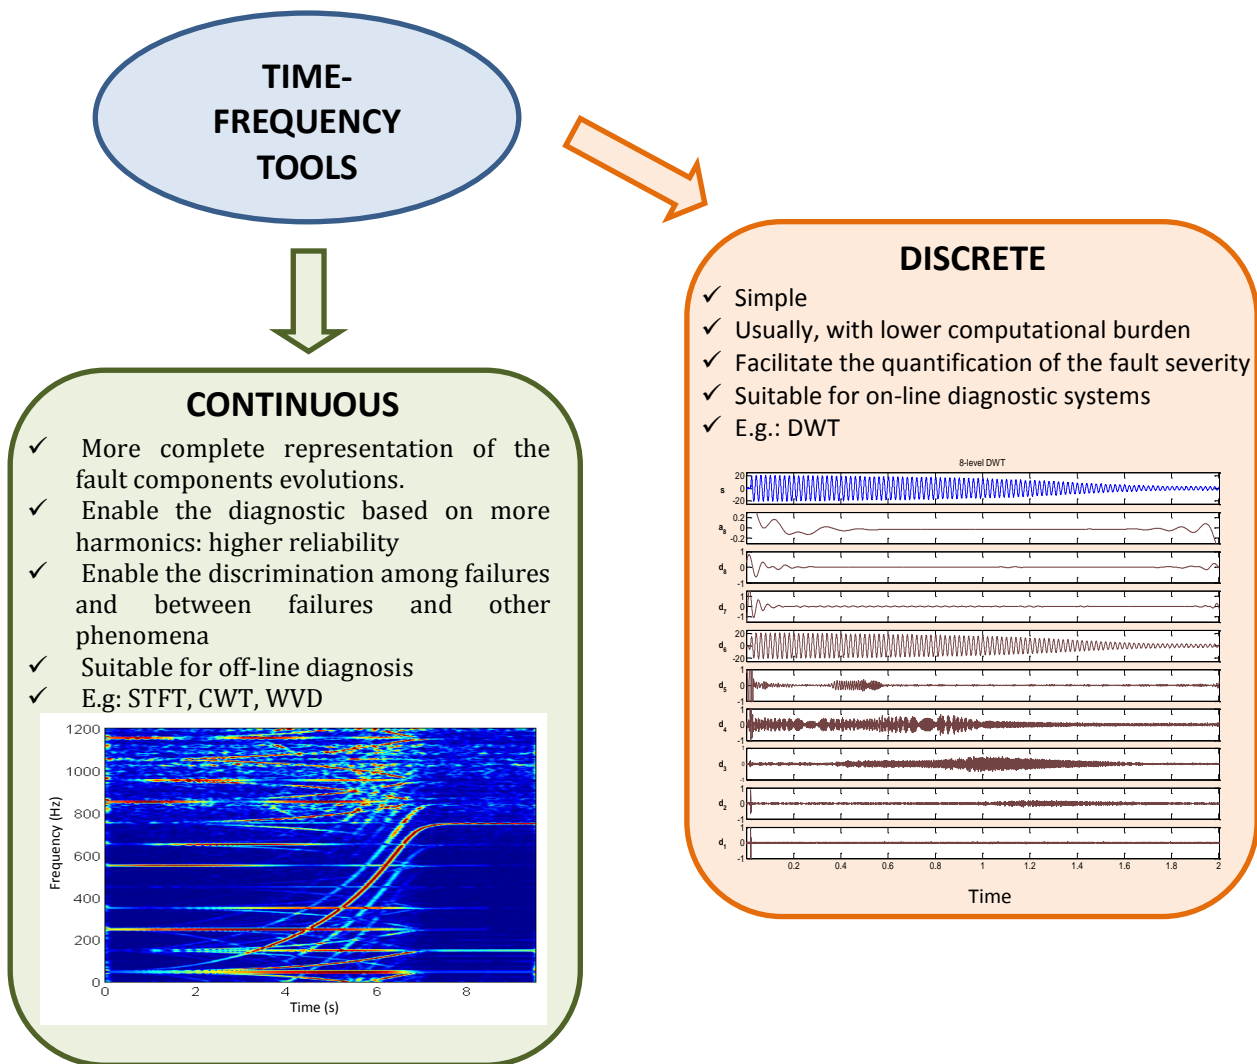
Figure 4. Schematic representation of the different types of time-frequency tools.

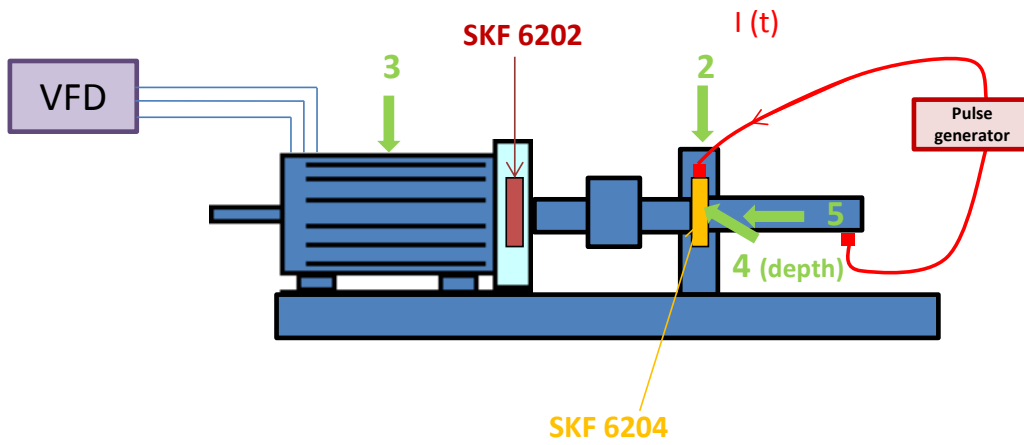
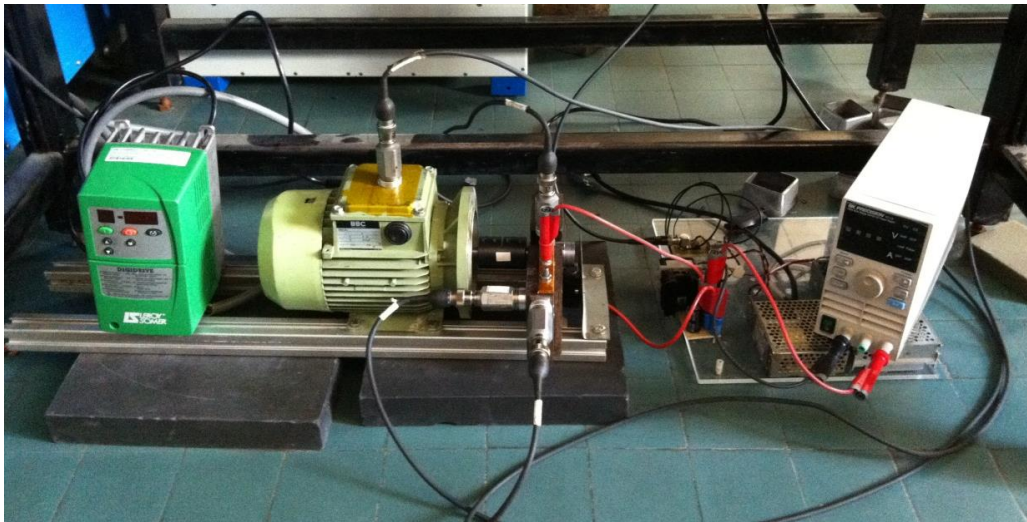
Figure 5. Scheme (top) and picture (bottom) of the experimental test bed.

Laboratory experiments were developed using the test bench depicted in Fig. 5. An induction motor was driven through a frequency converter that set the supply frequency at 50.3 Hz. The rated characteristics of the motor were: rated power $P_n=0.45$ kW, rated speed $n_n=2830$ r.p.m, rated voltage $U_n=380/220$ V, rated frequency= 50 Hz and power factor $\cos\phi=0.79$. One of the motor bearings was the SKF 6202 model; this bearing was showing incipient signs of damage due to its prolonged use. In the opposite border to the motor shaft, the tested SKF 6204 bearing was mounted.

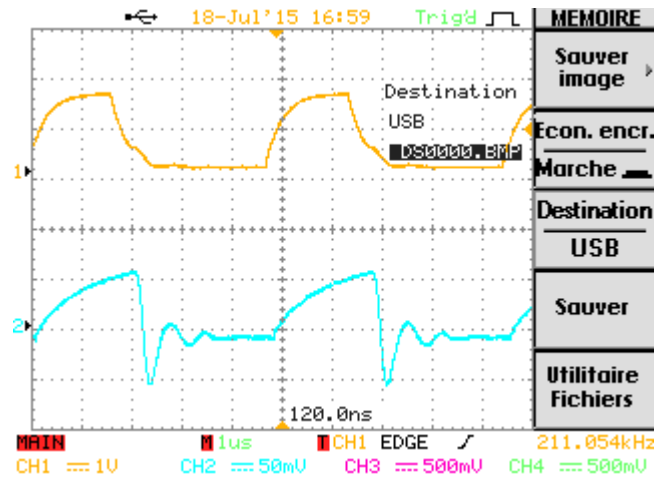
Figure 6. Waveforms of the voltage applied between bearing cage and shaft (top) and resulting current pulses (bottom).

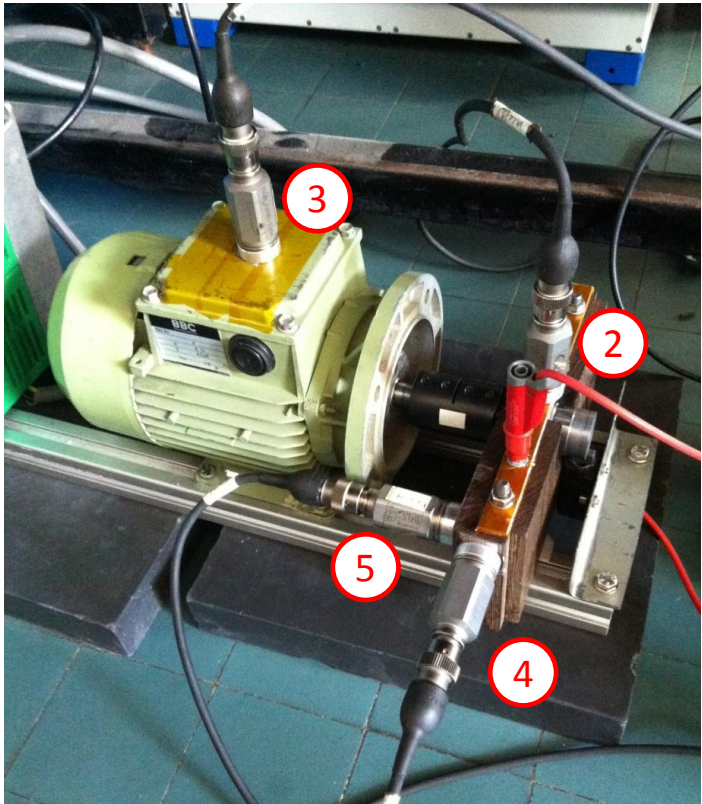
Figure 7. Detail of the vibration measurement points.

time-frequency analysis to see how the bearing currents increase the damage of the bearing outer raceway over time. Note that (unlike what happens at points 2, 4 and 5) at point 3 the indicator remains approximately stable. This is logical since this measurement point is much farther from the bearing where the fault takes place (see Fig. 7).

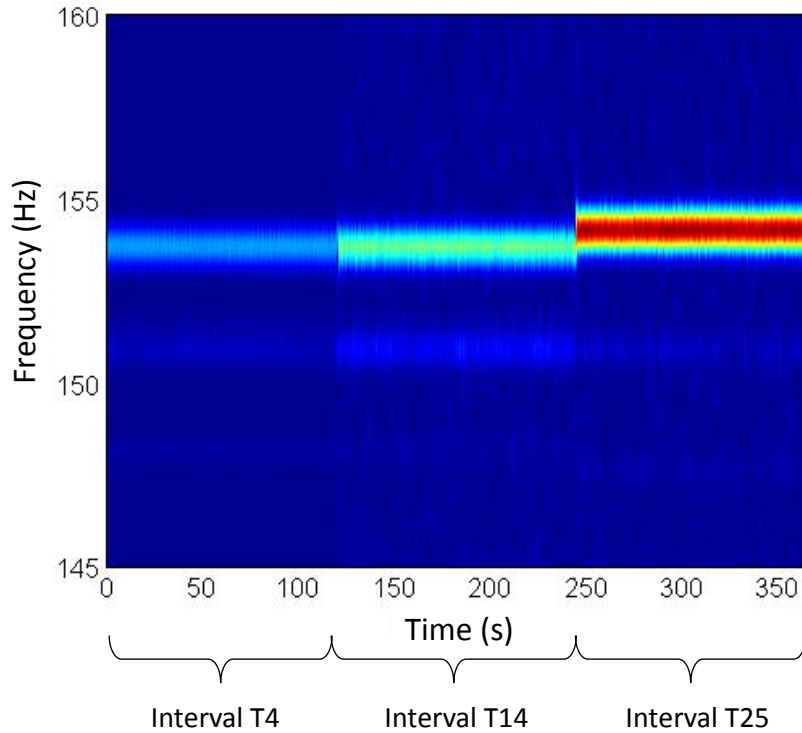
Figure 8. STFT analysis for the vibration signal at point 2 during the time intervals T4, T14 and T25 (frequency band 145-160 Hz).

With regards to Fig. 8, note how the frequency component at around 154 Hz associated with the outer raceway damage in the bearing SKF 6204, in which the currents were injected (see f_o in Table II) progressively increases its amplitude as the severity of the failure gets worse due to the circulation of these bearing currents (note the more intense colour in interval T25 in comparison with the intervals T14 and T4, where the development of the fault was more incipient). Note also that there is slight ‘displacement’ of that frequency between T14 and T25 (the frequency is slightly higher in T25). On

the other hand, note that there is a very slight component at around 151 Hz (which is almost unadvertised in that figure). This component is due to the degradation of the outer raceway of SKF 6202 due to its prolonged use (see frequency f_o in Table II); the amplitude of this component is more stable over time and has a much smaller value than the component associated to the failure in SKF 6204.

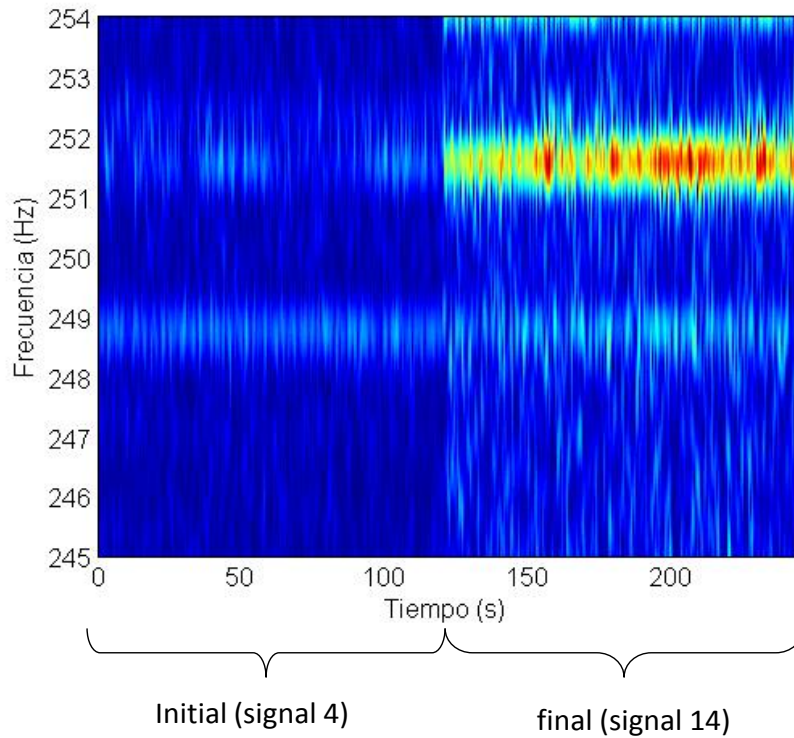
Figure 9. STFT analysis for the vibration signal at point 2 during the time intervals T4 and T14 (frequency band 245-254 Hz).

In Fig. 9, note that the amplitude of the component at around 247-248 Hz associated to the bearing failure in the inner raceway of SKF 6204 (see f_l in Table II) remains almost constant from T4 to T14. However, the component at near 251 Hz (associated with the inner raceway failure in SKF 6202) increases from T4 to T14, hence revealing a progressive degradation of this bearing (see Table II).

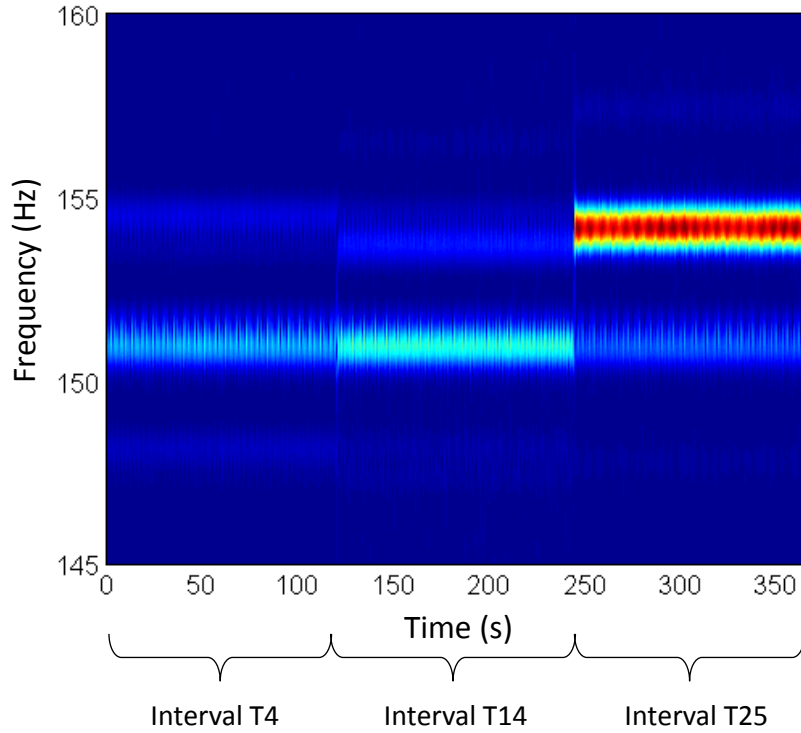
Figure 10. STFT analysis for the vibration signal at point 4 during the time intervals T4, T14 and T25 (frequency band 145-160 Hz).

Fig. 10 is equivalent to Fig. 8 but for point 4 instead of point 2 (see Fig. 7). Again, the figure only plots the frequency region under interest (145-160 Hz). Fig. 10 shows a quite similar behaviour of the fault components in the [145-160] Hz region as that shown in Fig. 8. The fault component associated to the damage in the outer raceway of SKF 6204 (around 154 Hz, see Table II) shows a prominent increment (especially from T14 to T25) that reflects the progressive damage in the outer raceway due to the injection of bearing currents. On the other hand, the amplitude of the component at around 151 Hz remains approximately constant (despite a slight increase in the interval T14); again, this may be linked with the inherent damage of SKF 6202 due to prolonged use.

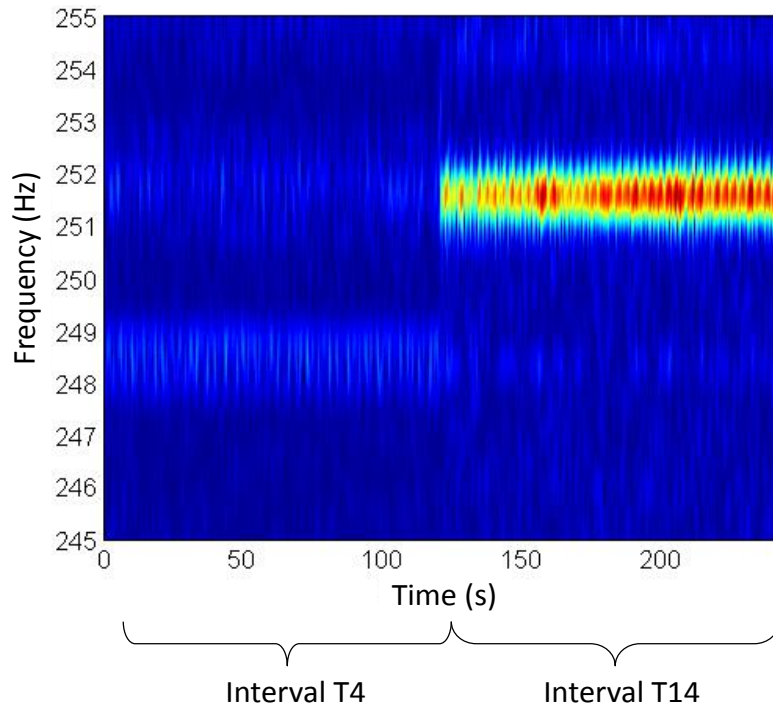
Figure 11. STFT analysis for the vibration signal at point 4 during the time intervals T4 and T14 (frequency band 245-255 Hz).

Fig. 11 depicts the time-frequency analysis for the time intervals T4 and T14, circumscribed to the frequency band [245-255] Hz. Note, again, the prominent amplitude increment for the component associated to the SKF 6202 inner raceway damage.

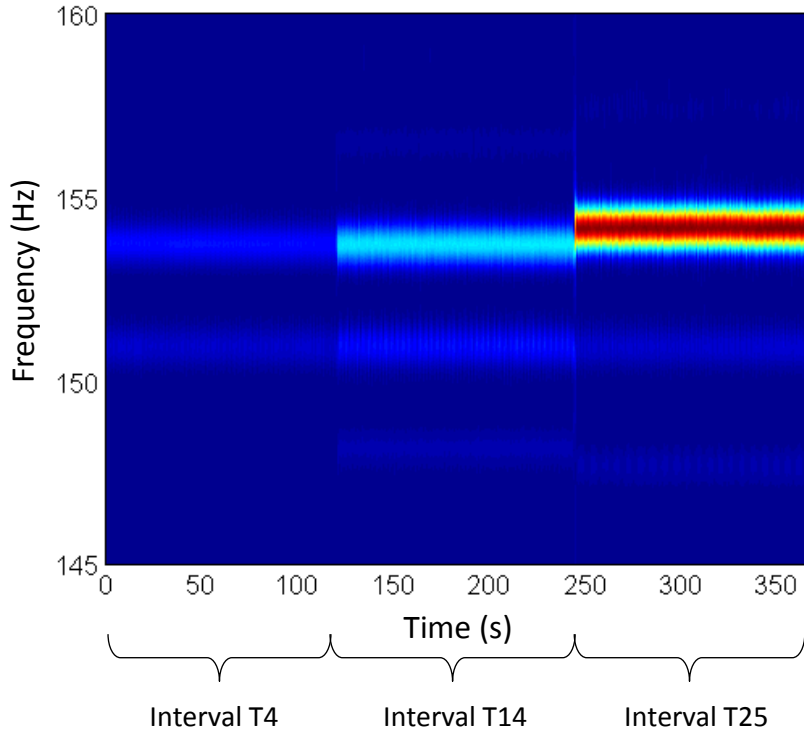
Figure 12. STFT analysis for the vibration signal at point 5 during the time intervals T4, T14 and T25 (frequency band 145-160 Hz).

Fig. 12 depicts the time-frequency analysis of the vibration signals captured at point 5 during the three intervals (T4, T14 and T25); the graph is restricted to the frequency interval [145-160] Hz. Note that it is clearly evident the progressive increment in amplitude of the component associated with the damage in the outer raceway (f_o) for bearing SKF 6204 (component around 154 Hz), which is provoked by the current injection in this bearing. On the other hand, the component at around 151 Hz (which is linked to the damage in the outer raceway of SKF 6202) has relatively low amplitude that remains almost constant, as observed in the graph.

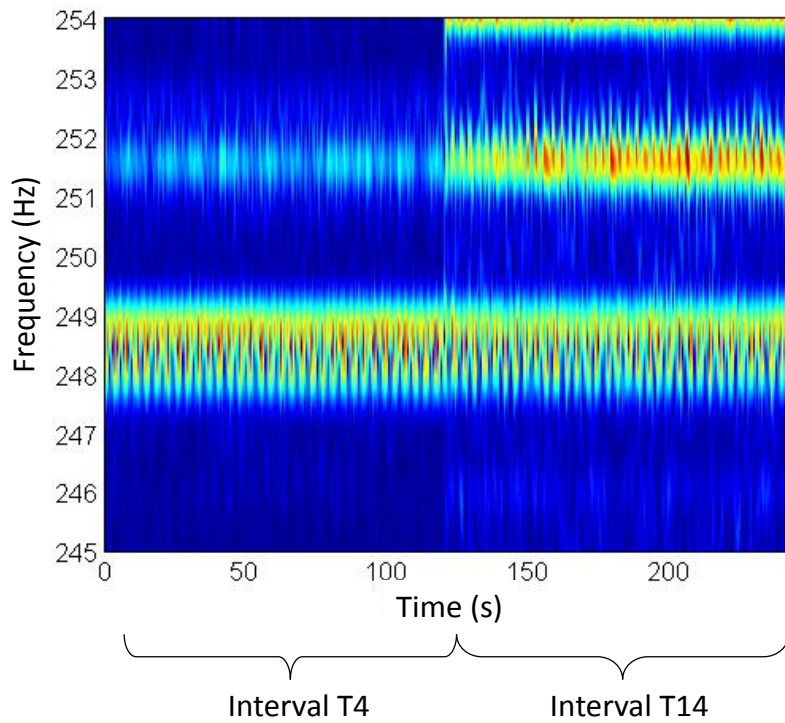
Figure 13. STFT analysis for the vibration signal at point 5 during the time intervals T4 and T14 (frequency band 245-254 Hz).

Fig. 13 shows the time-frequency analysis for the time intervals T4 and T14, circumscribed to the frequency band [245-254] Hz. Note, the amplitude increment for the component associated to the SKF 6202 inner raceway damage (around 251 Hz, see Table II). Also note that the significant amplitude of the component associated with the SKF 6204 inner raceway failure. Once again, time-frequency tools provide the possibility of discriminating between the components caused by the failures at the different bearings.

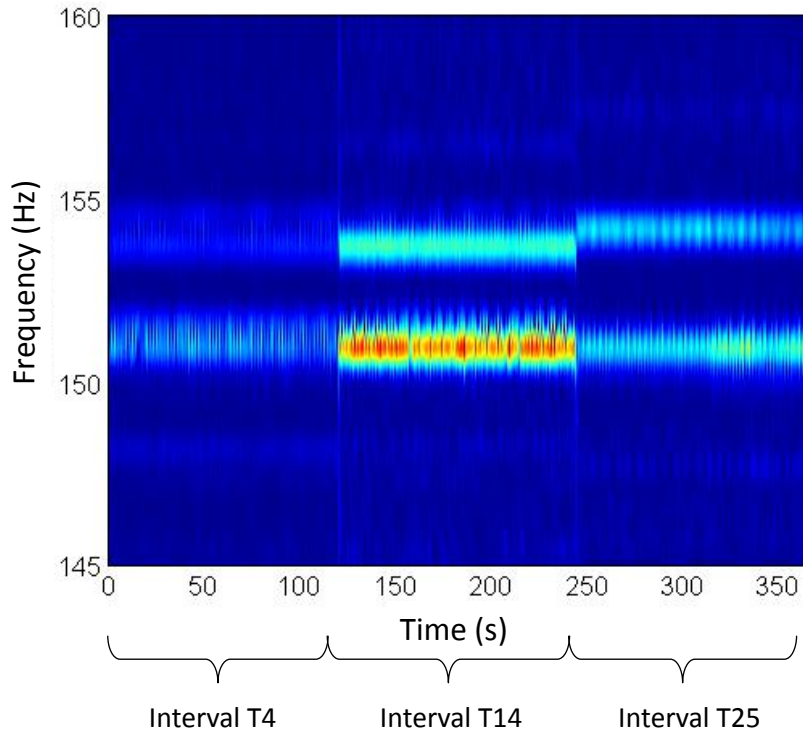
Figure 14. STFT analysis for the vibration signal at point 3 during the intervals T4, T14 and T25 (frequency band 145-160 Hz).

Fig. 14 depicts the time-frequency analysis of the vibration signals captured at point 3 during the intervals (T4, T14 and T25); only the frequency range [145-160] Hz is plotted. Note that in this case, since the vibration measurement point is over the motor frame, much nearer to bearing SKF 6202 than to SKF 6204 (see Fig. 7), the effects of the failure in the nearest bearing are much more noticeable. Hence, the component at around 151 Hz, which is associated to the outer raceway damage in bearing

SKF 6202 (see Table II) is much more prominent than that at around 154 Hz (caused by the damage in SKF 6204). In any case, the time-frequency analysis, once again, enables to discern between the components caused by different bearings and to detect their progressive increase in amplitude over time.

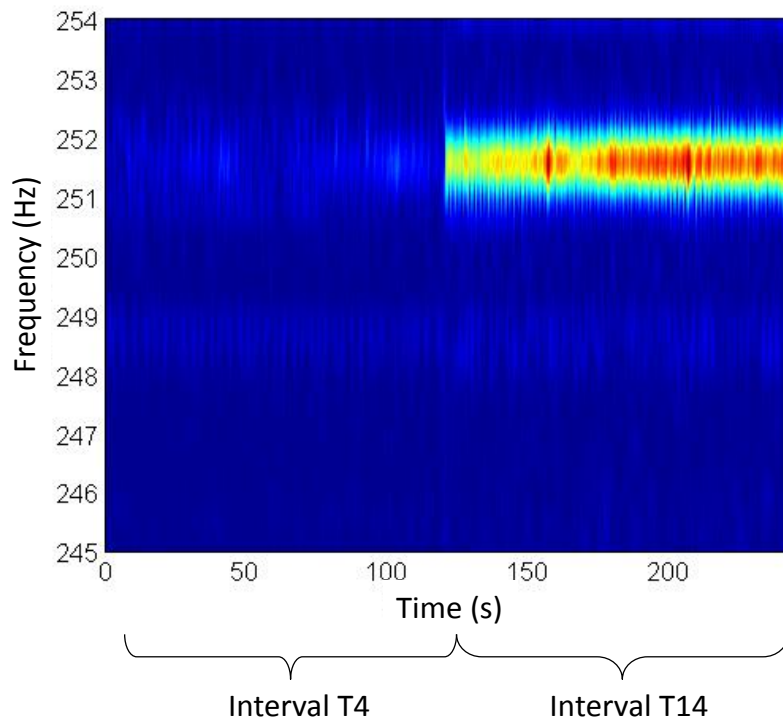
Figure 15. STFT analysis for the vibration signal at point 3 during the time intervals T4 and T14 (frequency band 245-254 Hz).

Fig. 15 shows the time-frequency analysis for the time intervals T4 and T14 for the frequency range [245-254] Hz. Note, again, the amplitude increment for the component associated to the SKF 6202 inner raceway damage (around 251 Hz, see Table II). Also note the presence of the component associated with the SKF 6204 inner raceway failure. Note that while the amplitude of the component associated with the SKF 6202 failure is larger, that of the component linked to SKF 6204 is lower than for the previous measurement points, due to the fact that measurement point 3 is much nearer to the first bearing than to the second. In any case, once again, time-frequency tools allow discrimination between the components caused by the failures at the different bearings, as well as monitoring of their severities.

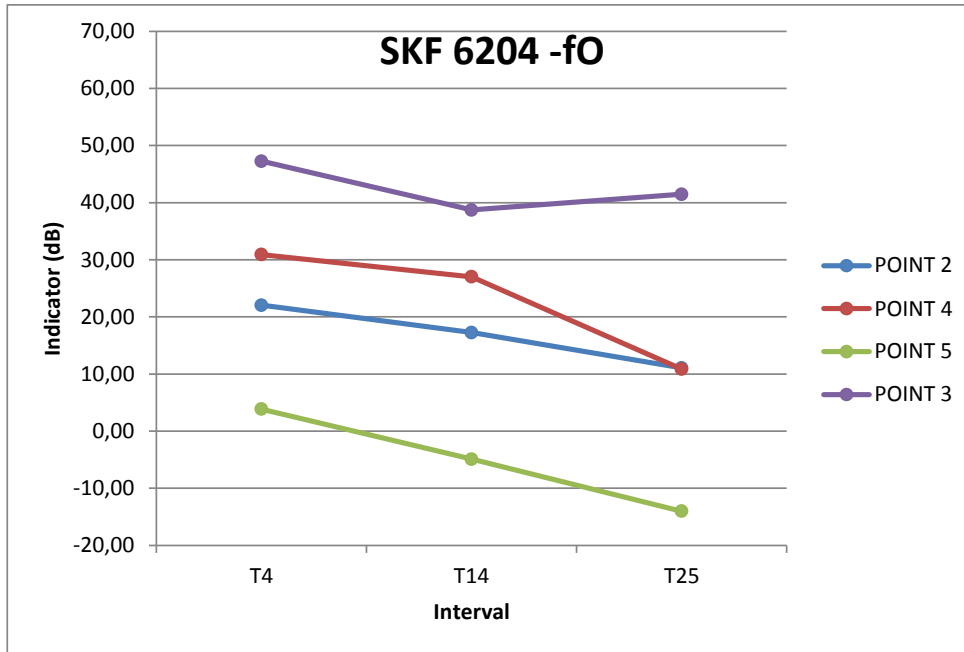
Figure 16. Graphical representation of the evolution of the fault severity indicator at each measurement point for the bearing SKF 6204 (fault component f_o (outer raceway damage)).

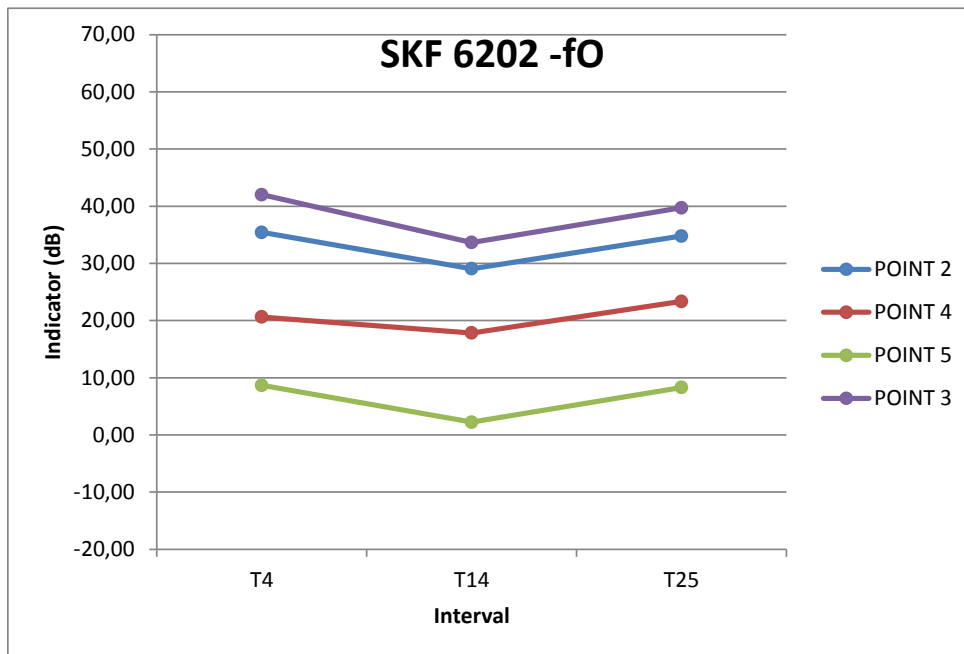
Figure 17. Graphical representation of the evolution of the fault severity indicator at each measurement point for the bearing SKF 6202 (fault component f_o (outer raceway damage)).

On the other hand, Fig. 17 is equivalent but for the SKF 6202 bearing. Note that the value of the indicator associated to the outer raceway failure in that bearing remains approximately stable. This is coherent with the time-frequency maps depicted in previous sections and shows how the level of failure in the outer raceway of this bearing does not substantially vary over the considered time intervals.

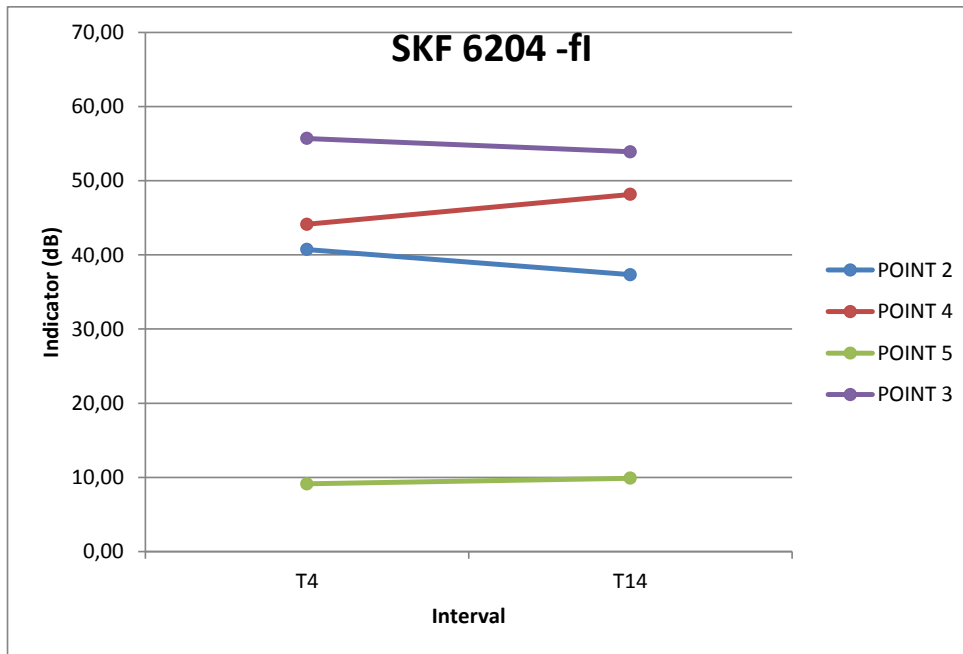
Figure 18. Graphical representation of the evolution of the fault severity indicator at each measurement point for the bearing SKF 6204 (fault component f_I (inner raceway damage)).

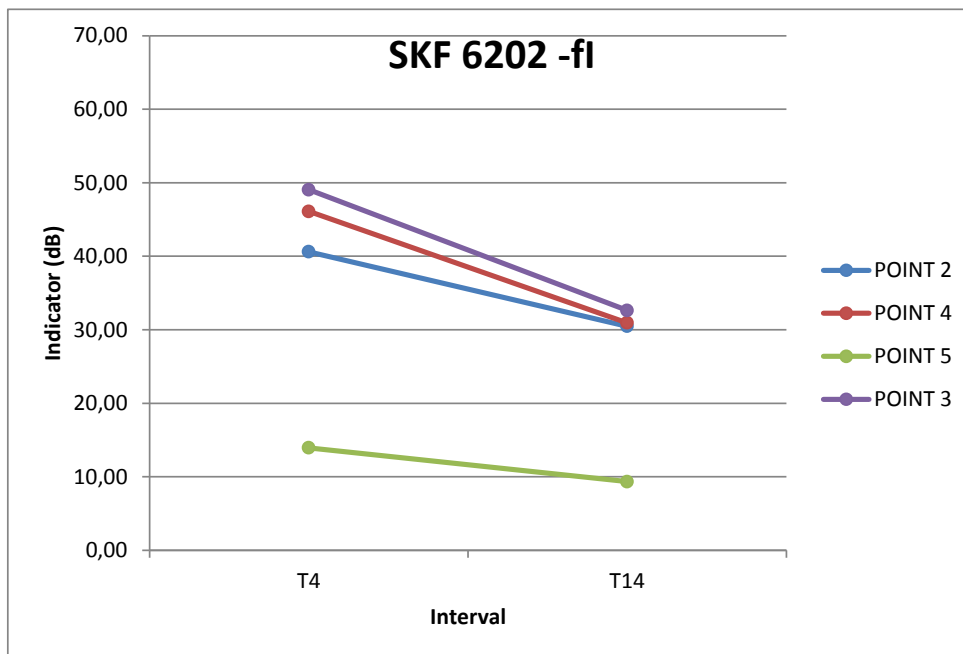
Figure 19. Graphical representation of the evolution of the fault severity indicator at each measurement point for the bearing SKF 6202 (fault component f_I (inner raceway damage)).

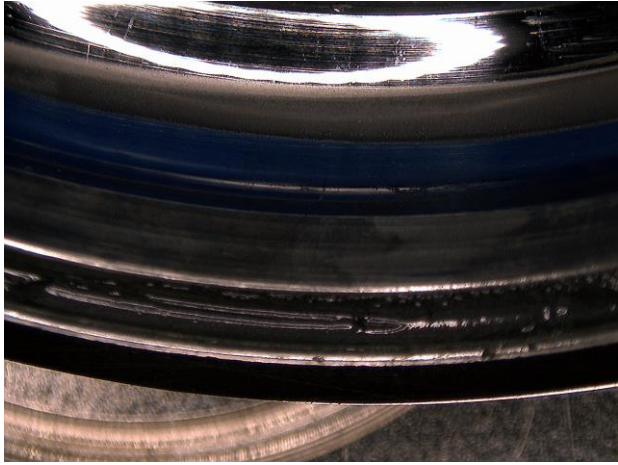
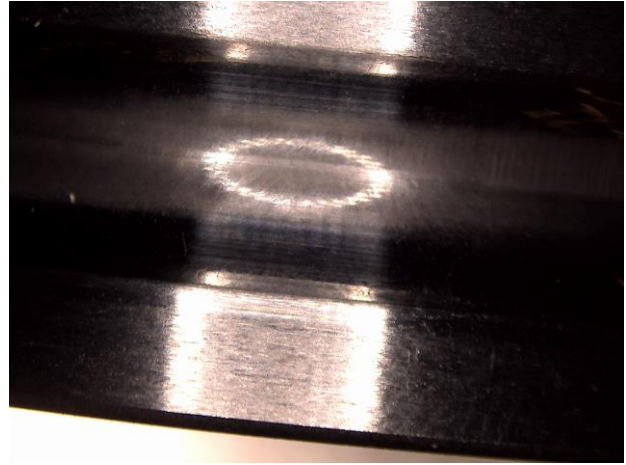
Figure 20. Pictures of the bearing SKF 6204 after its disassembly: (a) Outer raceway; (b) Inner raceway.

Fig. 20 shows some pictures obtained after disassembling the SKF6204 bearing after the tests. It can be observed the faulty condition of the outer cage provoked by the prolonged injection of currents; indeed, the pictures reveal the characteristic surface roughness pattern caused by this failure. On the other hand, the pictures reveal a slight level of failure in the inner raceway. These pictures prove that the information obtained with the time-frequency tools combined with the fault indicator provide a correct diagnostic of the condition of the bearing in the event of circulating bearing currents.
