SARA PERALES MOMPALER; Hernández Crespo, C.; Vallés Morán, FJ.; Martín Moneris, M.; Andrés Doménech, I.; Andreu Álvarez, J.; Jefferies, C. (2014). SuDS efficiency during the start-up period under Mediterranean climatic conditions. *CLEAN - Soil, Air, Water*. 42(2):178-186. doi:10.1002/clen.201300164.

1
2
3 **SuDS efficiency during the start-up period under Mediterranean**
4 **climatic conditions**
5
6
7
8

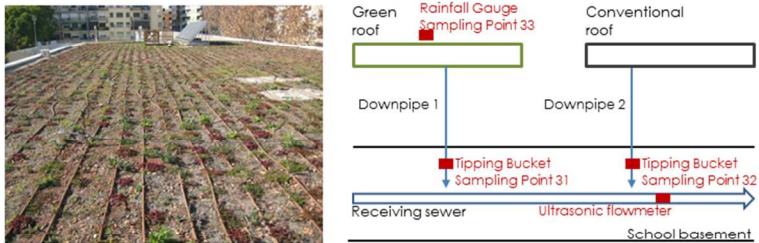
Site 3. Green roof. Photo (left) and monitoring points scheme (right).
254x190mm (96 x 96 DPI)

6 The Gonzalbes Vera Public School, located in the heart of the city of Xàtiva (38°59'26.80"N
7 0°31'04.31"W), was chosen as site 3 (Figure 3). 475 m² of the roof has been retrofitted with a
8 green roof and the playground has been re-paved with porous concrete. The substrate of the
9 vegetated roof has a density of 1060 kg m⁻³ and is rich in organic matter (29%), total nitrogen
10 (0.27%) and phosphorus (0.57% as P₂O₅). The depth of substrate is 10 cm and it is planted with
11 a variety of *Sedum*. Monitoring activities reported here comprised water quantity and quality
12 measurements from a section of the new green roof (218 m²) as well as runoff from the
13 remainder of the conventional roof which was untouched (107 m²).
14
15

17 Samples from both parts of the school roof, vegetated (31) and conventional (32), were
18 collected in four bottles linked to the tipping buckets (two bottles per tipping bucket). The
19 boxes where the buckets were placed were designed to allow the bottles to be filled
20 consecutively at the start of the rain event and thus, there were a total of four samples per
21 event. Finally, one bottle was located on the roof to collect rain water and atmospheric
22 deposition (33).
23
24

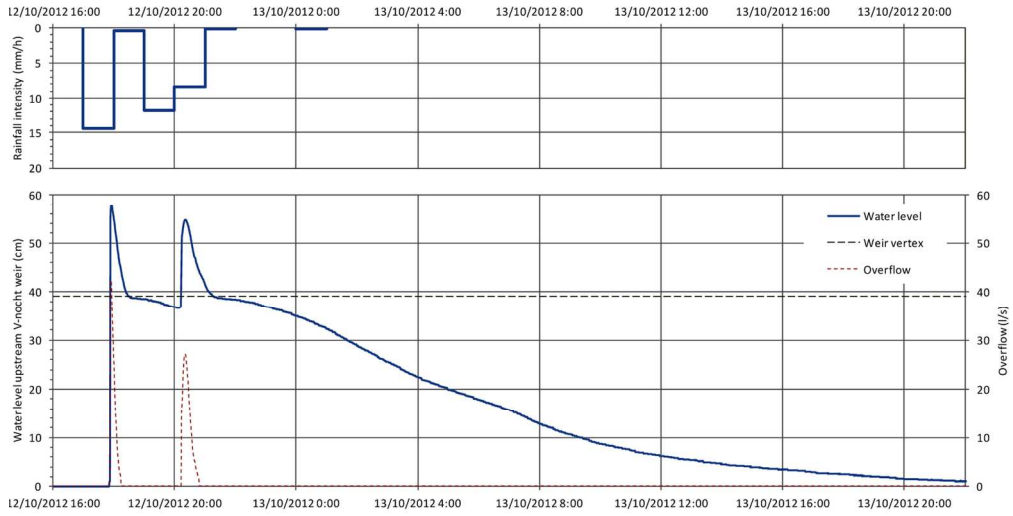
Hydraulic performance for site X1 during event 2.
69x35mm (600 x 600 DPI)

Hydrographs and water levels monitored at 1 and 2 show in detail the hydraulic performance of these SuDS. Figure 4 represents the hydraulic behavior of site 1 during event 2. This event was chosen among the huge amount of data collected and processed during the project, because it highlights properly the conclusions reached. Overflow occurs when the water level upstream exceeds the weir vertex level. Figure 5 shows results for the same event at the Ring Road site. Since the receiving sewer hydrograph was also monitored at this location, the results are more conclusive. It will be observed that each time the swale overflows (twice in event 2), the peak flow of the spill flow occurs later than the sewer peak flow. This highlights the attenuating effect produced by the swale. Spill volumes during event 2 can also be calculated: 54.1 m³ for 1 and 33.4 m³ for 2. The spill volumes were compared with the infrastructure storage volumes (170 m³ and 218 m³ respectively). The result shows that spill volumes were smaller than those detained.

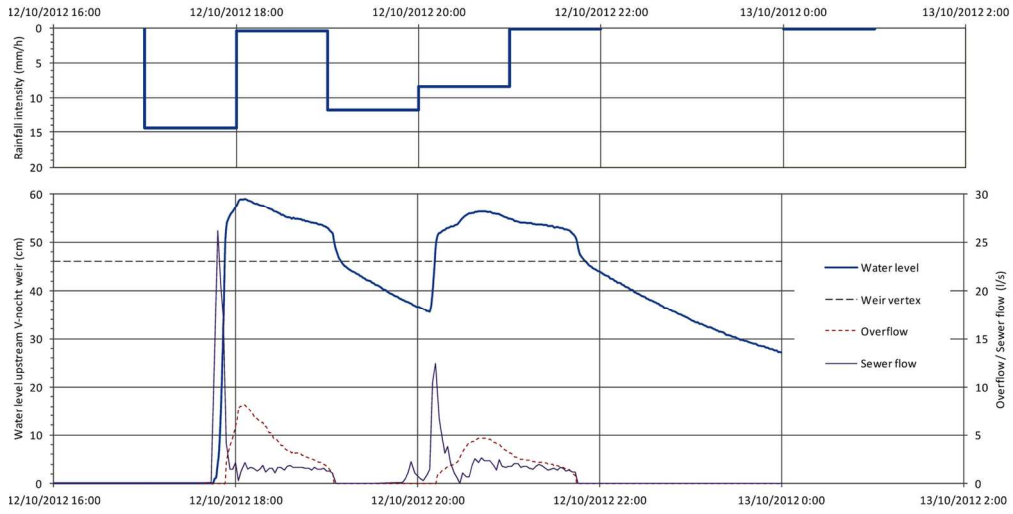
Hydraulic performance for site X1 during event 2.
68x34mm (600 x 600 DPI)
