Flood risk of natural and embanked landscapes on the Ganges–Brahmaputra tidal delta plain

L. W. Auerbach¹, S. L. Goodbred Jr^{1*}, D. R. Mondal², C. A. Wilson¹, K. R. Ahmed³,
K. Roy³, M. S. Steckler⁴, C. Small⁴, J. M. Gilligan¹, B. A. Ackerly⁵

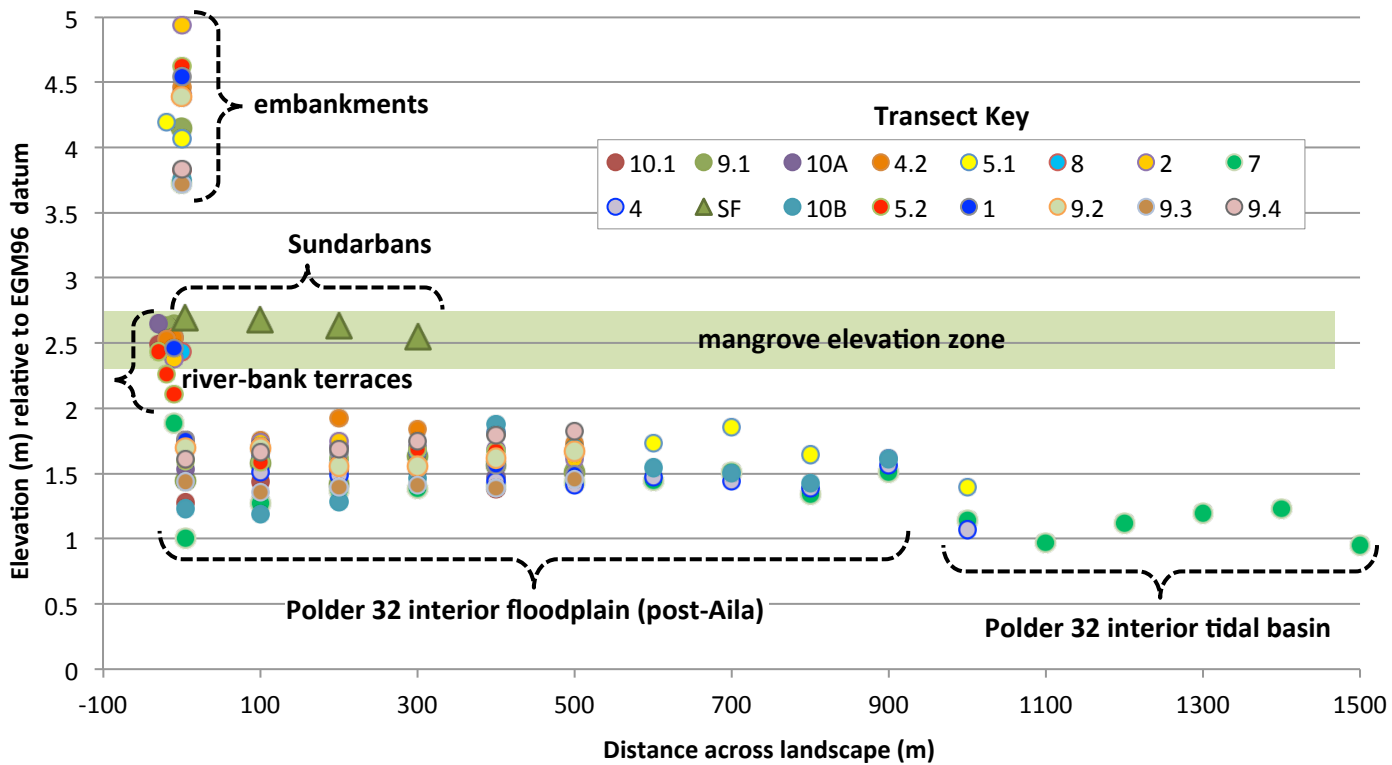
Figure S2 | GPS elevation survey data. Polder 32 elevation transects (colored circles) extend up to 1500 m from the embankment into the polder interior. These results are the same dataset shown in Figure 2, but here the full data range of transect >500 m inland of the embankments are shown. Mean elevation of the polder interior floodplain is 1.5 ± 0.1 m, with its protective embankments ranging 3.7 to 4.6 ± 0.1 m. The mean elevation of the Sundarbans (green triangles) is 2.65 ± 0.10 m, with the range of intertidal mangrove vegetation shown by the green bar.

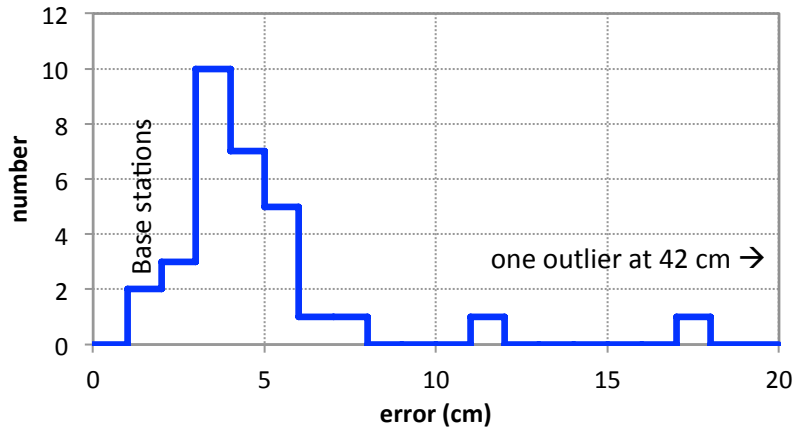
Figure S3 | Histogram of error for the GPS elevations. Mean error of the dataset is 5.2 ± 2.8 cm.

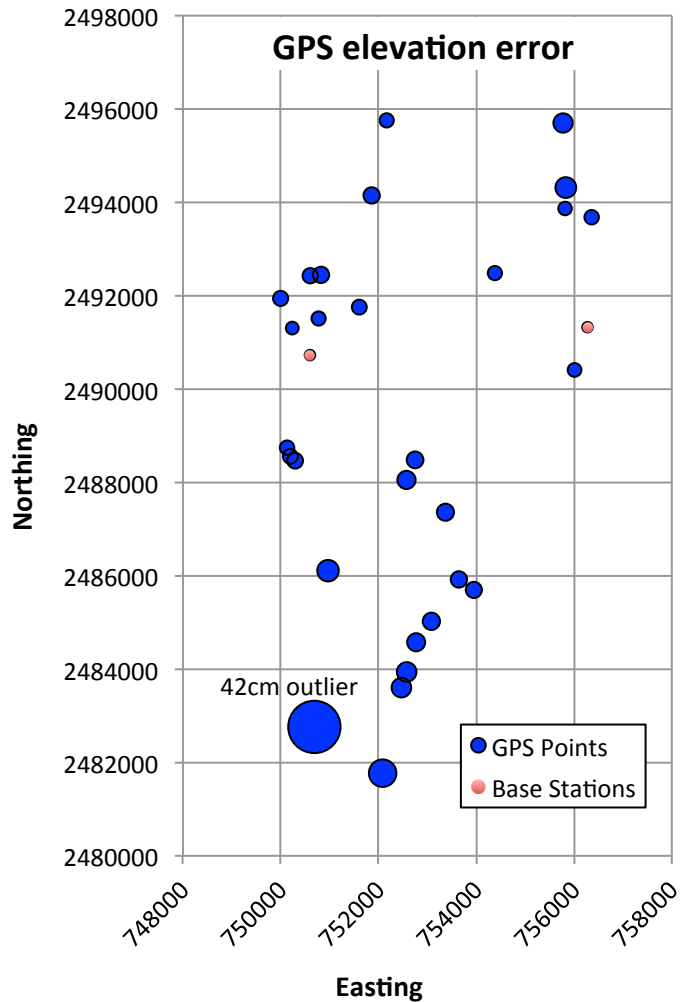
Figure S4 | Plot of GPS survey point locations with symbols proportional to their elevation error, ranging 2-42 cm.

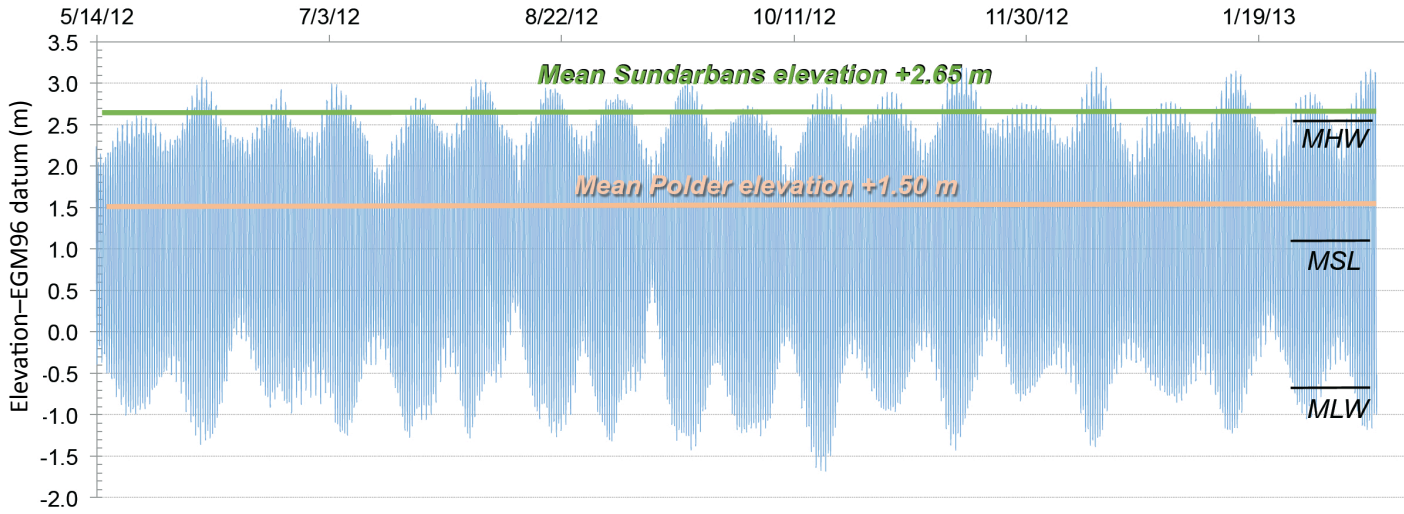
Figure S5 | Water-level data from tidal channel east of Polder 32. Data collected at 10-minute intervals using a deployed pressure gauge. Location shown in Figure 1. Instrument height was surveyed during the GPS survey to tie observed water levels to the EGM96 datum. The characteristic fortnightly variations in tidal range reflect spring-neap astronomical cycles.

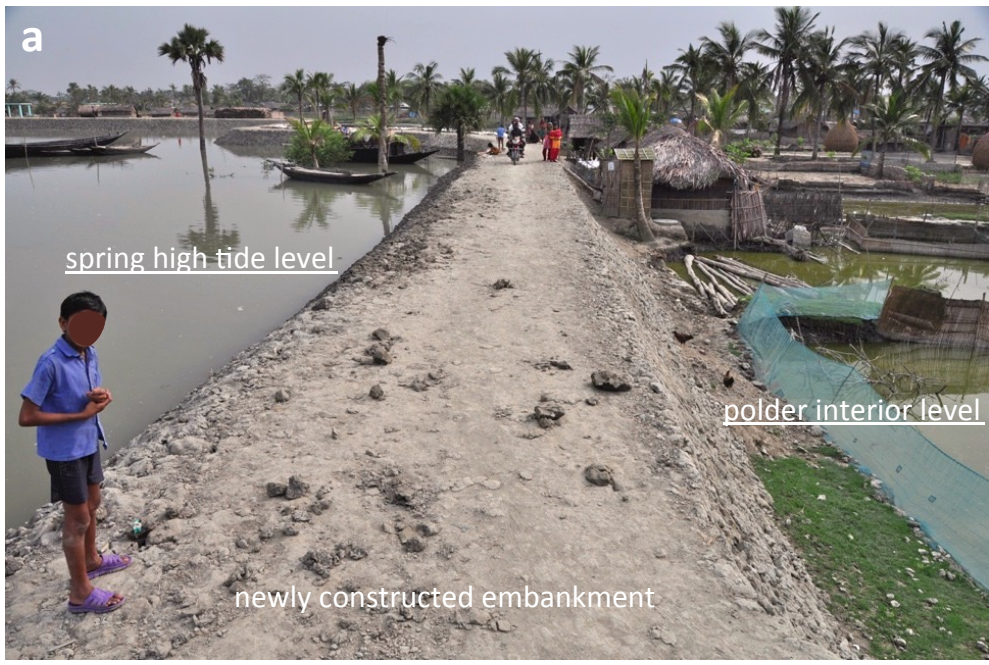
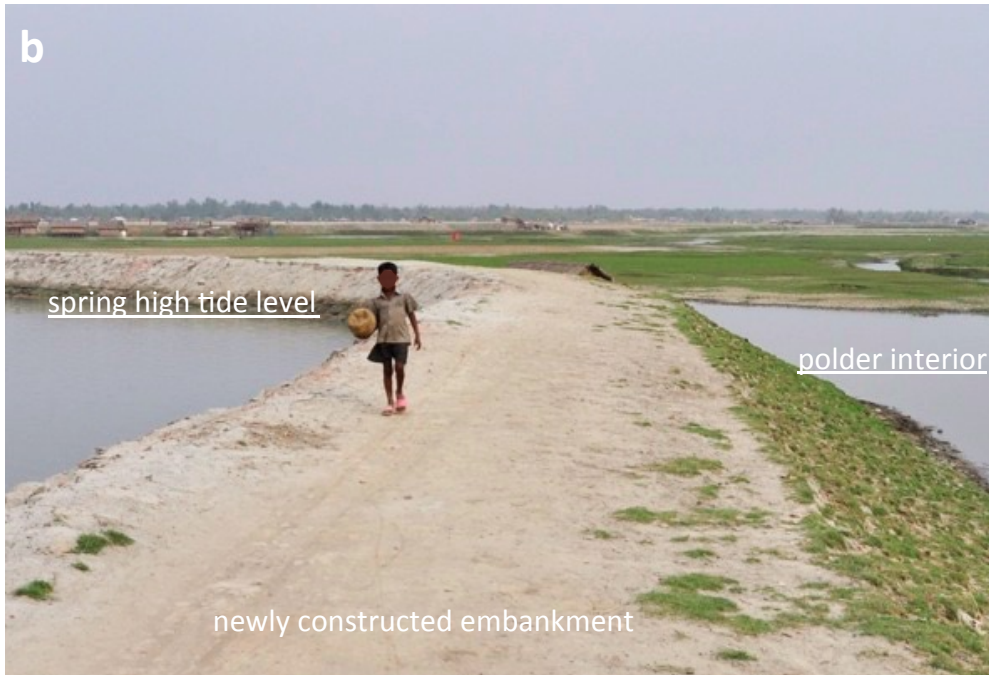
Figure S6 | Field photos contrasting tidal channel water levels with Polder 32 interior.
a, b Photos of newly reconstructed embankment along one of the major breaches. Images taken near to spring high tide, contrasting the relative elevation between high water and the polder interior.

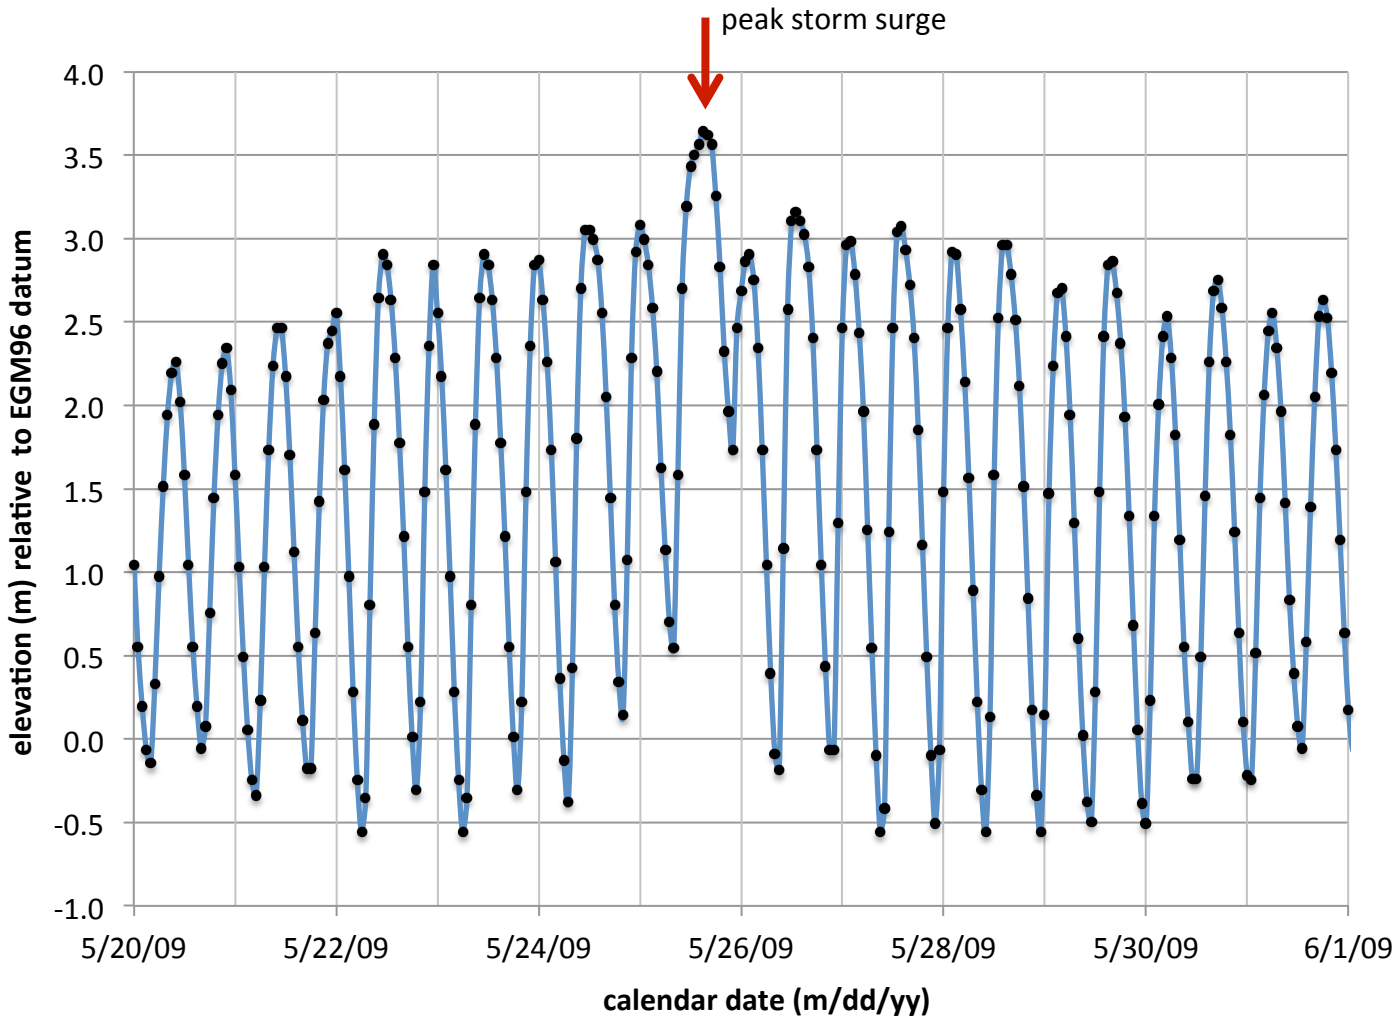
Figure S7 |Tide gauge record showing Cyclone Aila storm surge. The storm made landfall on May 25, 2009, coinciding with low tide. With much of the storm inland during the ensuing flood tide, the resulting surge (red arrow) was only ~50 cm above the astronomical high tide. There were no reports of the surge overtopping the embankments on Polder 32, yet the storm forced five major breaches of the embankments despite the modest surge height (Figure 1). The tide gauge data shown here are from Mongla, about 15 km east of Polder 32 (Figure S1) and connected by several large tidal channels .

the embanked region. Given the modest storm surge height (Supplementary Fig. 3; ~0.5 m above spring high tide), it is also likely that the out-of-phase timing between the flooding storm surge and ebbing astronomical tide generated locally accelerated current velocities and scour within existing channel thalwegs. In summary we note that the preferential failure of embankments at Polder 32 and at specific locations on the island were non-randomly distributed and clearly correlate with the physical attributes described above; however, the exact cause or combination of factors causing the failures remains uncertain.

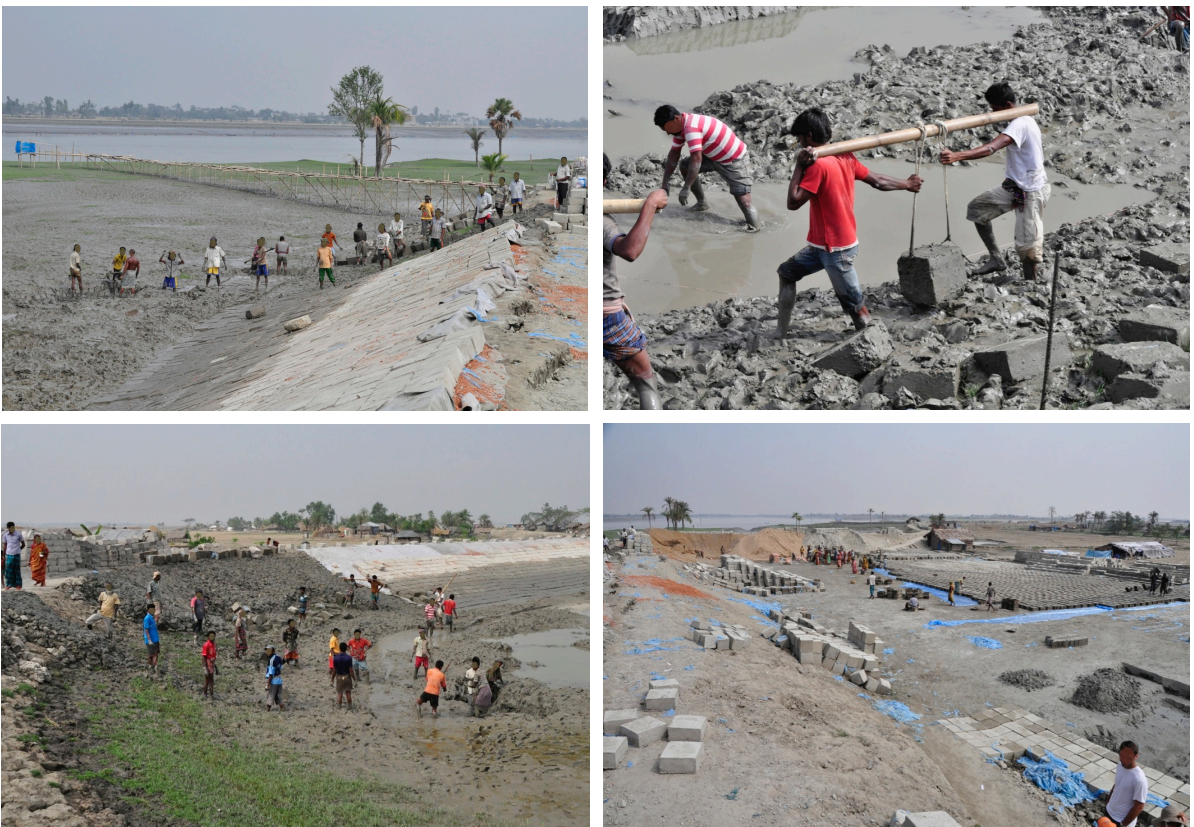
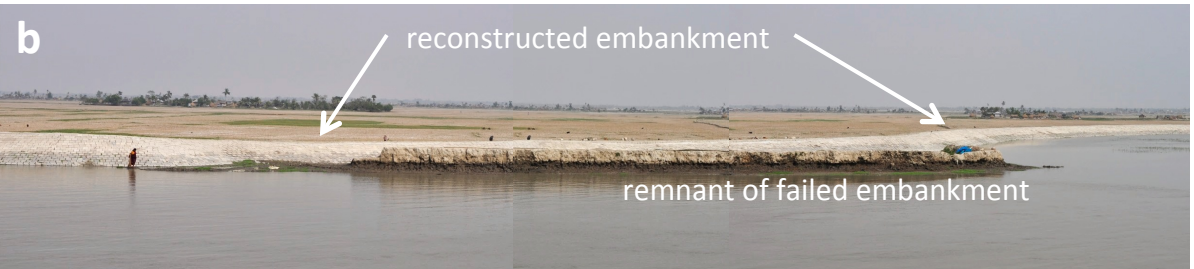
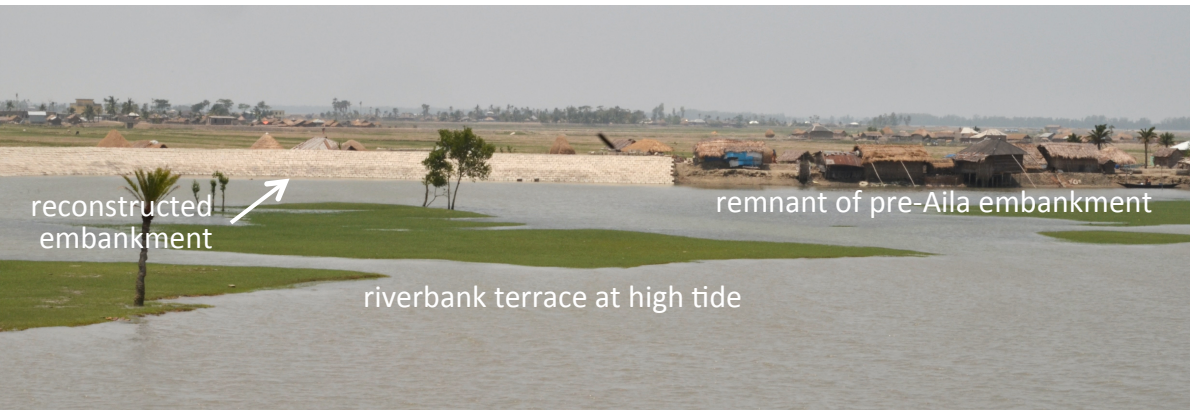
Figure S9 | Field photos showing embankments and repair efforts on Polder 32. **a**, Local and regional labor reconstructing a portion of embankment. Concrete blocks are made on site and emplaced by hand. Embankment repair and maintenance was an important income source following Cyclone Aila during the temporary loss of local livelihoods such as shrimping and rice cultivation. Photos taken at low tide. **b**, Repaired sections of the Polder 32 embankment observed along the Sibsa River during high tide.

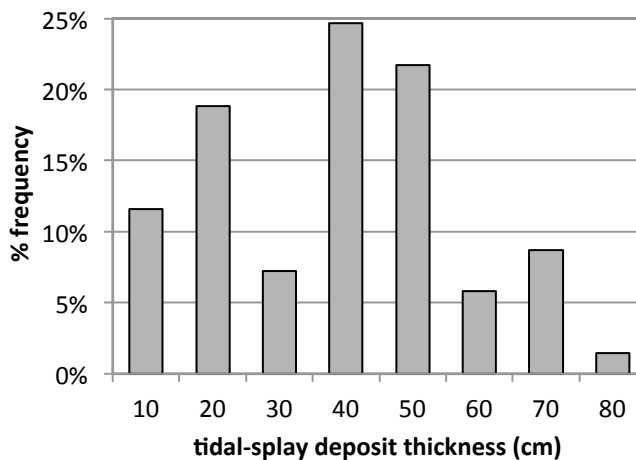
Figure S11 | Histogram of tidal-splay sediment thickness measured across Polder 32. Post-storm tidal sediments were identified in 67 of 114 cores, ranging in thickness from 5-72 cm. Mean measured thickness of deposited sediment is 37 ± 18 cm.

Sediment cores collected on Polder 32 revealed a locally thick, surficial deposit of silt and fine-sand laminae at 67 of 114 sampled locations (Figs. 1, 3d and Supplementary Fig. 10). These deposits range in thickness from 10- cm to 72 cm (Supplementary Fig. 11), with a mean of 40 cm, and were most apparent as tidal splay deposits located adjacent to large channel scours observable in post-storm satellite imagery (Fig. 1). The well-laminated sandy unit is consistently underlain by a darker grey, silty soil that corresponds to the former agricultural surface prior to flooding (Supplementary Fig. 10). We infer that the tidal splay deposits are a product of the two-year period of daily tidal inundation that followed embankment breaches. Areas of Polder 32 that did not experience significant post-storm deposition were generally located at the distal reaches of the tidal splay features or where local embankments were repaired soon after the storm. By contrast, Polders 31 and 33 to the west and east of Polder 32, respectively, were subjected to only local flooding during the storm and none thereafter (Fig. 1). At these locations, 7 of 11 sediment cores comprised only the ambient agricultural soil, with the remaining sites bearing just a few centimeters of storm-deposited sediment.

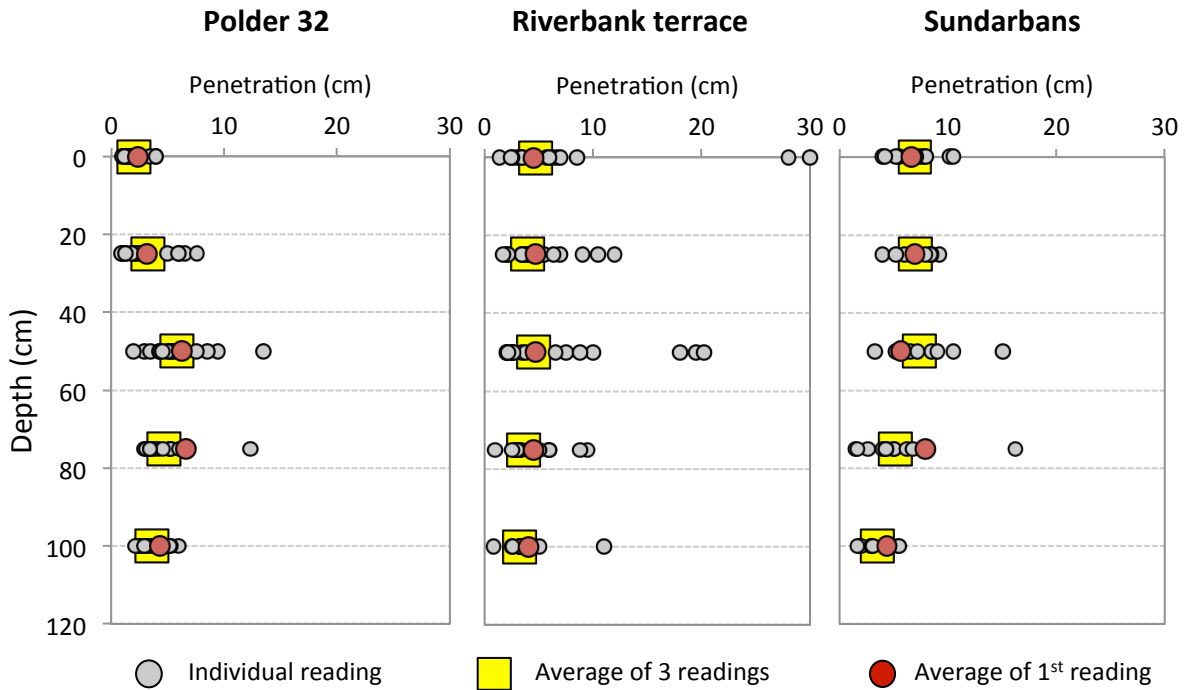
Figure S12 | Results of dynamic cone penetrometer tests. Results show that sediments in the upper 50 cm on Polder 32 are more consolidated than sediments on the riverbank terraces and in the Sundarbans.

Compaction in coastal deltas, which may be a great source of elevation offset, is perhaps the least constrained parameter for a land surface budget, particularly in the G-B delta. In a global assessment of deltas, ref. 1 differentiated compaction due to natural processes (C_n = loss in void space due dewatering, grain packing realignment, also oxidation of organic matter) and anthropogenic compaction (C_a = volume change from underground [oil, gas, water] extraction, human-influenced soil drainage and accelerated oxidation). In the G-B delta, natural compaction is likely to be spatially and temporally variable, depending on heterogeneous stratigraphy; however no substantive measurements of natural compaction have been reported to date. Recent preliminary results from fiber-optic cables installed at different locations in the G-B delta indicate compaction may be confined to the upper 10 m of sediment (S. Nooner [U. of North Carolina, Wilmington] and M. Steckler [Columbia U.], personal communication). We estimate a conservative value of 0.4 cm/yr for C_n , which is similar to that reported for coastal Bangladesh² and would be the only source of compaction affecting the ‘pristine’ Sundarbans landscape. Local observations indicate that saline groundwaters in the region preclude extraction for irrigation or household consumption, so this potential source of compaction is not relevant in most of SW Bangladesh. However, due to substantial human-modification to the poldered landscape, including draining of surface water and soils for agriculture, we expect C_a to be more significant in populated regions of the G-B delta. Therefore, we estimate an enhanced rate of shallow soil compaction of 0.8 cm/yr for poldered areas to account for these processes (Supplementary Fig. 12). This value is expected to be a short-term consequence of the initial draining and drying of
