**SELMON
EXPRESSWAY**

Whiting Street PD&E Study

**Contamination
Screening Evaluation
Report**

February 2024

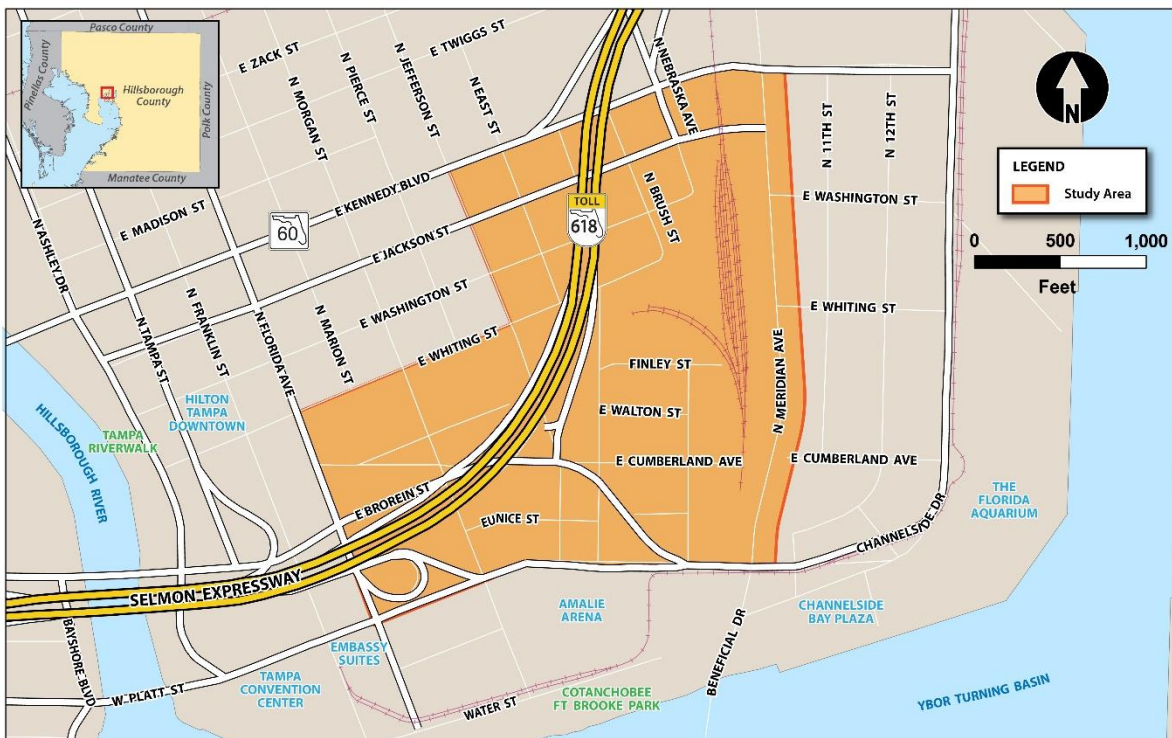
Figure 1.1: Original Location Map

It was anticipated that the Florida Avenue off-ramp (Ramp 6A) would be widened to two lanes, the Channelside Drive off-ramp (Ramp 6B) would be removed, and a new Whiting Street off-ramp would extend from the Selmon Expressway, near Morgan Street, to Nebraska Avenue and intersect with the new Whiting Street alignment to provide a direct connection from the Selmon Expressway. See **Figure 1-1** for the project location map.

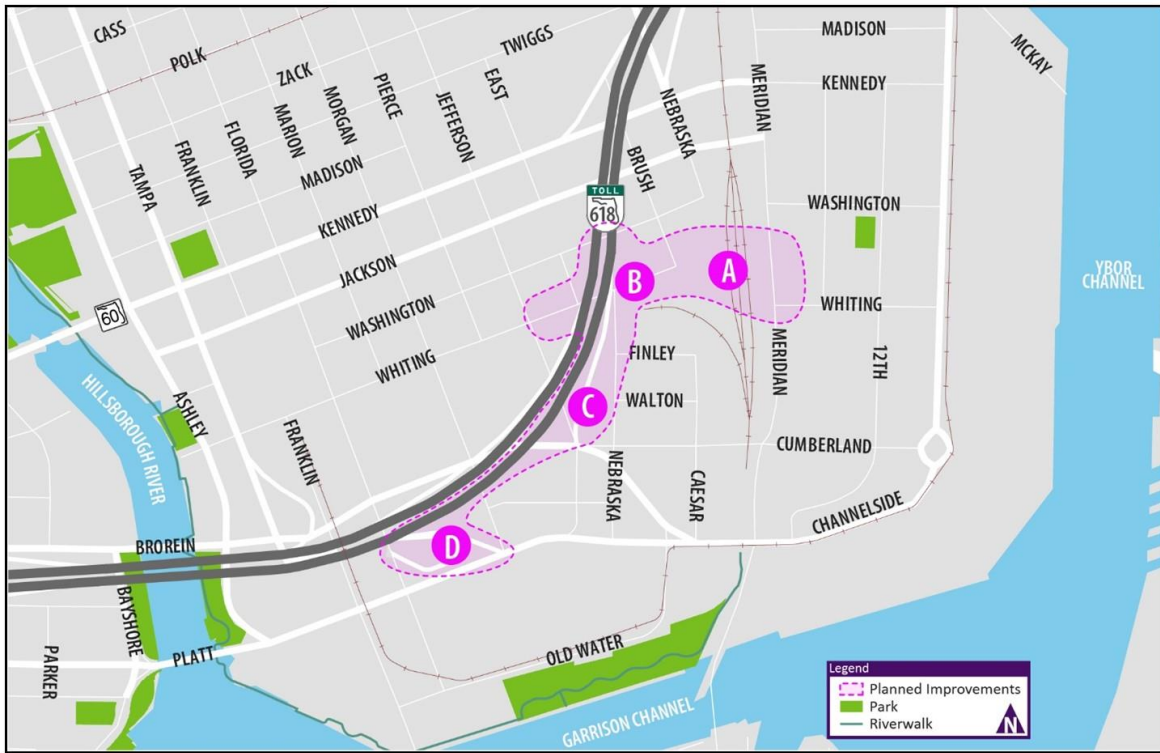
Figure 1.2: Locations of Proposed Improvements

Whiting Street currently ends at Brush Street, west of the existing railroad tracks. The preferred alternative proposes to extend Whiting Street, from Brush Street to Meridian Avenue, with a new signal at the T-intersection of Whiting Street and Meridian Avenue. The proposed typical section for the Whiting Street extension includes two 11-foot-wide travel lanes in the eastern direction, one 11-foot-wide travel lane in the western direction, a 10-foot-wide cycle track separated from the north side of the westbound travel lane by a four-foot traffic separator, curb and gutter, and 10-foot-wide sidewalks on both the north and south sides of the road. The eastbound approach to Meridian Avenue includes one 11-foot-wide dedicated left turn lane and one 11-foot-wide left/right turn lane. The existing grassed median on Meridian Avenue will be split in order to accommodate the proposed signalized intersection. The preferred alternative includes the addition of a northbound dedicated left turn lane from Meridian Avenue to Whiting Street and the opening of the median to feed a southbound left turn lane from Meridian Avenue to Whiting Street. The preferred alternative does not propose any other improvements to Meridian Avenue.

Whiting Street is currently a two-lane roadway with on-street parking on both the north and south sides of the road. East of the Selmon Expressway, Whiting Street is a brick road in need of repair. The preferred alternative proposes to widen/reconstruct Whiting Street from two to three lanes with two 11-foot-wide travel lanes in the eastern direction, one 11-foot-wide travel lane in the western direction, a 10-foot-wide cycle track separated from the north side of the westbound travel lane by a four-foot traffic separator, curb and gutter, and 10-foot-wide sidewalks on both the north and south sides of the road. The 10-foot-wide cycle track will extend to Jefferson Street. The preferred alternative also includes the installation of a new traffic signal at the intersection of Whiting Street and Brush Street.

The existing exit Ramp 6B provides users with the ability to travel east along Channelside Drive, towards the Amalie Arena and the Florida Aquarium. The preferred alternative proposes relocating exit Ramp 6B approximately 700 feet north and providing a direct connection to Whiting Street. The proposed ramp includes a single 15-foot-wide ramp lane, which will remain on structure beyond the existing Jefferson Street on-ramp. From this point, the ramp profile begins to decrease, and the ramp will be supported by a Mechanically Stabilized Earth (MSE) wall, which ends approximately 100 feet south of Whiting Street. The ramp widens to three 12-foot-wide lanes at the intersection, with one dedicated left turn lane and two dedicated right turn lanes. The proposed ramp will cut off access north, along Nebraska Avenue, and therefore requires a horizontal curve to connect Nebraska Avenue to Finley Street. The existing Jefferson Street on-ramp entrance will be shifted to the north to accommodate the new Whiting Street off-ramp.

The current configuration of exit Ramp 6A includes a tight single lane loop ramp that merges onto Florida Avenue under a free-flow condition. Modifications to this ramp include striping improvements to the ramp gore. In addition, safety improvements, including the addition of a high friction surface treatment, the addition of RRFB pedestrian signals at the ramp's connection with Florida Avenue, and removal of existing landscaping within the inside of the ramp loop to improve sight distance are proposed.

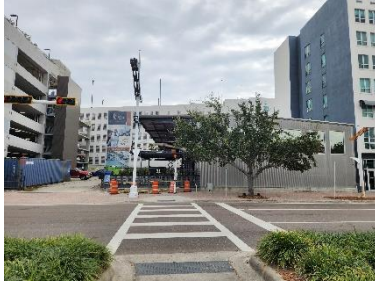
Photo ID 3 (Site 24)

24	3	Medium	General Portland/Peak Oil Co./Bay Drum Co.	211 N Meridian Ave.	PRP	<ul style="list-style-type: none"> Site located within 500 ft of ROW. Listed as a superfund site in the National Priority List (NPL). The United States Environmental Protection Agency (EPA) conducted a hazardous waste site investigation at the Peak Oil/Bay Drum site in 1983. Peak Oil Company was established in 1950 as an oil re-refining facility. Waste sludge from refining processes was placed in a holding pond (acid sludge pond). Potential contaminants included polychlorinated biphenyls (PCB), pesticides, solvents, extractable organic compounds and metals.
28	4	Medium	Liberty Tampa Brownfield (BF291602001)/Warehouse Garage/Meridian Avenue Improvements	227 N Meridian Ave./N Meridian Ave. & E John F. Kennedy Blvd.	BROWNFIELDS, CLEANUP SITES, DWM CONTAM, RESP PARTY, ASBESTOS, FINDS, ECHO, VCP, ERIC WASTE CLEANUP	<ul style="list-style-type: none"> Site located within 500 ft of ROW. Facility is reported as closed and remediation status is reported as complete. In 2018, a Site Rehabilitation Completion Order (SRCO) for the Liberty Tampa Brownfield Site (BF291602001), located at 227 North Meridian Street, Tampa, Florida was received from the EPC on January 16, 2018. The order is for a clean closure as described in Chapter 62-780, 62-780.680(1), Florida Administrative Code (FAC). No contamination of soil or groundwater is left at the site that exceeds the State of Florida's Contamination Cleanup Target Levels of Chapter 62-777, FAC. Based upon the information provided by Liberty Tampa Holdings, LCC, it is the opinion of the EPC that Liberty Tampa Holdings, LLC has successfully and satisfactorily implemented the approved Brownfield Site Rehabilitation Agreement (BSRA) schedule and, accordingly, no further action is required to assure that any land use identified in the BSRA is consistent with existing and proposed uses.
