**SELMON
EXPRESSWAY**

Whiting Street PD&E Study

**Cultural Resource
Assessment Survey
Pond Addendum**

January 2022

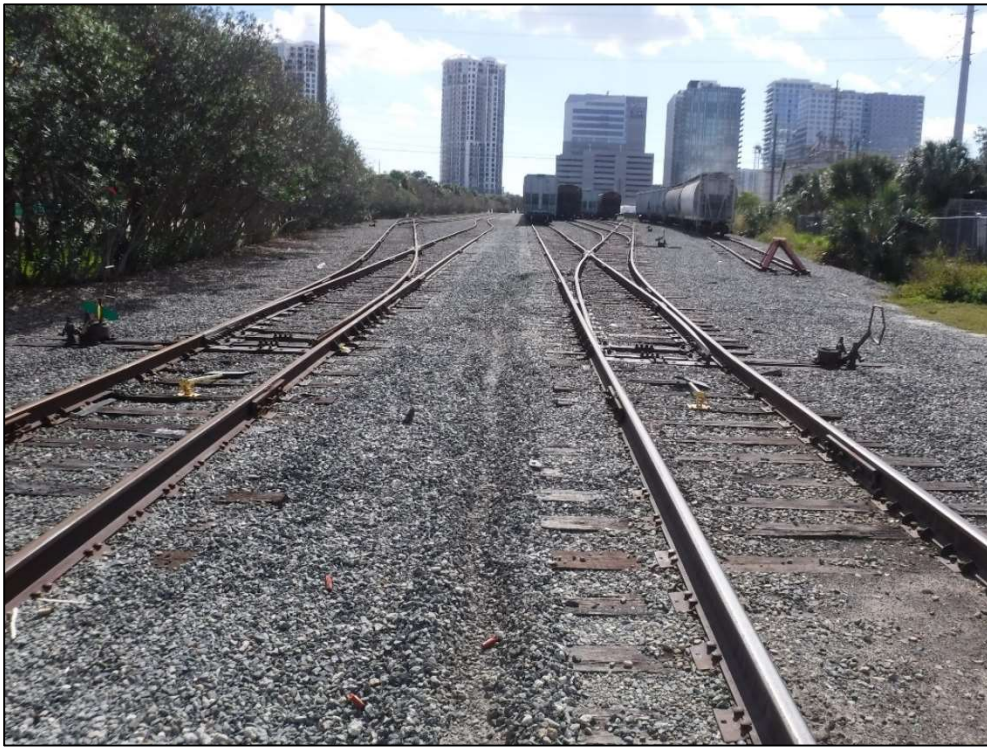
Figure 8.1: Existing Railway Corridor Containing Associated Gravel Ballast, Tracks, and Ties, Preventing Subsurface Testing Within Pond C, Facing South

The archaeological survey resulted in the identification of no archaeological sites or archaeological occurrences with the proposed pond sites, and confirmed the low archaeological potential of the archaeological APE. No shovel testing was feasible within the APE due to the presence of existing rail corridor, modified embankment, and drainage ditching. Representative photographs of the existing conditions within the archaeological APE are included for reference in **Figures 8.1–8.3**.

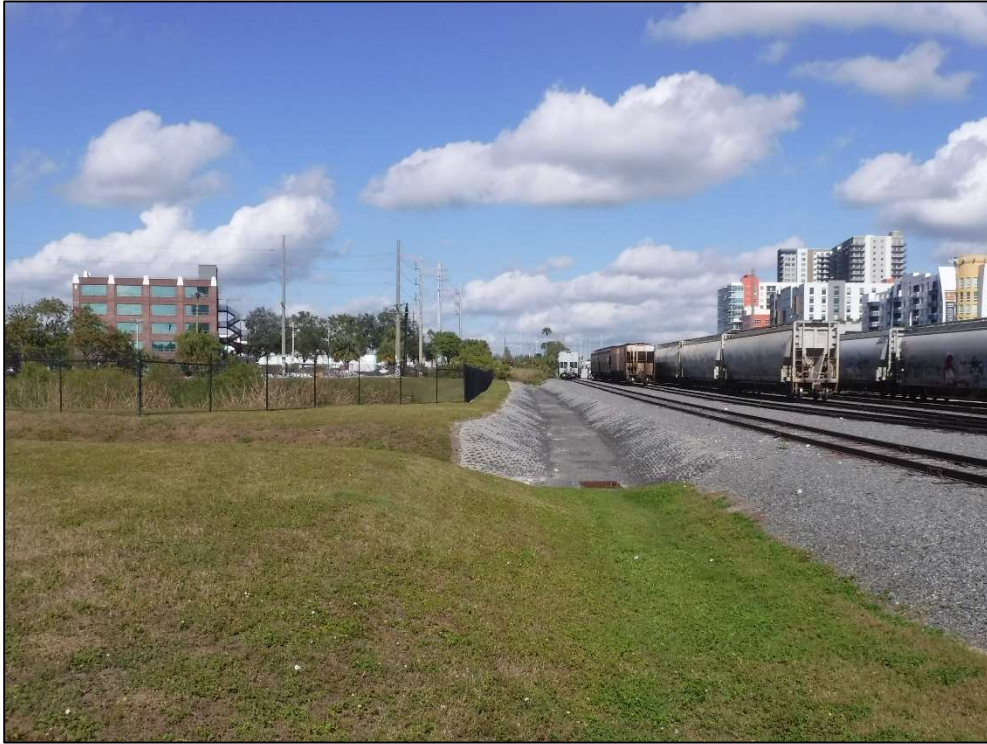
Figure 8.2: Modified Embankment, Drainage Ditch, and Existing Railway Corridor Containing Associated Gravel Ballast, Tracks, and Ties, Preventing Subsurface Testing Within Pond D, Facing North

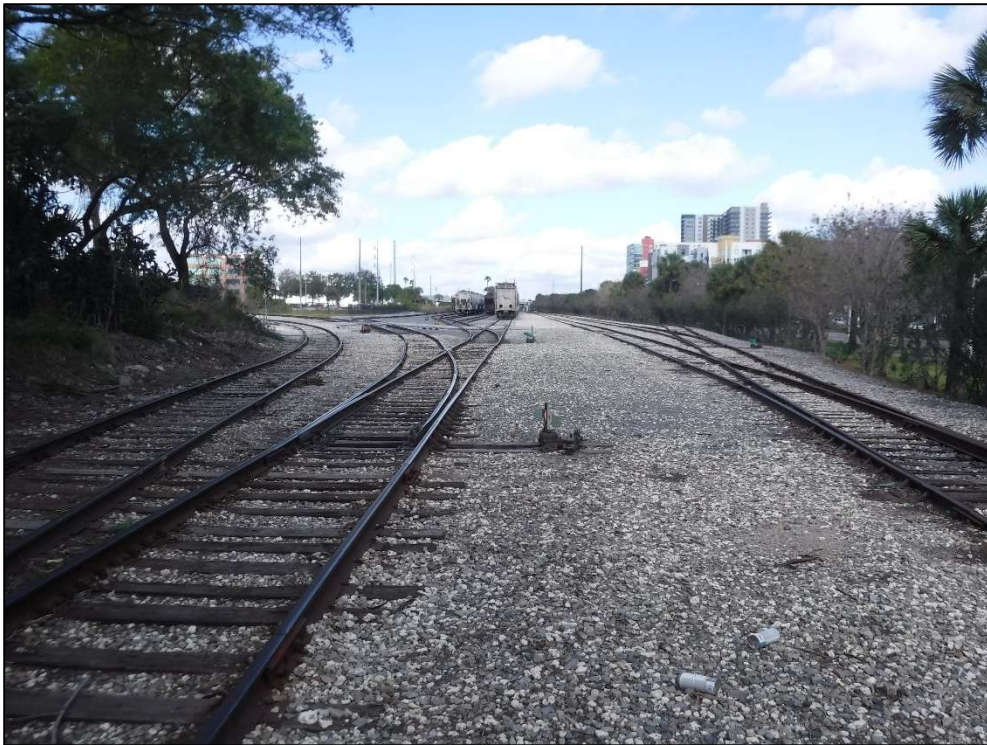
Figure 8.3: Existing Railway Corridor Containing Associated Gravel Ballast, Tracks, and Ties, Preventing Subsurface Testing Within Pond E, Facing North

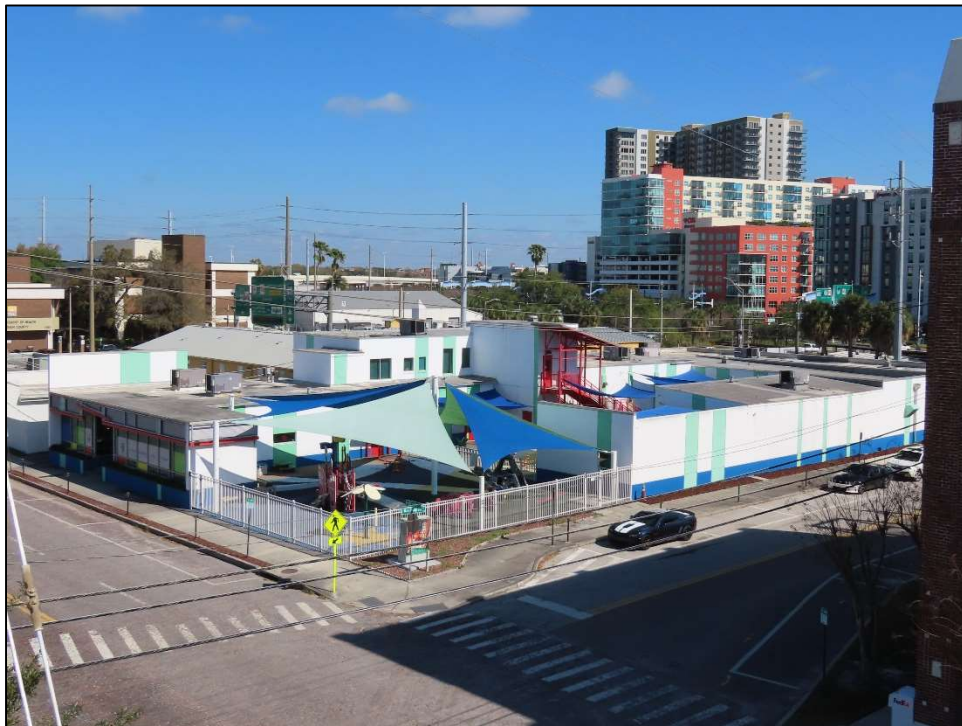
Figure 8.6: Carlton Academy Day School (8HI15085), c. 1946, located at 205 N Brush Street, considered National Register-eligible, facing Northeast

The circa 1946 Masonry Vernacular style structure located at 205 N Brush Street is in Section 19 of Township 29 South, Range 19 East, on the Tampa (1956 PR 1981) USGS quadrangle map in the city of Tampa, Hillsborough County, Florida (**Figure 8.5**). The original block of the building is located on the east portion of the parcel and features a L-shaped shaped concrete block structure with a flat roof of built up material. This original block is comprised of a two-story section along the north parcel line and one-story section along the east parcel line. A one-story circa 1960 addition is located on the west façade of the northern section, forming the current northwest corner of the building. A two-story circa 1960 addition is located in the interior of the northeast corner of the structure, connecting to a portion of the original two-story section of the building. Both of these additions feature concrete block structural systems with flat roofs.

A one-story circa 1960 concrete block addition is located along the southern parcel line, with a shed roof of built up material. These three additions extended the building's footprint towards the west parcel line and create an asymmetrical horseshoe shaped plan (**Figure 8.6**). The open area within the building's footprint now serves as a courtyard and is used as a playground for the daycare which operates out of the building. Windows observed on the structure include metal fixed one-light and two-light windows, some of which are paired or grouped. A metal window wall is located on the west façade of the structure where the main entrance is located. The double door entrance is recessed into the west façade and accessed via a small concrete staircase. Decorative elements observed on the exterior of the structure include scored stucco panels, a stucco parapet at the roofline, stucco planter boxes, and wire mesh panels above windows. Only the scored stucco panels and parapet details are considered to be historic.

The structure at 205 N Brush Street exhibits a common architectural style found in Central Florida, and its original design is compromised by several additions which have altered the historic plan of the structure, and non-historic alterations including replaced exterior material, windows, and doors. Therefore, it is considered ineligible for listing in the National Register, individually or as part of a historic district.

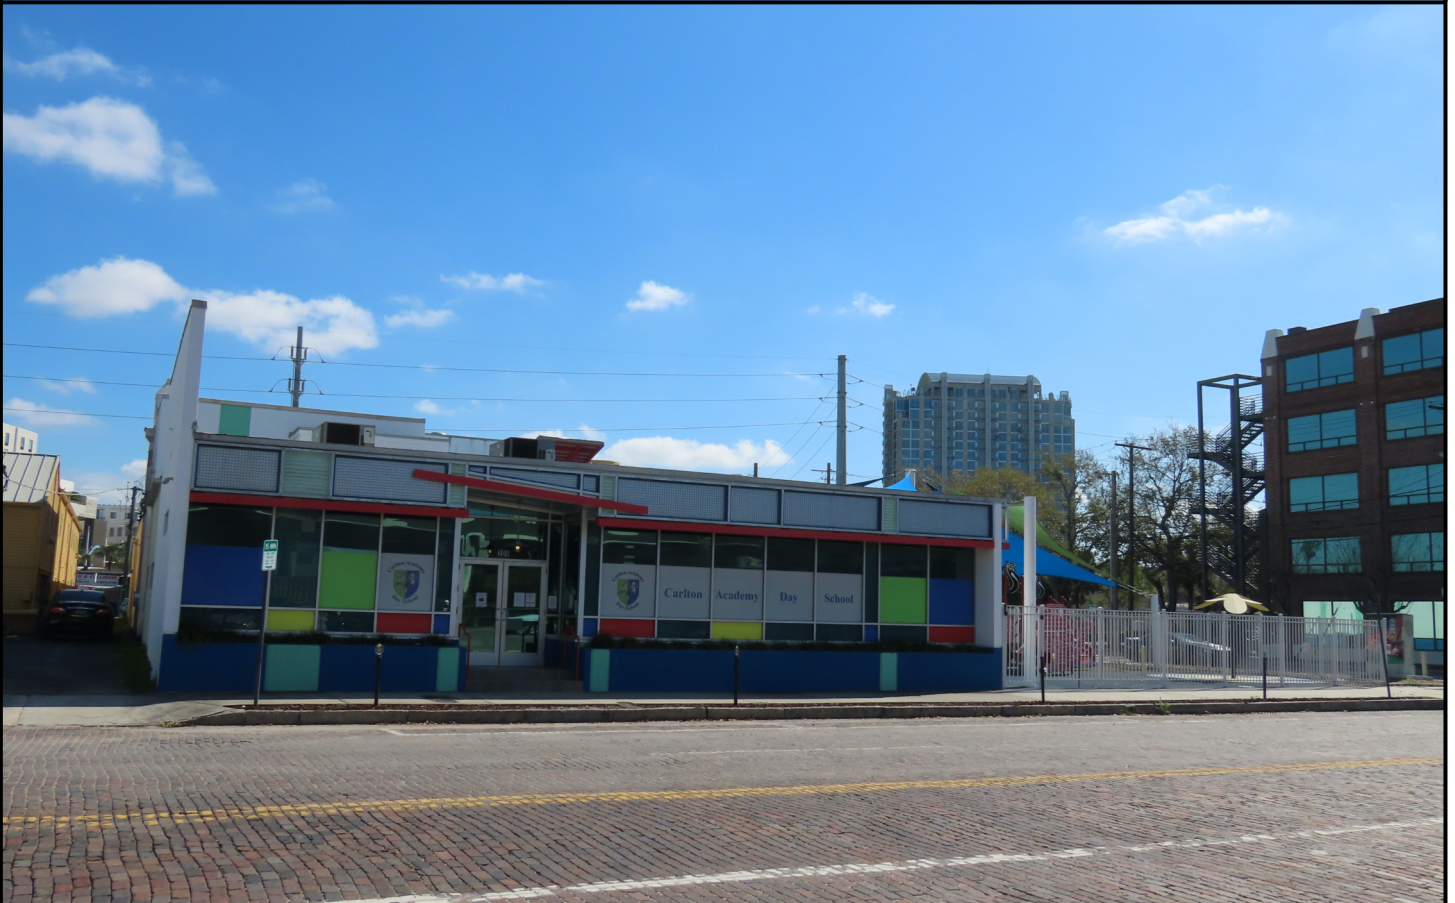
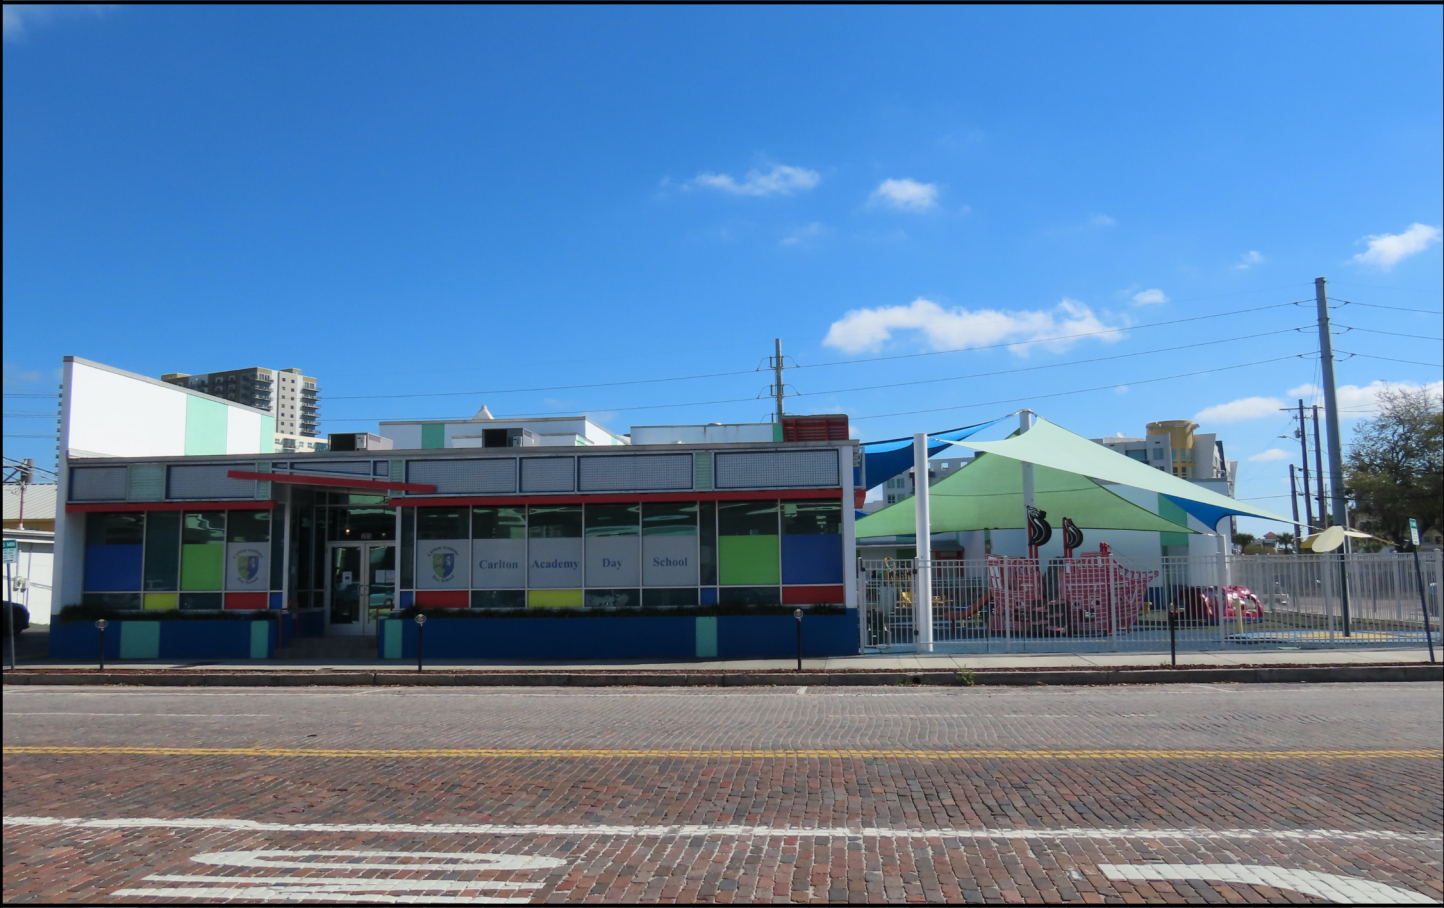
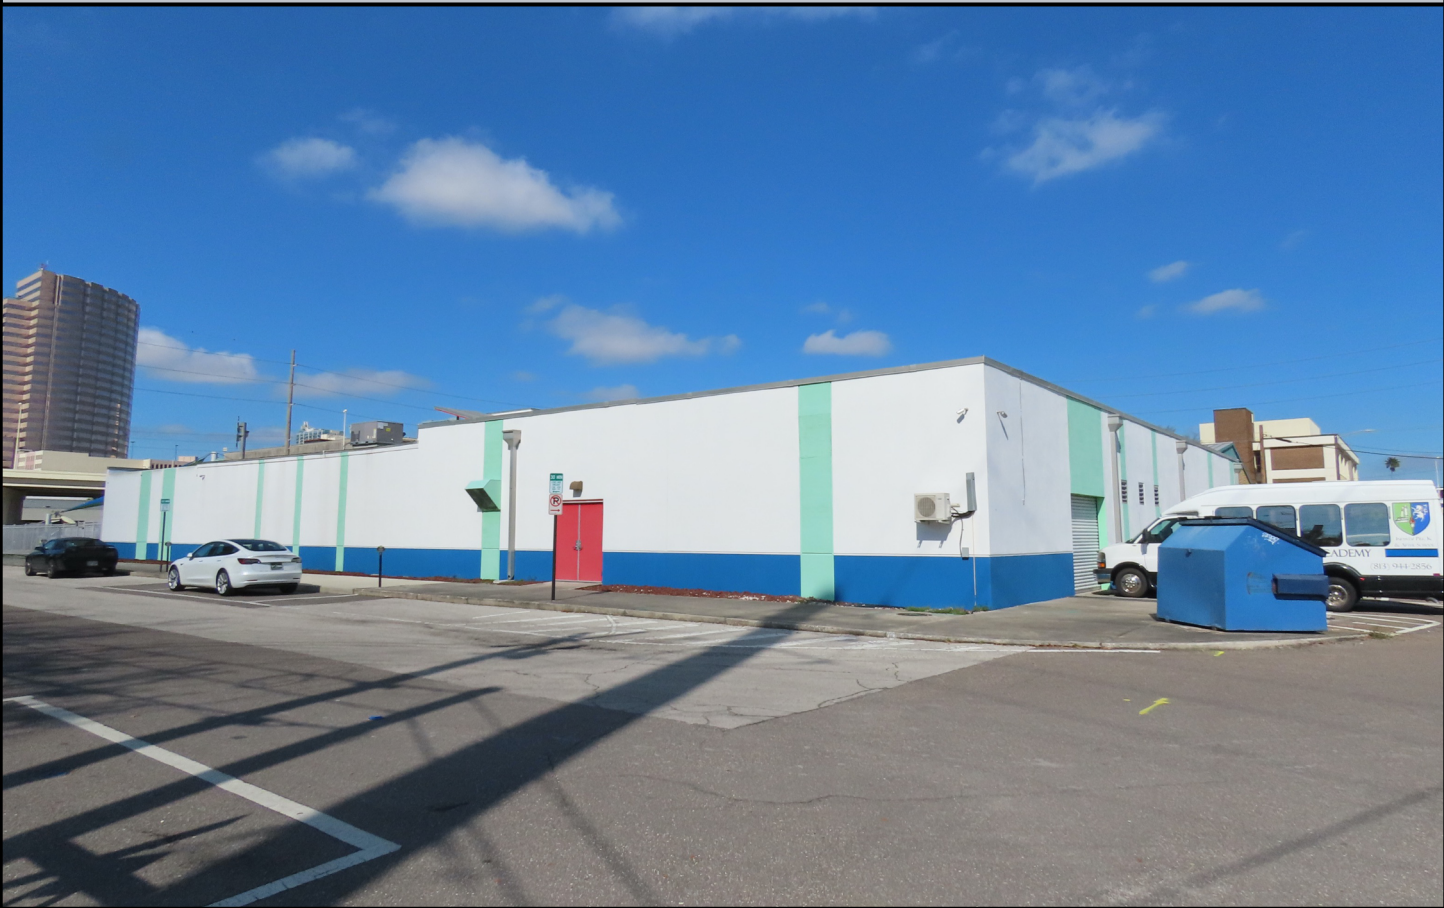
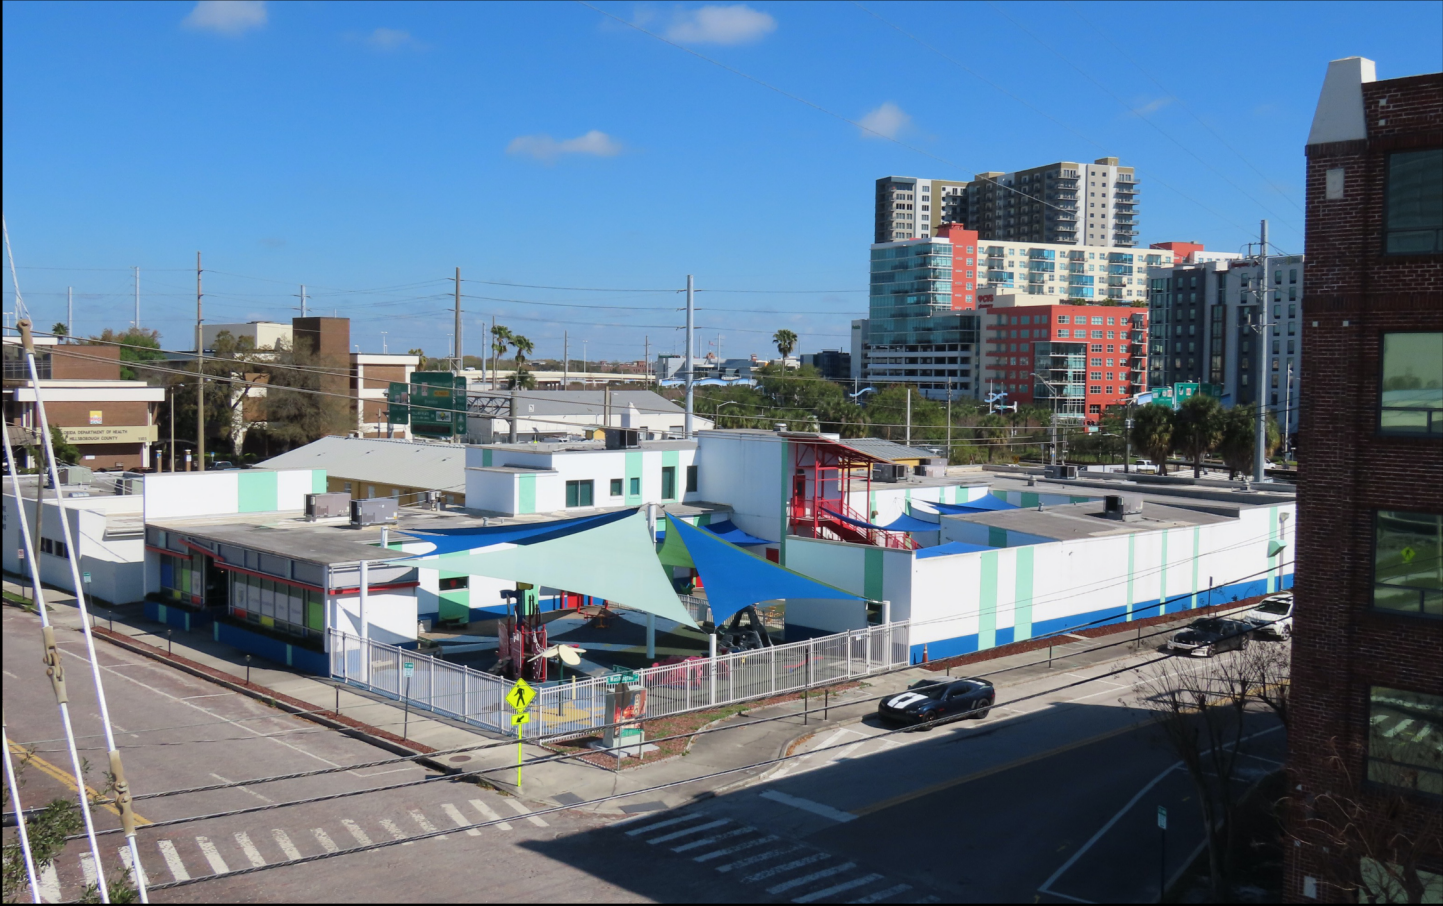
8HI15085

This Masonry Vernacular school exhibits a common style found in Central Florida, additions which alter its historic plan, non-historic alterations, and no known historic associations. Therefore, it is considered to be National Register-ineligible.
