# MANUFACTURINGAsk YourselfSAFETYALERT"Could it happen here?"

#### Suspended Load

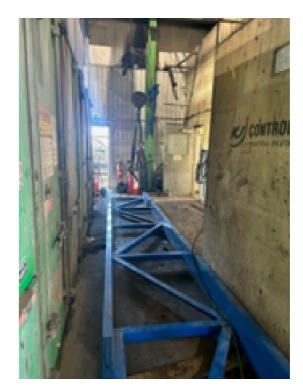
During a capital upgrade project, a company was contracted for a catwalk installation in the debarker building. When they attempted to vertically hoist a section of catwalk into a balanced position, the existing ductwork blocked the way.

After lowering the frame to the ground and readjusting the rigging, they resumed hoisting the frame at an angle to clear the obstruction.

During this process, one of the contract workers passed underneath the suspended load. When they were almost clear of the frame, the rigging gave way and the catwalk suddenly dropped striking the worker.

The contract worker sustained moderate injuries.

- Never walk under a suspended load. Use tag lines, caution tape and follow designated travel paths.
- Ensure those handling lifting and rigging tasks are properly trained.
- Conduct pre-work hazard assessments and lift plans to identify and control hazards.
- Identify high-risk tasks and provide supervision, observation and site inspections.

Establish control zones during lifting to restrict access and maintain a safe distance from the lifting area.
