Design and Analysis of a Gas Turbine Blade

Abdul Qadir Talal¹, Dr K Fazlur Rahman ²

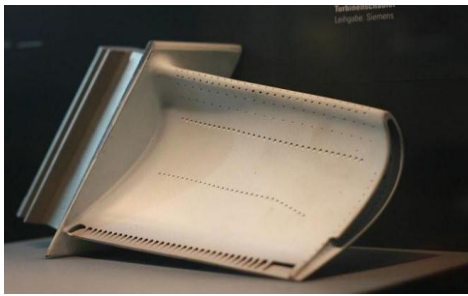
Fig 1.2: Gas Turbine rotor blade

In a gas turbine engine, a single turbine section is made up of a disk or hub that holds many turbine blades. That turbine section is connected to a compressor section via a shaft (or "spool"), and that compressor section can either be axial or centrifugal. Air is compressed, raising the pressure and temperature, through the compressor stages of the engine. The temperature is then greatly increased by combustion of fuel inside the combustor, which sits between the compressor stages and the turbine stages. The high-temperature and high- pressure exhaust gases then pass through the turbine stages. The turbine stages extract energy from this flow, lowering the pressure and temperature of the air and transfer the kinetic energy to the compressor stages along the spool. This process is very similar to how an axial compressor works, only in reverse. The number of turbine stages varies in different types of engines, with high-bypass-ratio engines tending to have the most turbine stages. The number of turbine stages can have a great effect on how the turbine blades are designed for each stage. Many gas turbine engines are twin-spool designs, meaning that there is a high-pressure spool and a low-pressure spool. Other gas turbines use three spools, adding an intermediate-pressure spool between the high- and low-pressure spool. The high-pressure turbine is exposed to the hottest, highest-pressure air, and the low-pressure turbine is subjected to cooler, lower-pressure air. The difference in conditions leads to the design of high-pressure and low-pressure turbine blades that are significantly different in material and cooling choices even though the aerodynamic and thermodynamic principles are the same. Under these severe operating conditions inside the gas and steam turbines, the blades face high temperature, high stresses, and potentially high vibrations. Steam turbine blades are critical components in power plants which convert the linear motion of high-temperature.

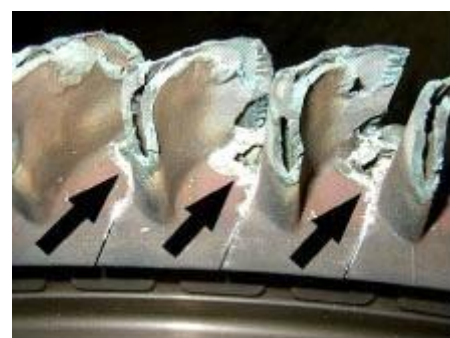
Fig 2.2: blade failure due to fatigue

Turbine blades are most susceptible to crack formation in regions of contact surfaces, which are exposed to both centrifugal loading and oscillatory vibrations. These mating component are failed due to fretting fatigue. Fretting fatigue results in an increase in tensile and shear stress at the contact surface, which leads to crack initiation and its propagation till failed completely. At elevated temperatures, fatigue cracks

have been observed to initiate from grain boundaries, slip bands, pores, twin boundaries or due to cracking of inclusions/precipitates. The majority of turbine failure includes fatigue leading to crack initiation and propagation. The operating conditions of high rotational speed at elevated temperature, corrosion, erosion and oxidation accelerates fatigue failure.

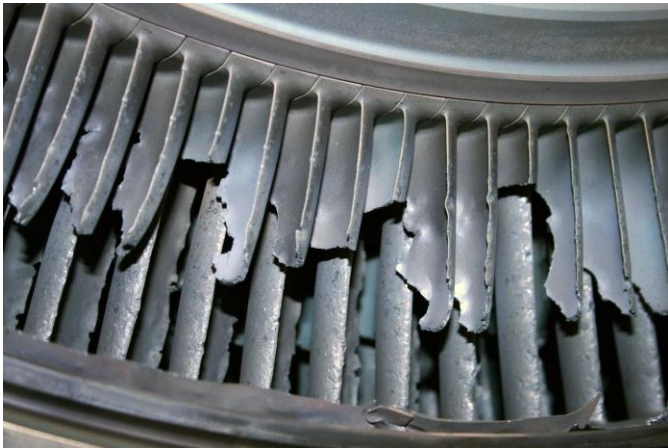
Fig 2.3: blade failure due to overheating

The surface degradation of turbine blade by the formation of needle separation topologically closed packed phase (TCP) occurs due to overheating. This structural instability of the alloy results in decrease in strength and ductility of alloy (Rybhino et al., 2012). Tawancy et al., (2009) have examined the first stage turbine blades and vanes and concluded that the failure of both components took place due to overheating. Overheating promoted creep, resulting in inter-granular cracking that shortened the fatigue life of blades and vanes.

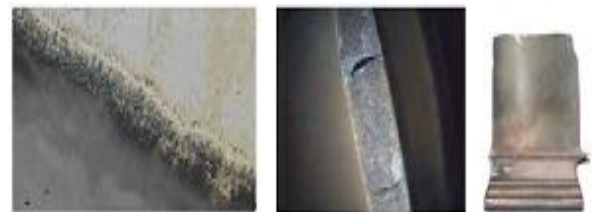
Fig 2.6: Characteristic forms of failures caused by overheating of blade material

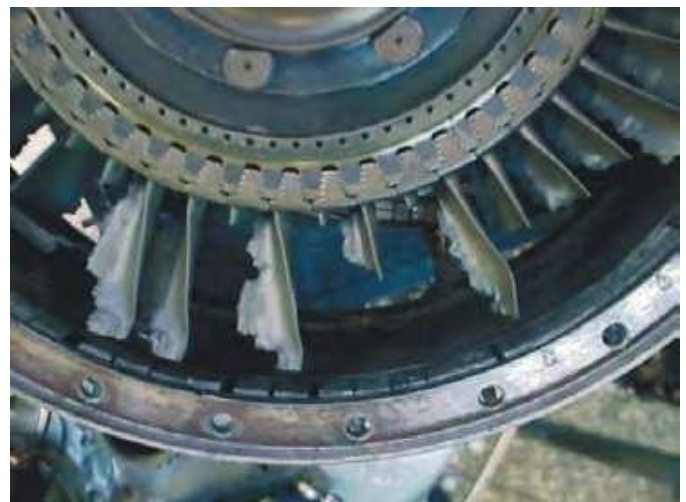
Fig 2.7: Characteristic forms of failures to gas turbine caused by long-lasting excessive temperature of exhaust gases

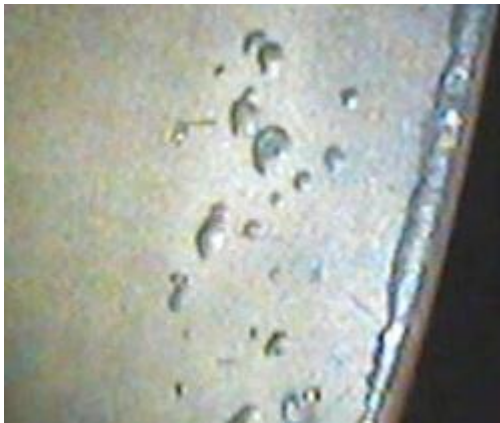
Fig 2.8: Failures to turbine blades operated in the seashore environment, caused by chemical impact of exhaust gases

Blade deformations in the form of dents are caused by a foreign matter ingested by the turbojet engine compressor and by particles of metal and hard carbon deposits from the combustion chamber. Such dents result in stress concentrations in blade material and prove conducive to the initiation of fatigue processes. Scratches on blade surfaces due to the foreign matter impact are also reasons for local stress concentrations and, consequently, potential corrosion centers. What results is, again, material fatigue which, together with possible corrosion, prove conducive to fatigue fracture.

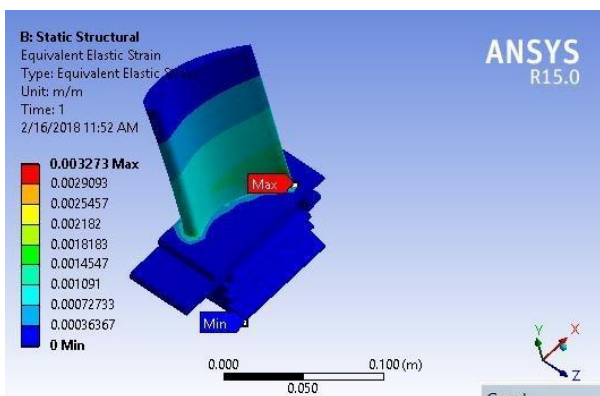
Fig 5.7: Elastic Strain on IN738 Turbine Blade Material

blade materials. Maximum temperatures were observed at the leading edge of the blade and decreased towards the trailing edge and blade root. Maximum von-mises stresses and strains were observed near the root of the turbine blade and upper surface along the blade roots. Total deformation obtained from each blade analysis were negligible, as 0.16221mm was obtained for IN 738 and 0.12125 mm obtained for U 500. This report serves as a guideline for the selection of suitable materials for minimal gas turbine blade failure and optimal working scenario.
