Assessment of the Possibility of Application of New Types of Filler Materials in the Renovation of Functional Surfaces of Crane Wheels

Keywords: cladding; wheel; renovation

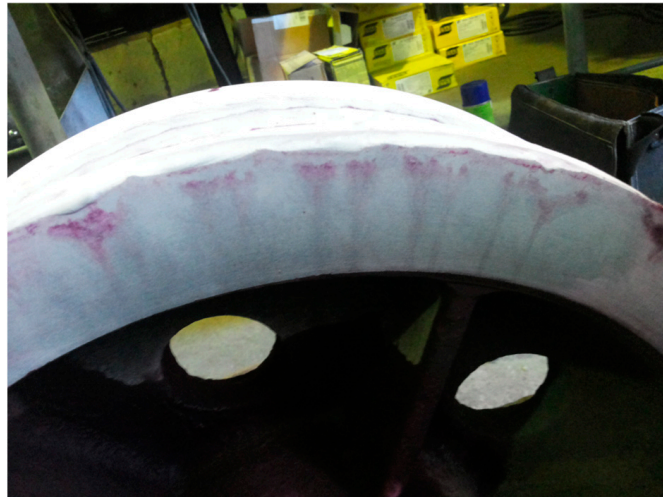
Figure 6. Running wheel w03 during capillary check—outside of rim.

On the basis of the visual inspection of the clads carried out in accordance with ISO EN ISO 17637 under 500 lux illumination, it can be stated that the functional parts of the wheel after chip machining did not show any surface defects. The wheel was machined to the required dimensions by turning. No chipping pores or cracks were identified that would classify the patterns as unsatisfactory. Visual inspection of the wheels was followed by capillary inspection. It was carried out in accordance with EN ISO 3452 (Figure 6). Its results confirmed the result of the visual inspection. The realized guides were free of surface defects. The residual developer (CaCO_3 coating) was cleaned from the wheel after the capillary inspection using Diffu-Therm BRE-S aerosol. The presence of internal defects was assessed by ultrasonic inspection in accordance with EN ISO 17640. The reflection method was used. The entire wheel circumference including the rims was analysed. The presence of internal defects in the flange or subflange layers was not observed.

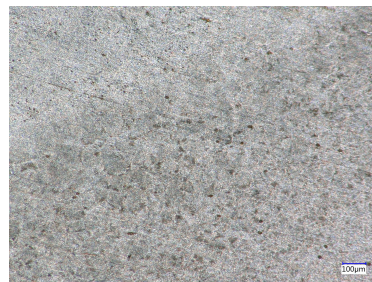
Figure 10. Microstructure of the IL to HAZ transition of round 01.

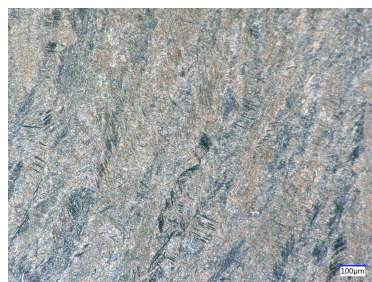
Figure 11. Microstructure of the CL clad of the wheel 02.

The presence of massive carbide inclusions was not observed in the microstructures of the cladding layers of rounds 02 and 03.

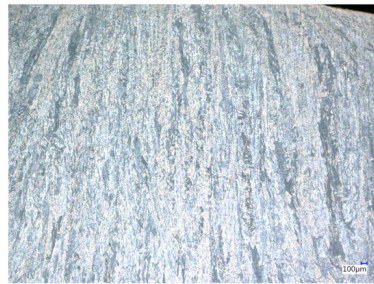
Figure 14. Microstructure of CL clad of the wheel 03.

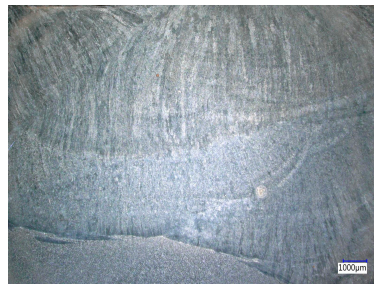
Figure 15. Microstructure of the CL to IL transition of the wheel 03.

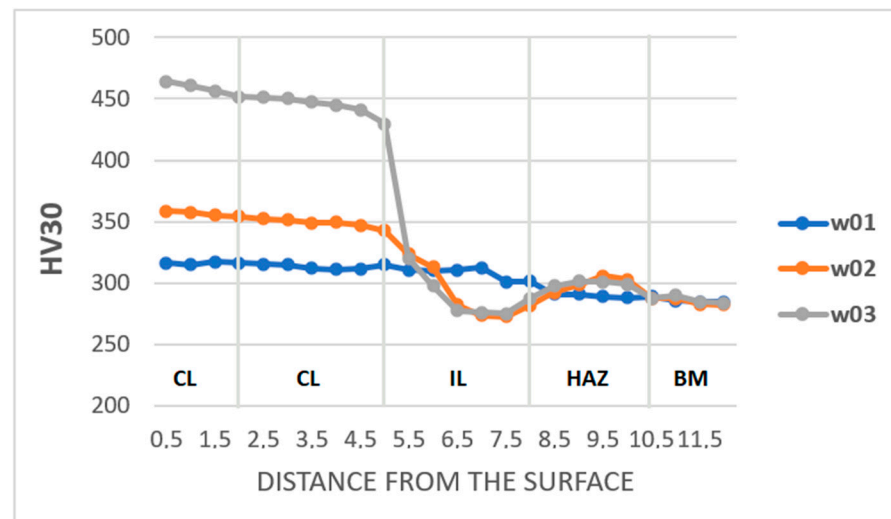
Figure 17. Measured average hardness values HV30 measured on clads from wheels. CL—covering layer; IL—inter layer, HAZ—heat-affected zone; BM—base material.

The results of the hardness evaluation are documented in the graph in Figure 17. Presented are the incremental values measured in lines on three samples from each wheel. Twenty-four indenter punctures were performed on each test lug. The first indentation was at a depth of 0.5 mm from the specimen surface, in the cover layer of the coating, and the last indentation was at a depth of 12 mm from the specimen surface, i.e., in the base material. Based on the measured values, it can be concluded that the maximum hardness values were exhibited by the clad in the cover layer made with C1 wire. An average hardness value of 461HV30 was measured at a depth of 0.5 mm. The maximum hardness value was also measured at a depth of 0.5 mm from the surface of the clad for the B1 wire. An average hardness of 358HV30 was measured in the cover layer. Among the evaluated additive materials used to produce the cover layers, the 317HV30 cladding layer showed the lowest average hardness at 1.5 mm depth for the cladding layer made with commercial A1 wire. The lowest average hardness values were measured in the interlayer area made with D1 wire, namely, 272HV30. These measured values were consistent with the chemical composition of the cladding wire used. The base material for all the wheels evaluated showed reasonable hardness values in the range 290HV30–282HV30.

Prior to the test, the surface hardness at the point of contact of the tribological pair was measured on the surface of the roller of the rail material. The average surface hardness on the rollers was 216HV30. The average hardness measured on the A1 roll face was 315HV30. On the B1 clad, 358HV30 was measured, and on the C1 clad surfaces, an average hardness value of 465HV30 was measured. These values corresponded to the measured values presented in Figure 17.

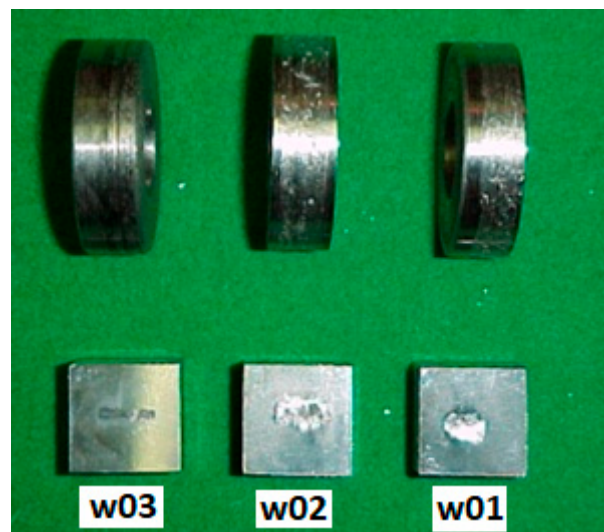
Figure 18. Tribological pairs after the 120 s^{-1} friction test.

In the framework of the evaluation of the resistance of the newly formed layers to the action of tribodegradation factors, the research was focused on the evaluation of the influence of adhesive wear on functional surfaces. Five test specimens from each wheel were evaluated at the specified test time. One set of tribological pairs is documented in Figure 18. The resistance of the test specimens' surfaces was assessed based on their weight loss. The same surface quality was used for all friction pairs. The surface perimeter of the rollers was turned to a roughness of $R_a = 3.2 \mu\text{m}$. Similarly, the milled surfaces of the squares taken from the rolled wheels had a surface roughness evaluated that matched the chemical composition of the clad coat at a depth of 1 mm from the surface of the roll to a roughness of $R_a = 3.2 \mu\text{m}$. The roughness was checked prior to the test with a Mitutoyo SurfTest SJ 302 contact roughness tester produced Mitutoyo Corporation, Kanagawa, Japan. The tribological pair was contact machined. The measured average weight loss results are documented in the graph in Figure 19.

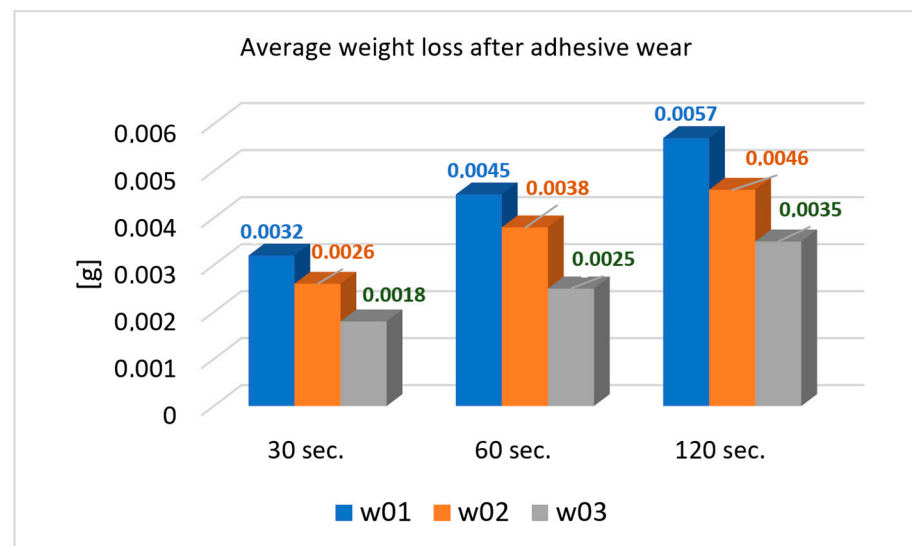
Figure 19. Average values weight loss samples after adhesive wear.

Based on the results of the evaluation of the effect of adhesive wear during the selected times, it can be concluded that the surface with the clad made with C1 additive material showed the highest resistance to material removal. At time 30 s^{-1} , an average weight difference of 0.0018 g was recorded for the samples. At time 60 s^{-1} , it was 0.0025 g and at 120 s^{-1} exposure, it was 0.0035 g. Compared to the conventional type of additive material, which was a wire designated as A1 adhesive wear, a second newly developed wire designated as B1 also resisted adhesive wear better.
