MSC-05161

APOLLO 15 MISSION REPORT

MANNED SPACECRAFT CENTER
HOUSTON, TEXAS
DECEMBER 1971

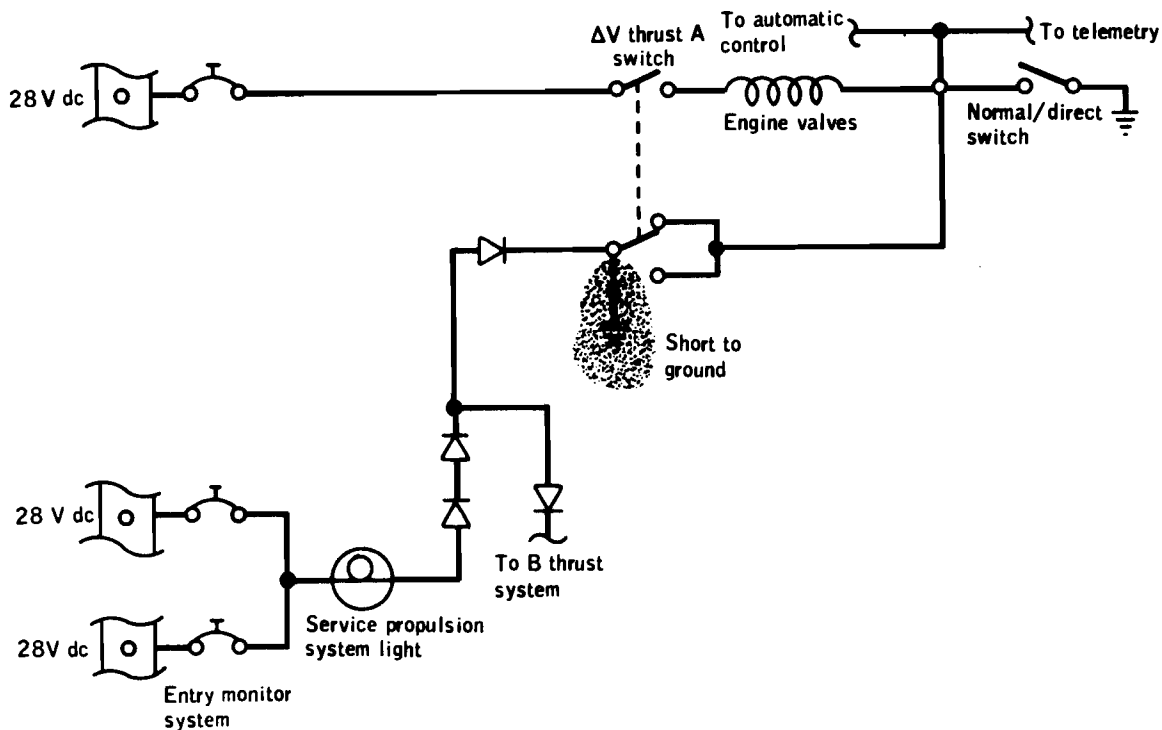
Figure 14-3.- Service propulsion system thrust light circuitry.

The short was isolated to the system A delta-V thrust switch which was found to be intermittently shorted to ground (fig. 14-3). A test firing performed at 28:40:22 verified that the short existed on the ground side of the service propulsion system pilot valve solenoids.

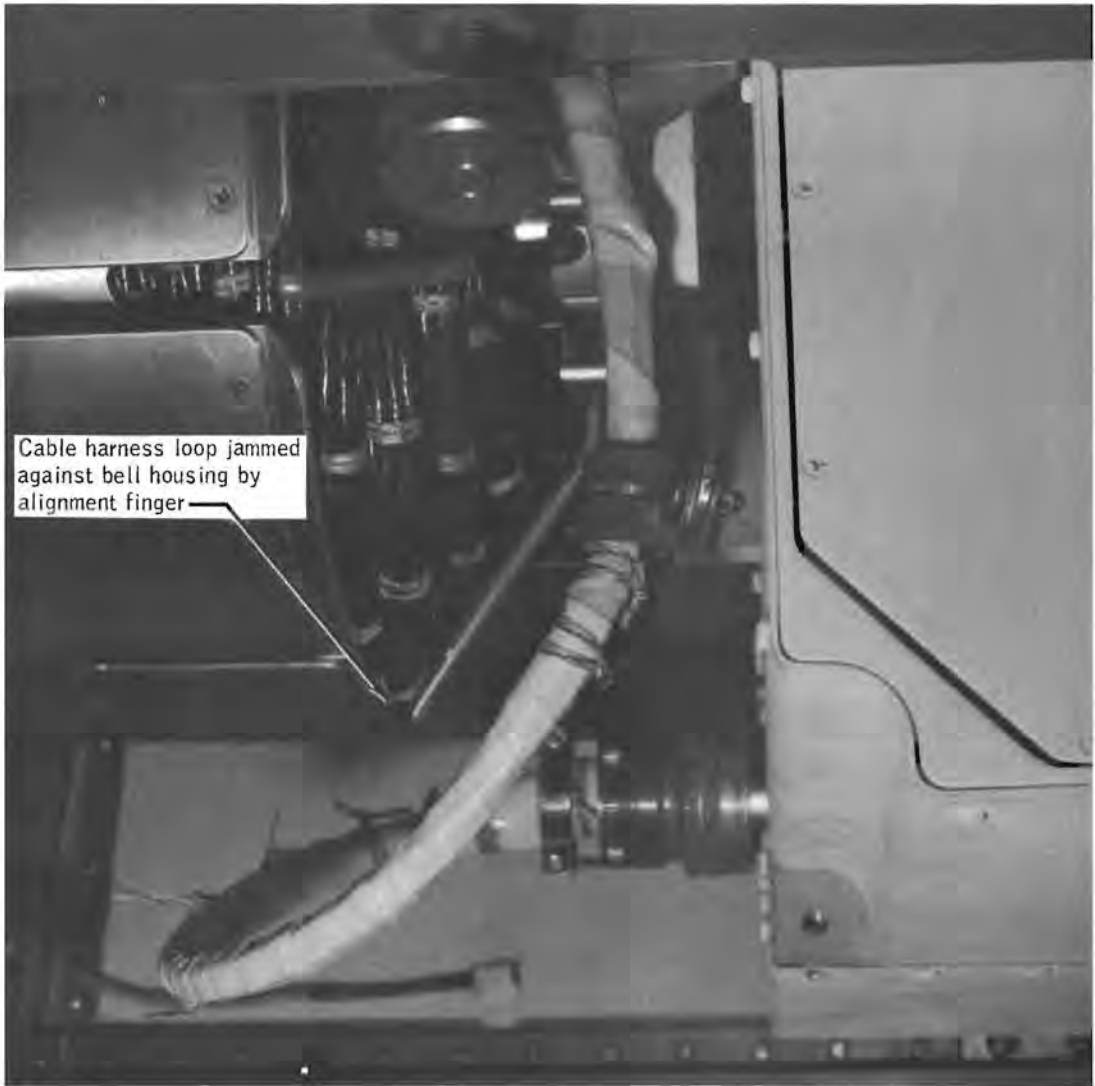
Figure 14-8.- Side view of mass spectrometer deployment mechanism (experiment attached).

An inflight test of the Apollo 15 boom indicated that the problem was a function of temperature. Testing and examination of the Apollo 16 spacecraft showed that the failure was possibly caused by pinching of the cable harness during the last several inches of boom retraction. The cable could have been pinched between the bell housing and rear H-frame bearing (figure 14-7), or a cable harness loop was jammed by a boom alignment finger against the bell housing (fig. 14-8).

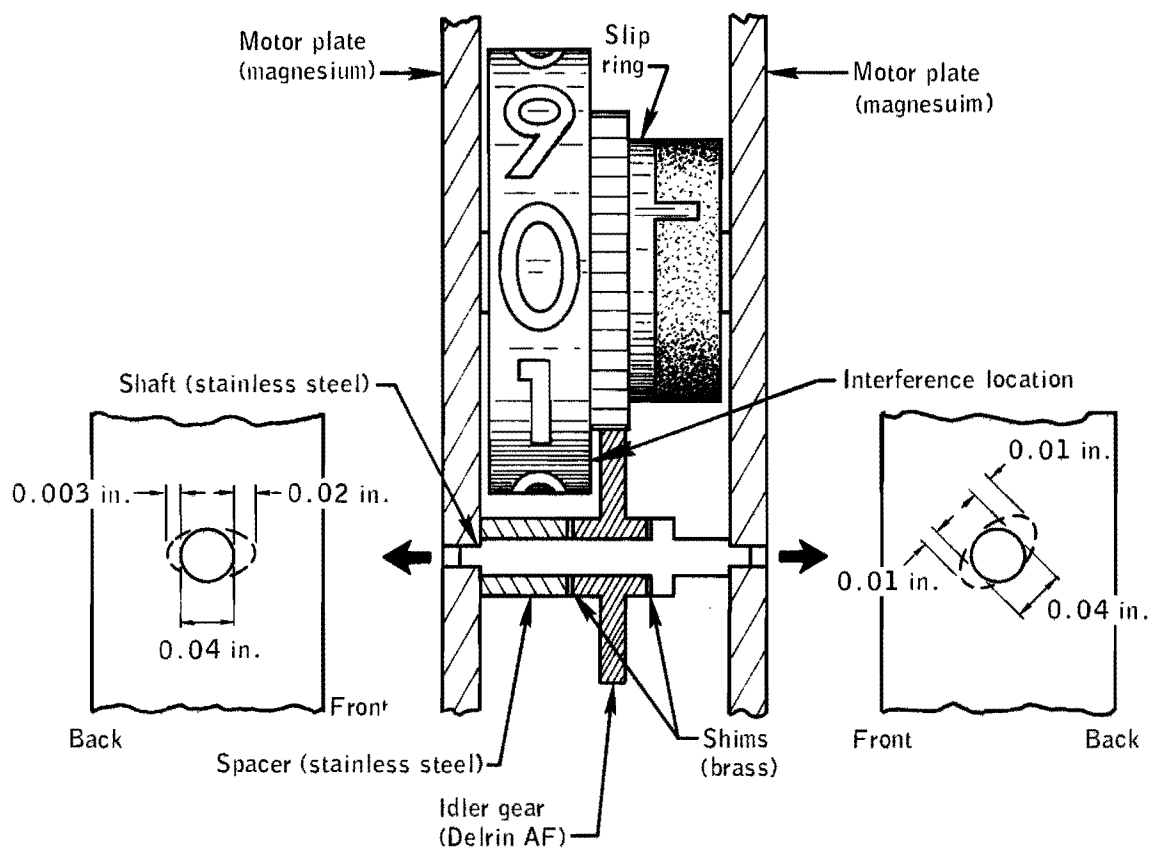
Figure 14-17.- Digital event timer mechanism.

Inspection of the unit showed that the magnesium bearing points had been elongated as shown in figure 14-17. Torque from the stepping motor applied to the idler gear not only resulted in rotation of the shaft but also caused the shaft to tilt (fig. 14-17). The wearing eventually allowed the shaft to tilt sufficiently to cause the gear to rub against the

number wheel. When the timer counted down, the motor torque threw the gear teeth into the front edge of the counter wheel. Testing indicates that this bearing hole elongation occurs after approximately 500 hours running time (specification life is 1400 hours).

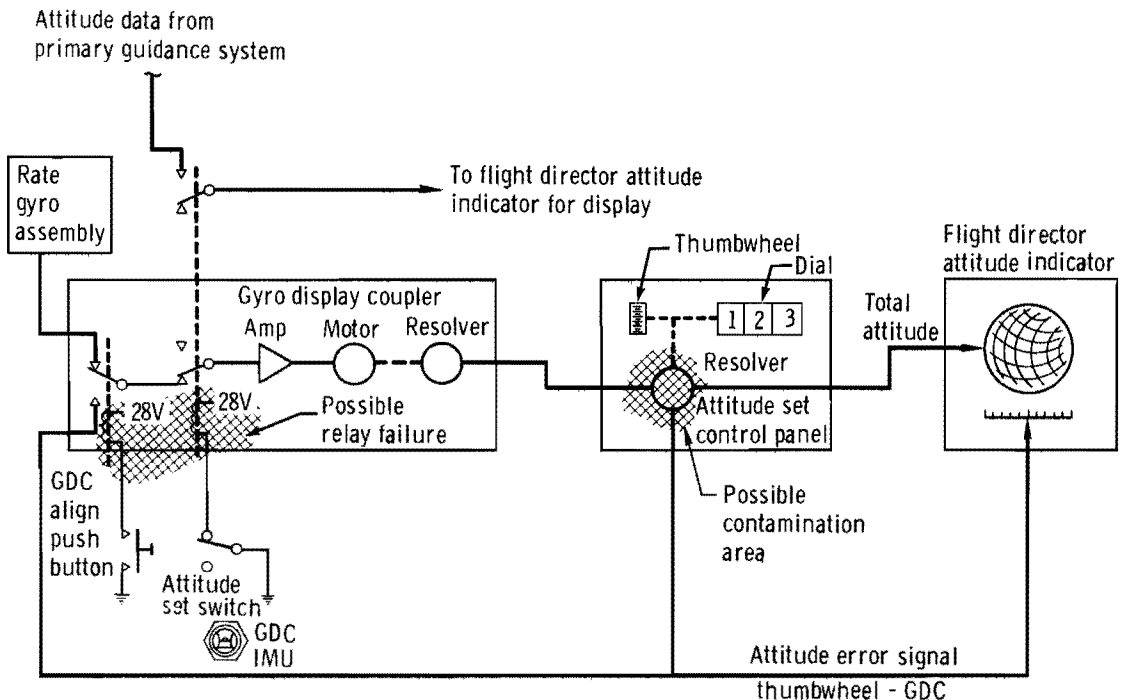
Figure 14-21.- Simplified align loop.

For normal operation during alignment, resolvers in the gyro display coupler electronics are compared to resolvers, one for each axis, on the thumbwheels used to set desired attitude. The difference is an error signal. The error is displayed on the attitude error needles, and the signal is used to drive the resolvers to match the attitude set on the thumbwheels. The anomaly could have been caused by either of two failure modes. An intermittent open in the roll axis align loop or a low gain problem in the electronics (fig. 14-21).

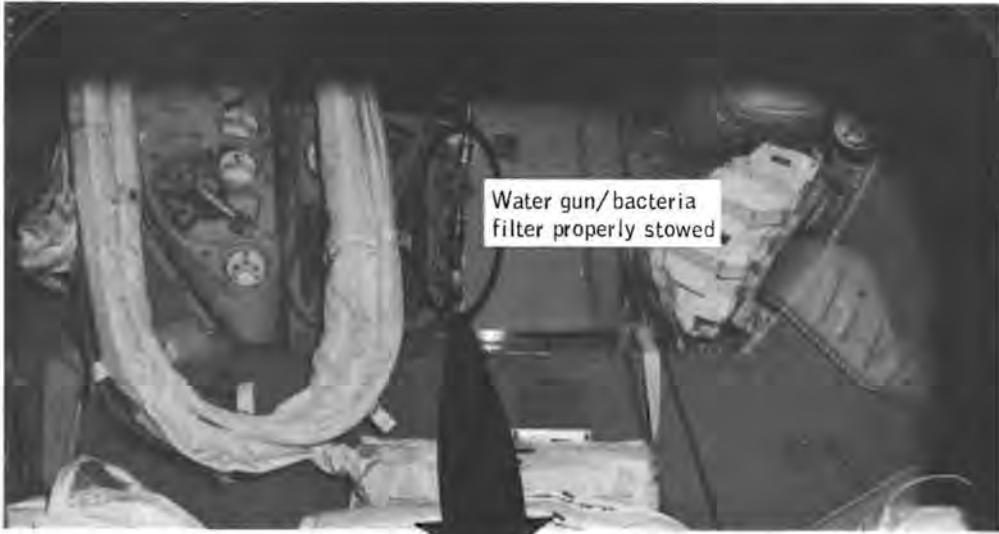
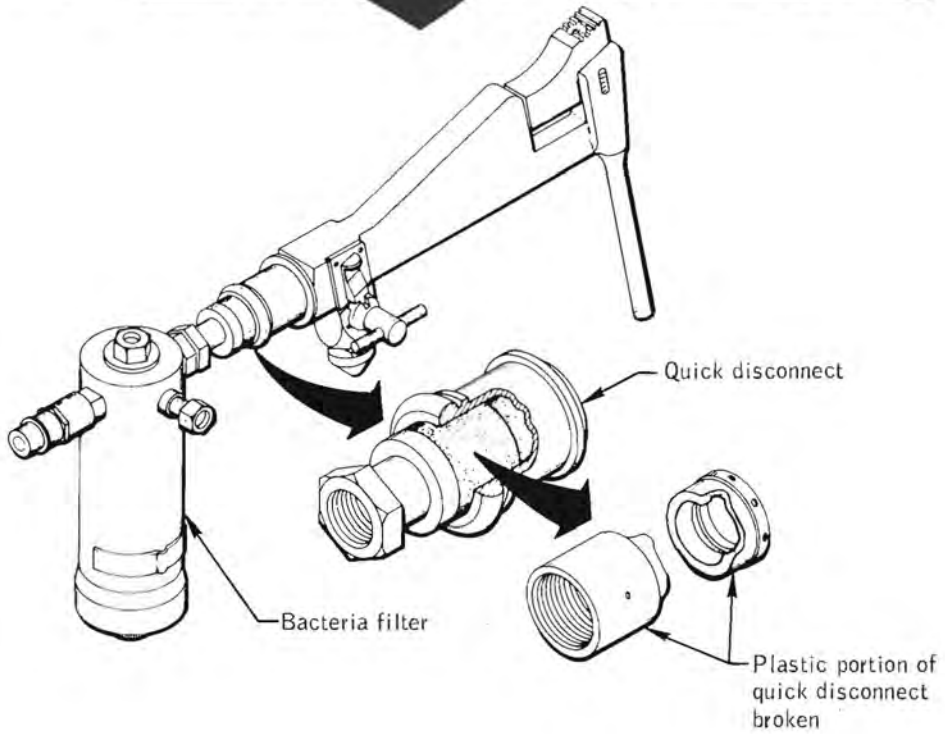
Figure 14-28.- Water gun/bacteria filter.

A water leak occurred at the quick disconnect between the bacteria filter and the water gun (fig. 14-28) shortly after the first extravehicular activity. The leak was caused by the plastic portion of the disconnect being broken and was stopped by removing the filter.

When the water gun/bacteria filter combination is properly stowed, the gun is held in a U-shaped boot (fig. 14-28). Both the gun and filter are held in place by straps with the hose protruding above the liquid cooling assembly. Bending the hose can easily exceed the force required to break the quick disconnect between the bacteria filter and the water gun if the filter is not strapped down. A test showed that a torque of 204.6 inch-pounds caused a similar quick disconnect to break in half.

Based on the torque value of 204.6 inch-pounds, a force of approximately 27 pounds applied at the hose quick disconnect interface would break the disconnect between the filter and the water gun.

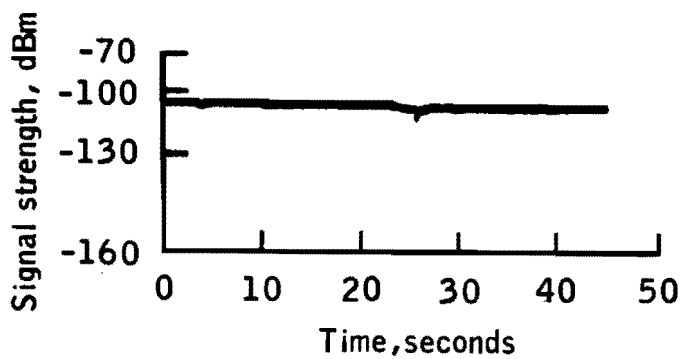
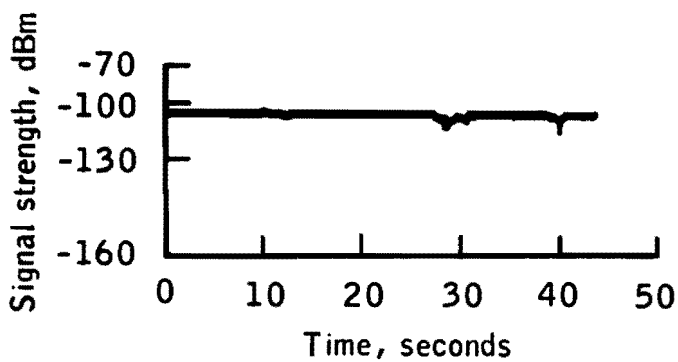
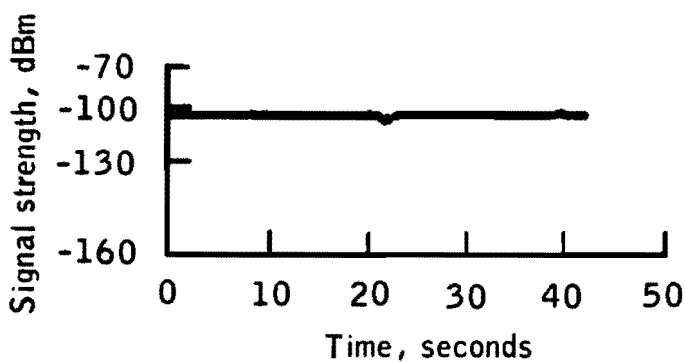
Figure 14-29.-- Damped antenna oscillations at random times.

Random oscillations occurred while the steerable antenna was in the auto-track mode. The oscillations were small, and damped without losing auto-track capability (fig. 14-29). The three times when the oscillations became divergent are shown in figure 14-30.

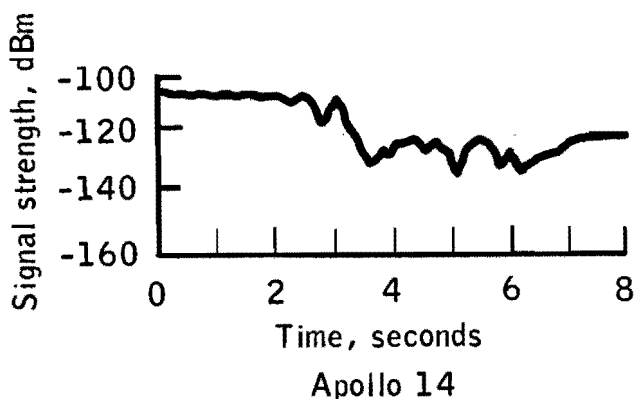
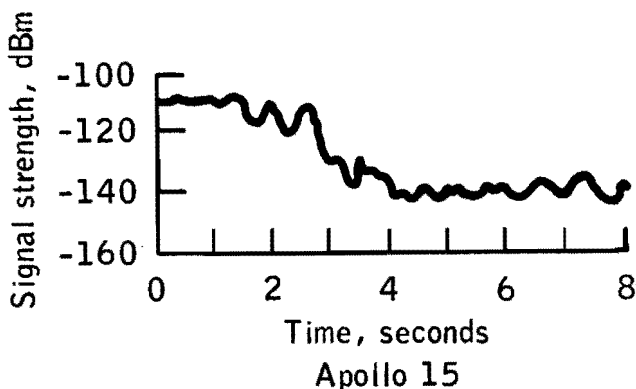
Figure 14-31.- Ground-received signal strength showing spacecraft antenna oscillation characteristics.

All oscillations indicated characteristics similar to the conditions experienced on Apollo 14 (fig. 14-31). After Apollo 14, one of the prime candidates considered as a possible cause was incidental amplitude modulation on the uplink signal. A monitor capable of detecting very small values of incidental amplitude modulation was installed at the Manned Space Flight Network Madrid site for Apollo 15. The data from this monitor indicated that no amplitude modulation existed on the uplink at the frequencies critical to antenna stability during the problem times. Consequently, incidental amplitude modulation has been eliminated as a possible cause of the antenna oscillations, and the problem must be in the spacecraft.

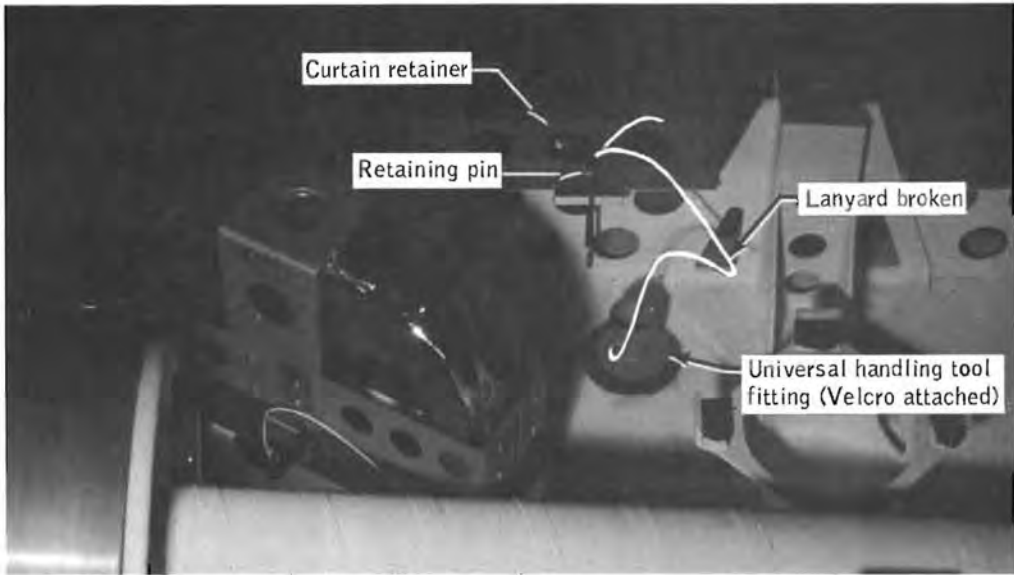
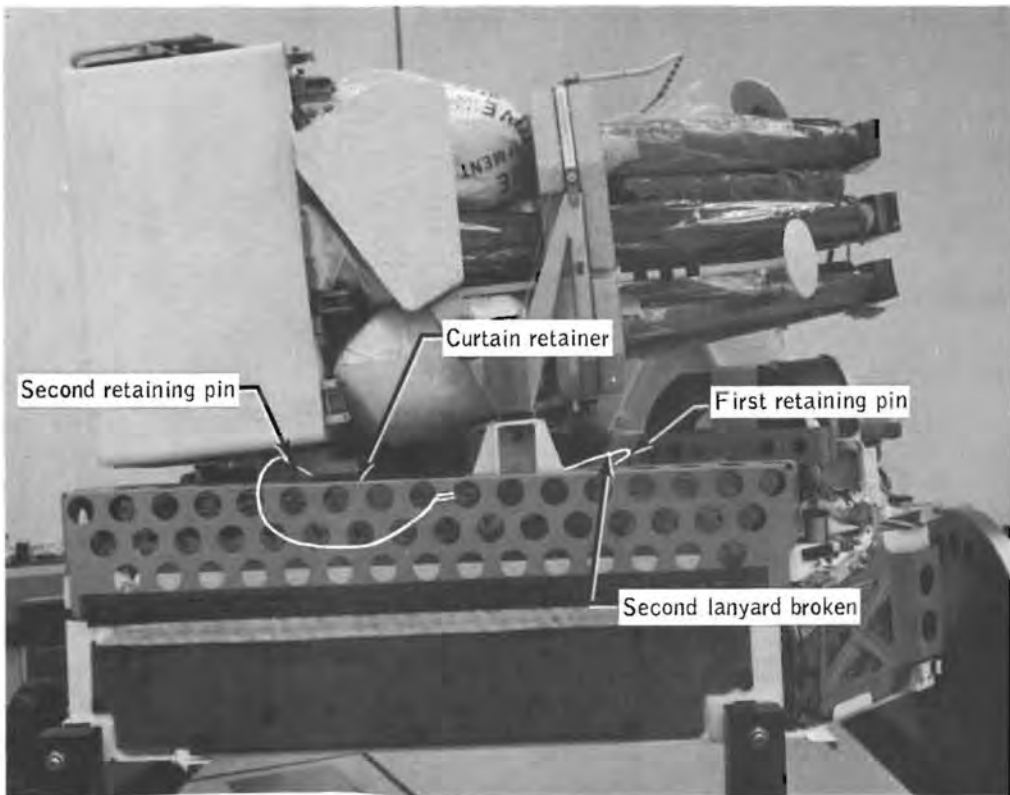
Figure 14-45.- Central station rear curtain retainer removal.

To remove the retainer for the central station rear curtain, added for Apollo 15, it was necessary to remove two retaining pins (fig. 14-45). The two pins, a universal handling tool fitting, and the curtain retainer are joined by a three-section lanyard. When the universal handling tool was inserted in the fitting and raised to remove the first pin, that section of the lanyard broke. When an effort was made to remove both pins simultaneously by inserting the handle under the lanyard joining the two pins, that part of the lanyard broke. The pins and retainer were then removed by hand.

(a) First break of lanyard

(b) Second break of lanyard
