APOLLO 6 MISSION REPORT

MANNED SPACECRAFT CENTER
HOUSTON, TEXAS
MAY 1968

MSC-PA-R-68-9

Prepared by: Apollo 6 Mission Evaluation Team

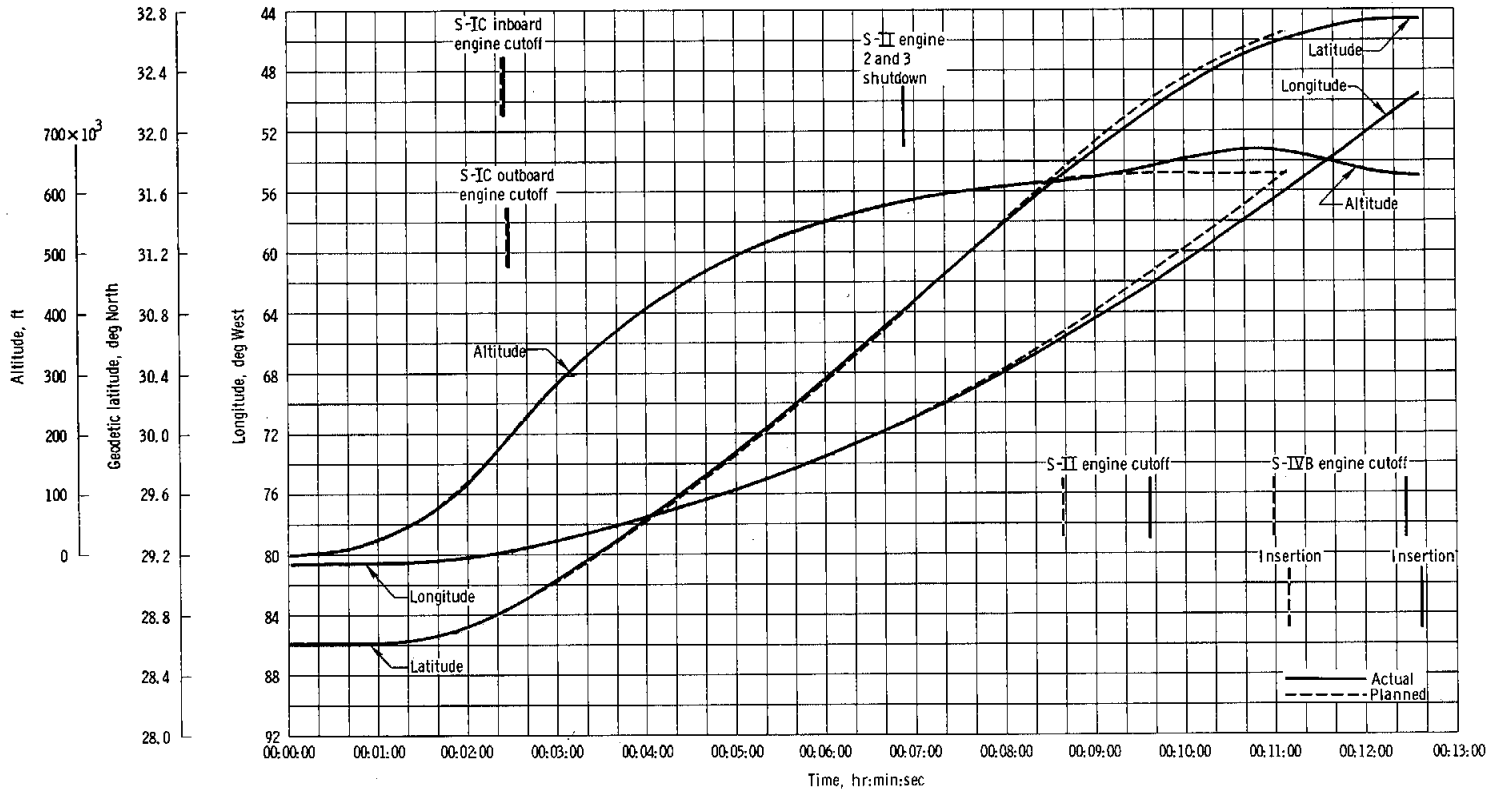
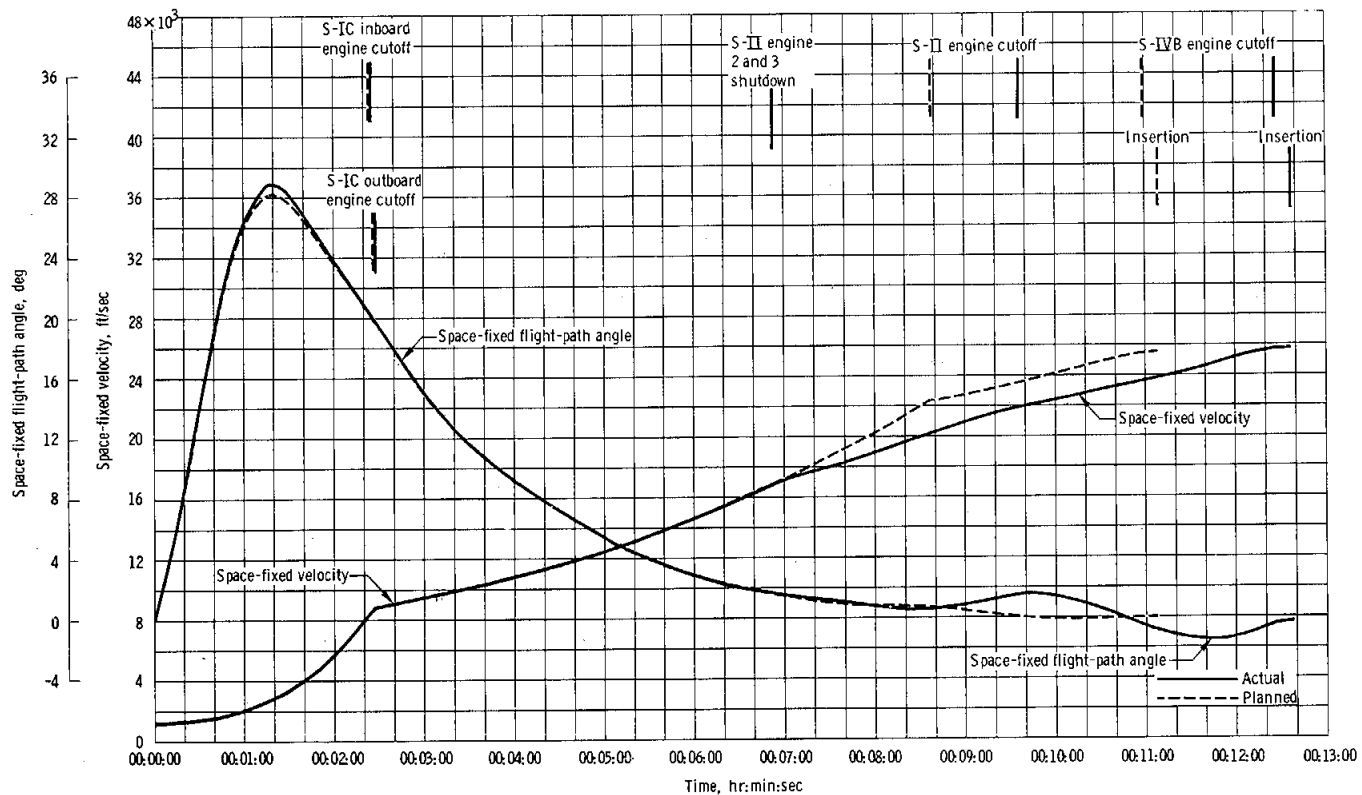
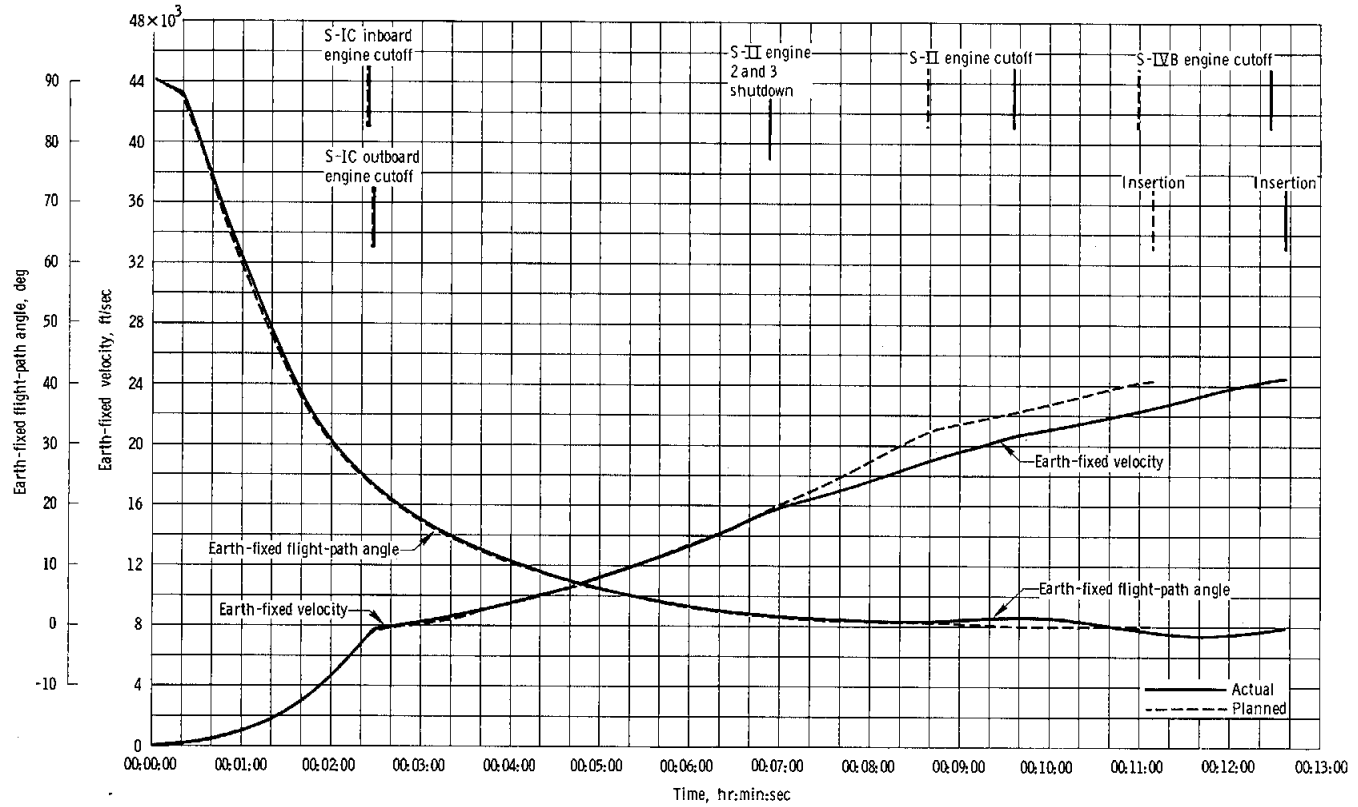
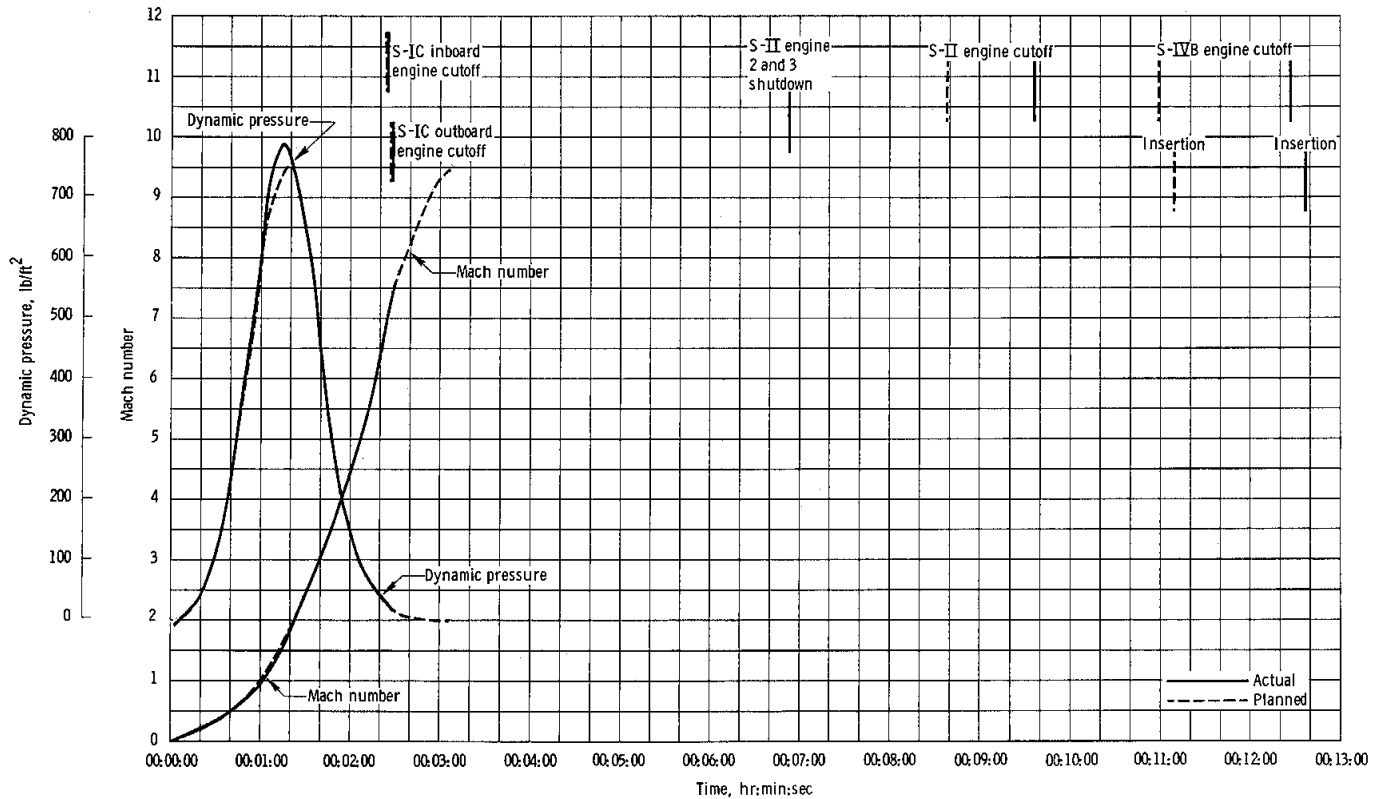
Figure 3-2 - Trajectory parameters during the launch phase.

The launch phase trajectory for the S-IC stage was nominal as shown in figure 3-2. Mach 1 occurred at 00:01:00.5 at an altitude of 23 435 feet and was approximately 0.6 second earlier and 779 feet lower in altitude than expected. The maximum dynamic pressure of 784 lb/ft² occurred at 00:01:15.2 and was 4.5 seconds earlier and 5330 feet lower in altitude than planned. The actual cutoff times for the inboard and outboard engines were within 1.1 second of the planned times. The conditions at outboard engine cutoff (table 3-II) were high in velocity and altitude by 24 ft/sec and 3648 feet, respectively, and low in flight-path angle by 0.17 degree. Launch escape tower jettison occurred in a normal manner at 00:03:04.8. The predicted time of tower jettison was 00:03:03.4.

As shown in figure 3-2, the trajectory for the S-II stage began diverging from the planned trajectory at 00:06:52.9. This was caused by the premature shutdown of S-II stage engines 2 and 3. The remaining

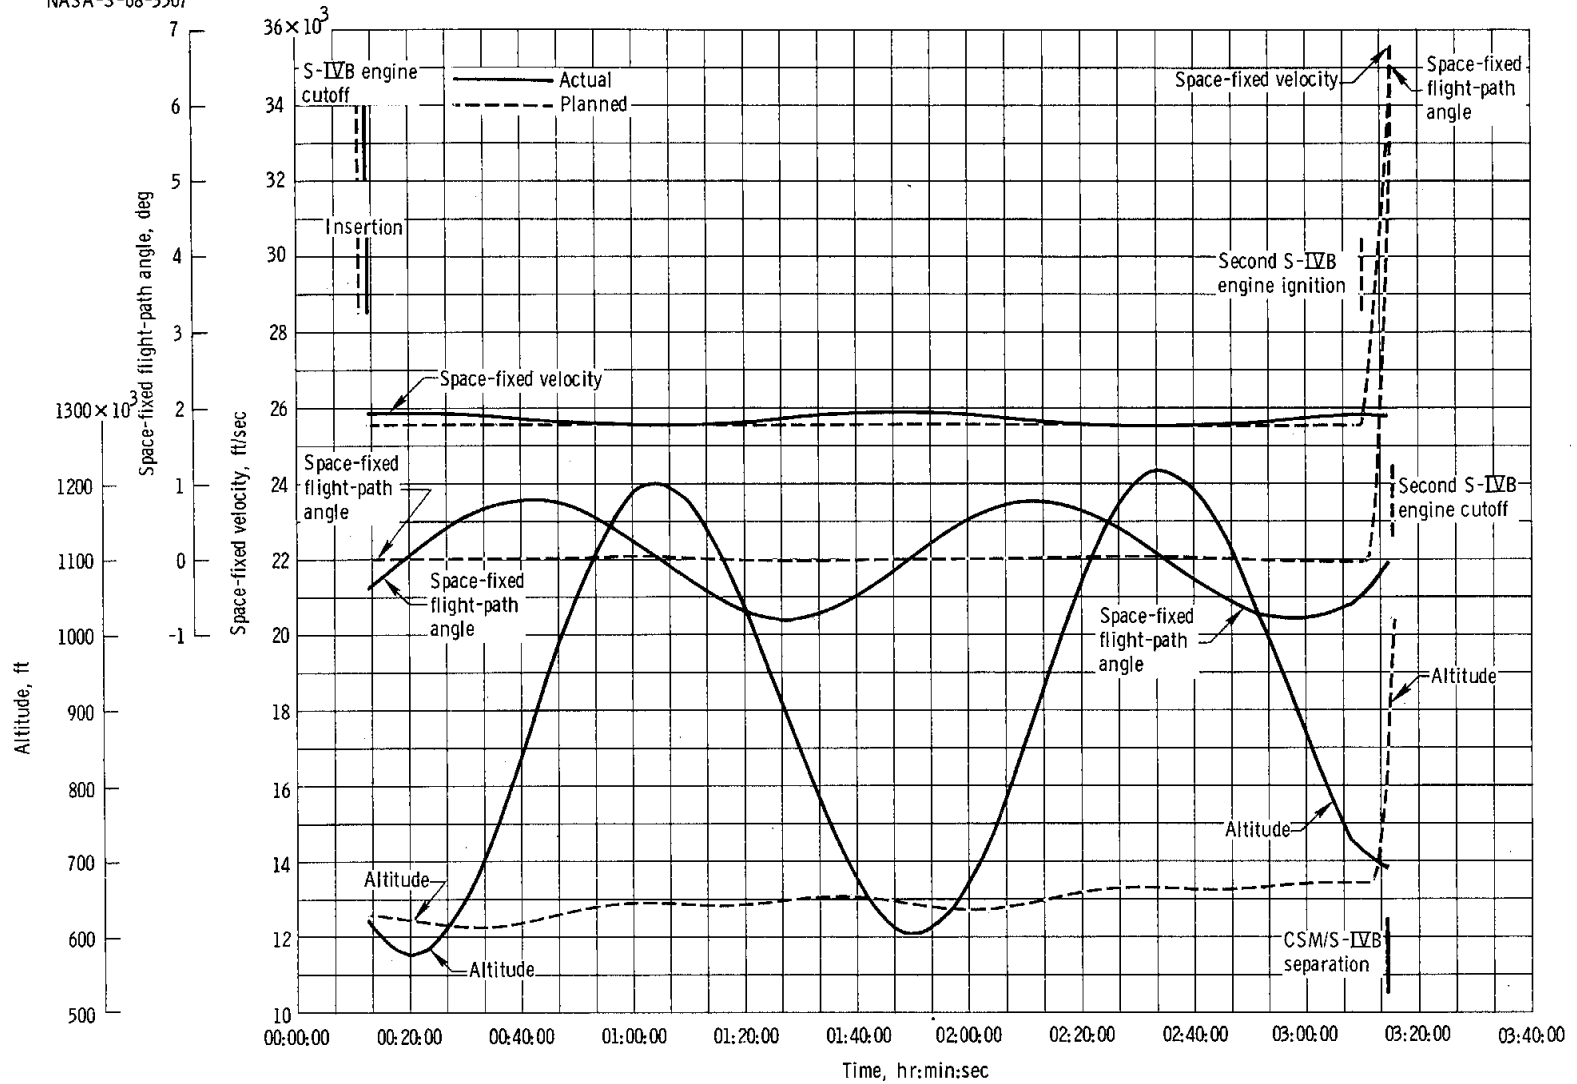
Figure 3-3. - Space-fixed velocity, flight-path angle, and altitude during the parking orbit.

Polynomials for the venting were developed from the S-IVB guidance data and were used with the tracking data to calculate the best-estimate trajectory. The CSM/S-IVB parking orbit was elliptical, as shown in figure 3-3; the S-IVB venting increased the altitude by approximately 6 n. mi. between insertion and restart preparations. The trajectory parameters for discrete events during this phase are presented in table 3-III.

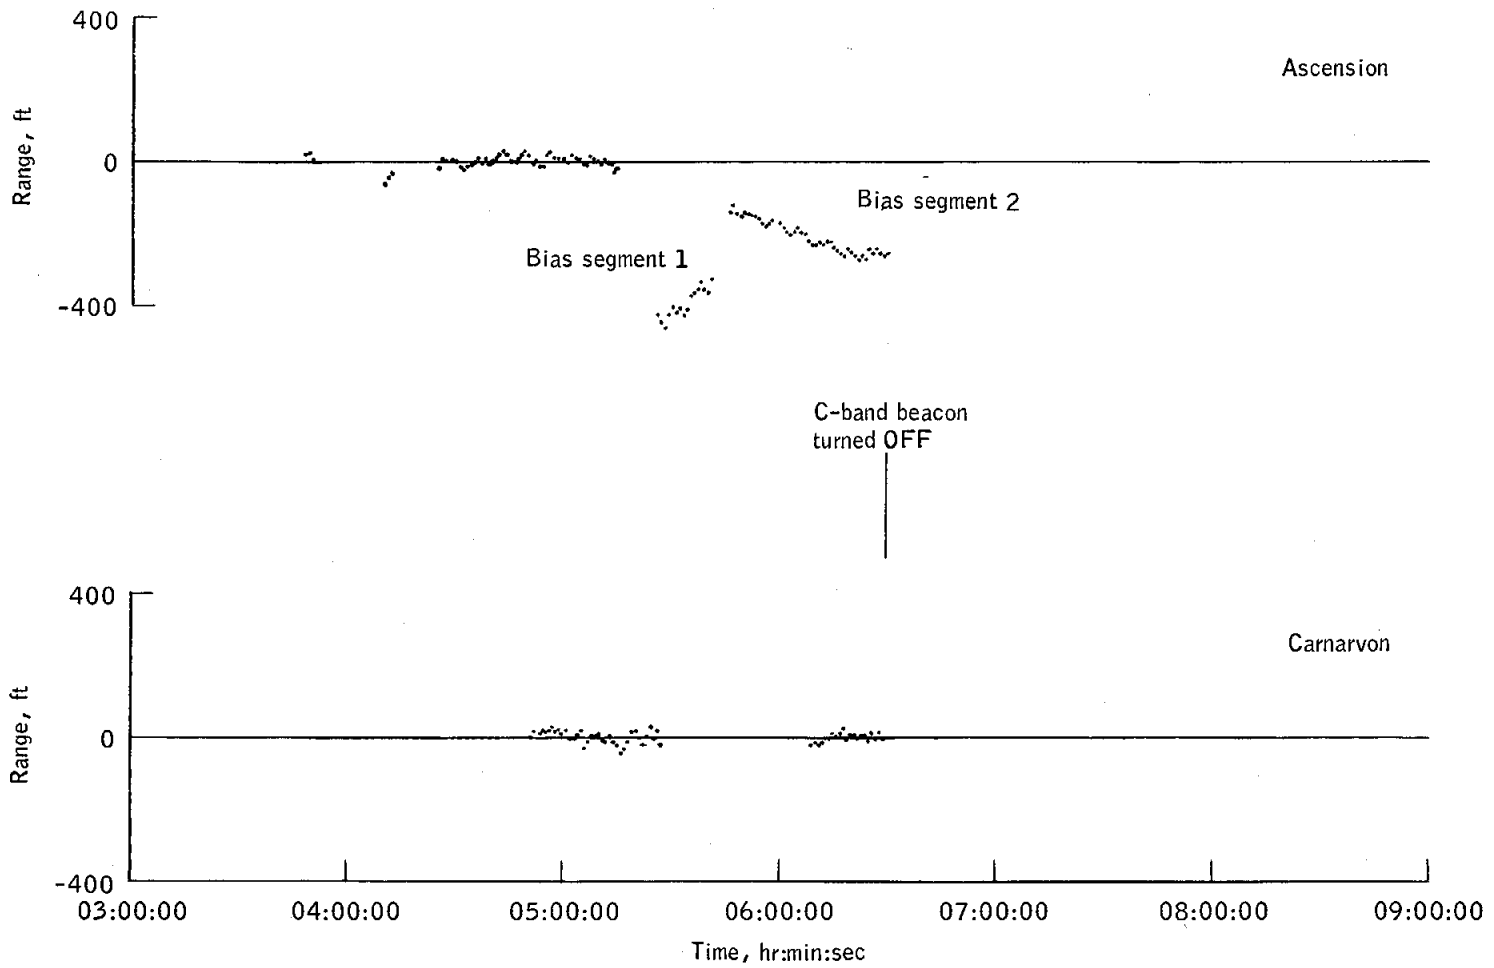
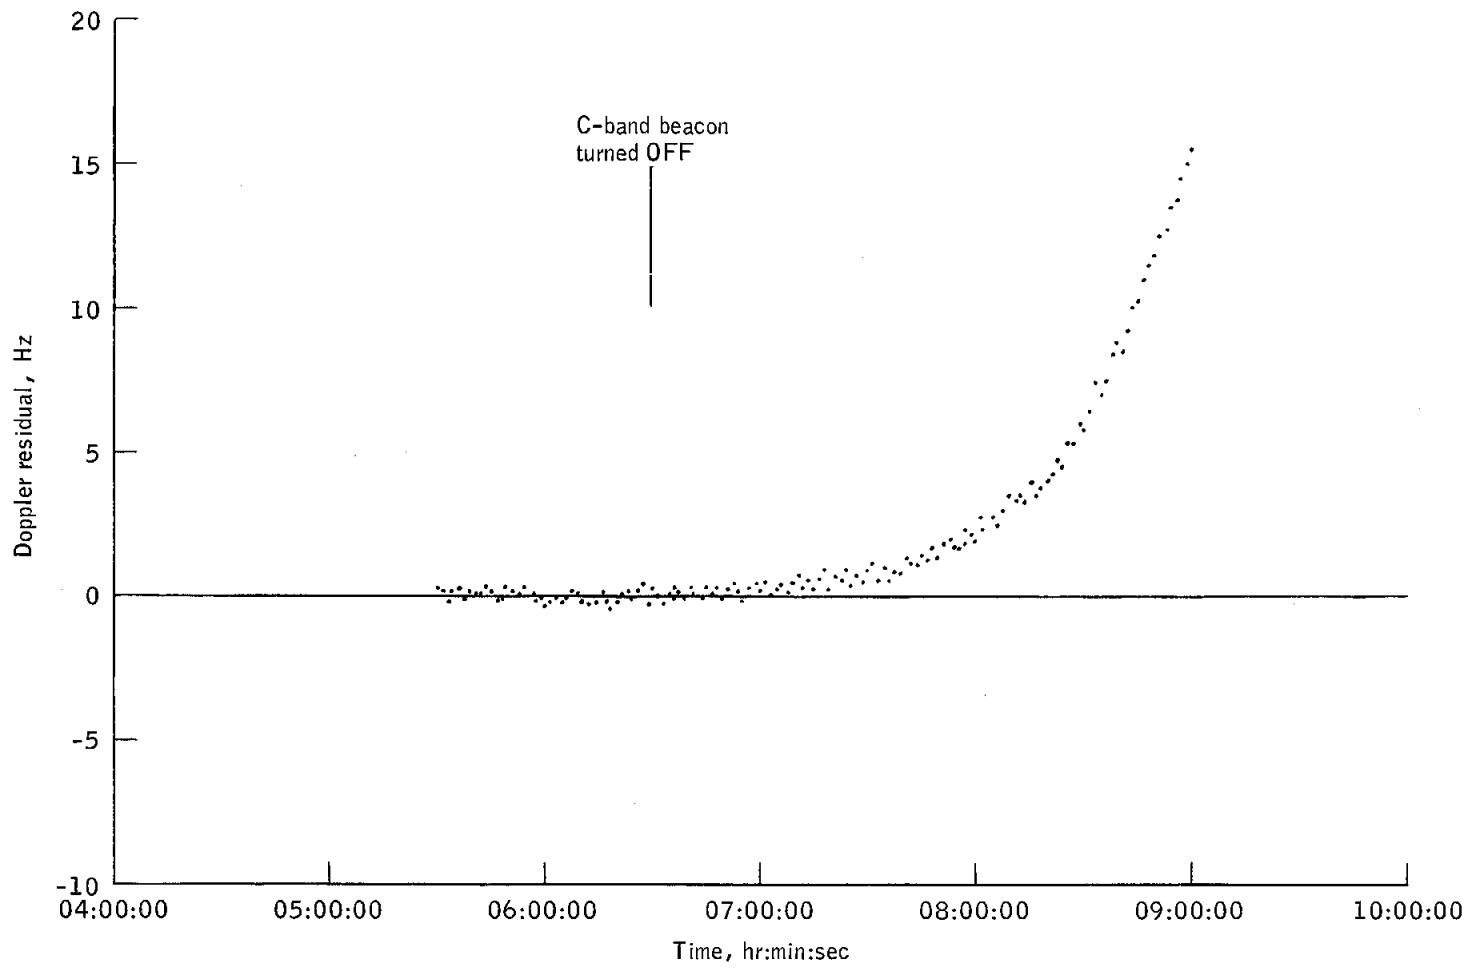
Figure 3-4.- Ascension and Carnarvon tracker residuals.

Several difficulties were encountered during the coast ellipse phase, particularly with the tracking data from the Ascension TPQ-18 radar at approximately the time of the second navigation update computation. The range residual plots for Ascension and Carnarvon (fig. 3-4) show biases in two segments of the Ascension data. This is a recurring phenomenon that has appeared on three consecutive missions.

fit with the C-band data as well as expected. When the C-band vector was compared with the S-band Doppler data, the residual pattern shown in figure 3-4 was apparent. This pattern was characteristic of an unmodeled thrust, and the Doppler shift of 17 Hz represented a total radial velocity of approximately 4 ft/sec. Water boil-off from the environmental control system was probably the cause for this velocity perturbation. Preliminary figures indicate that the water boil-off could have accounted for as much as 12 ft/sec change in velocity.

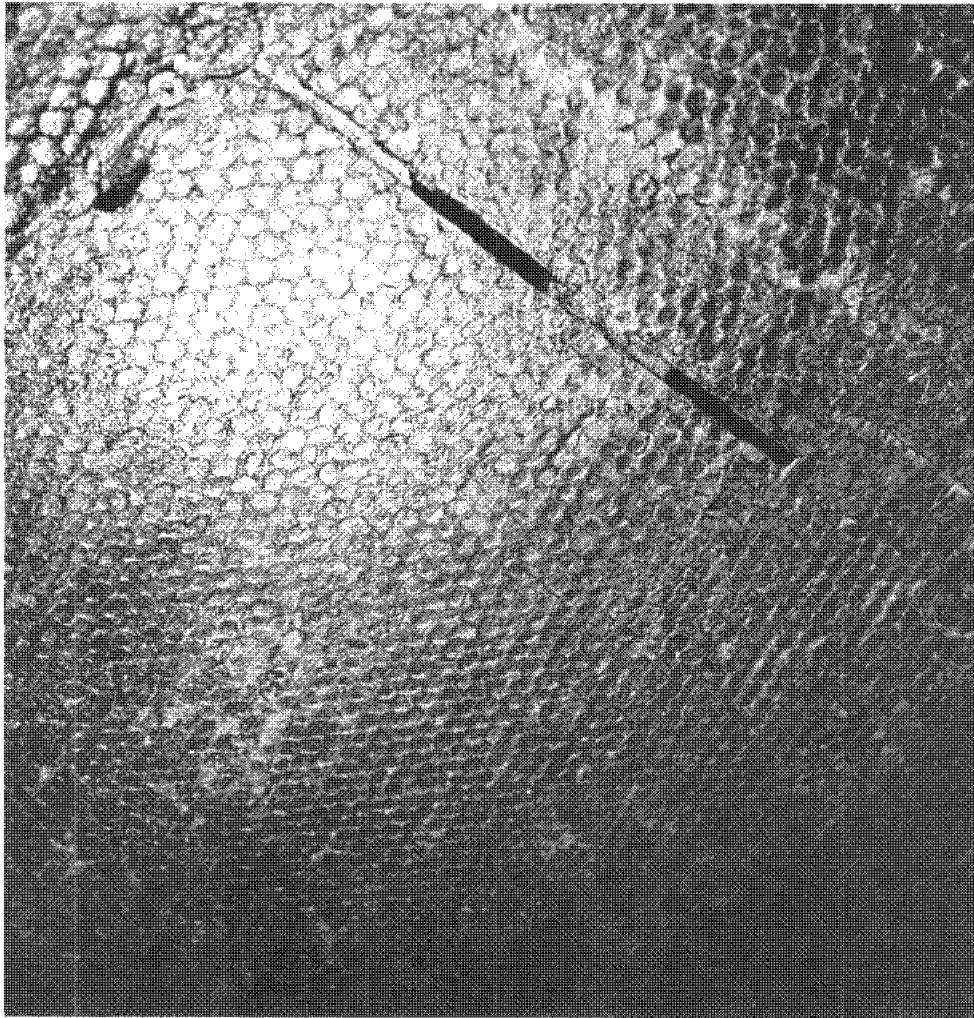
Figure 5.4-4.- Concluded.

Some ablator was missing from the gap splice, as shown in figure 5.4-4c. Visual inspection showed that most of the gap was intact; there was no evidence of erosion at the cavity edges where ablator was missing. These findings indicated that the ablator was lost after entry; the ablator could have been broken at landing or have been washed out by wave action. This phenomenon did not occur on the Apollo 4 command module (which remained in the water only briefly during recovery) but did occur on the AS-202 (which, like the Apollo 6 command module, was in the water for a longer period). Improved manufacturing processes eliminated the ablator splice between honeycomb segments on all block II heat shields.

(c) Closeup view of splice area.

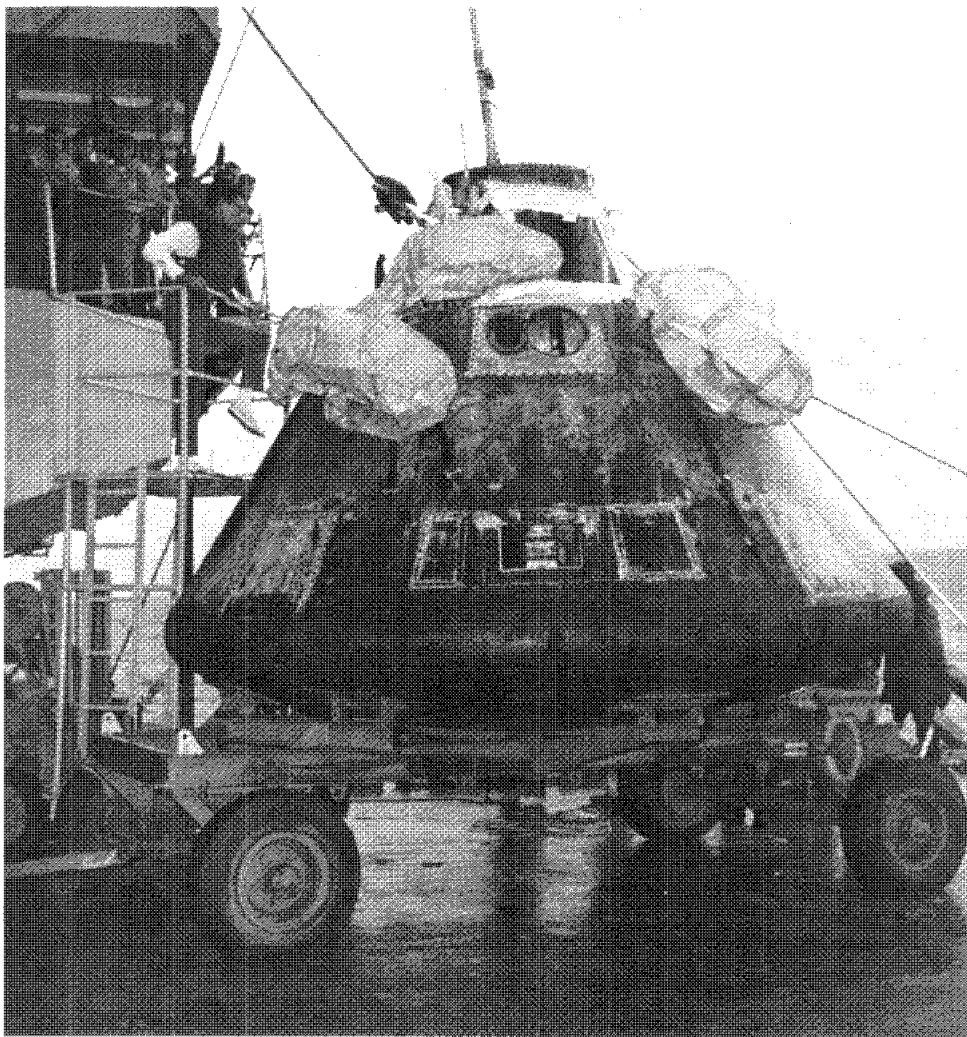
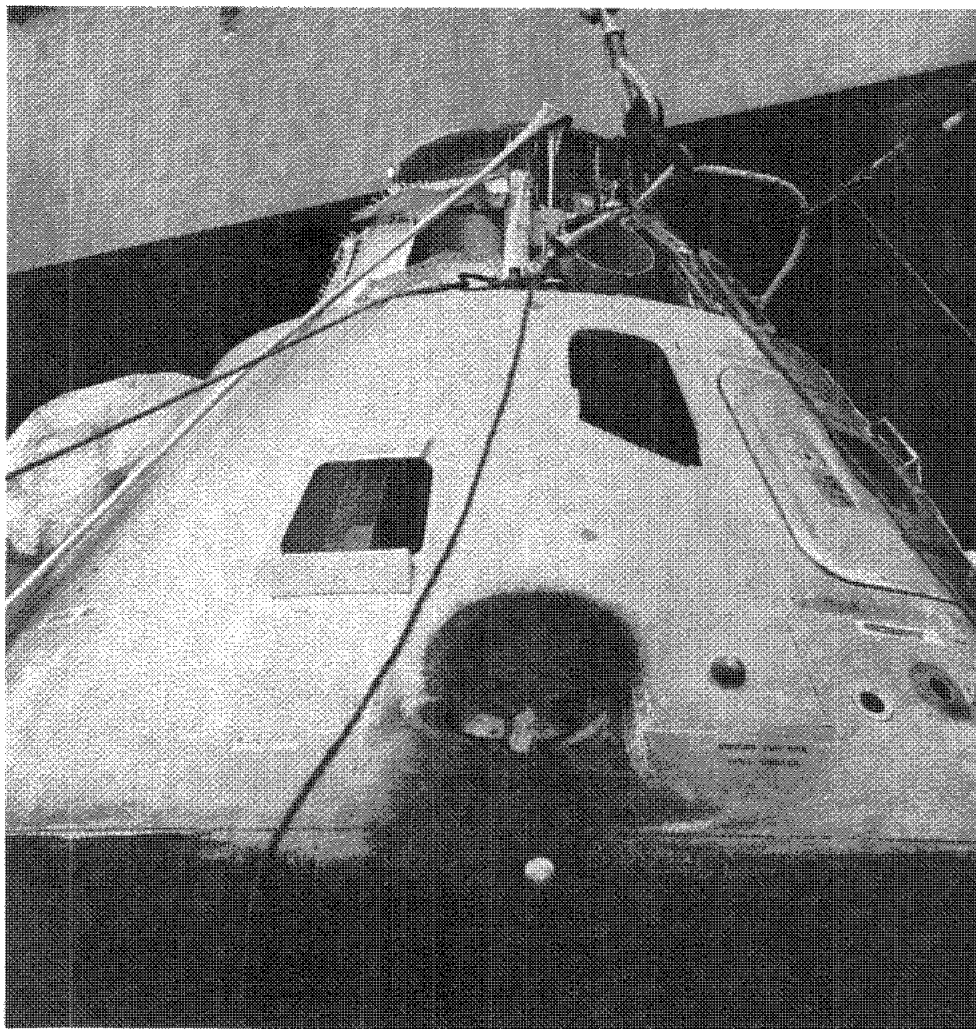
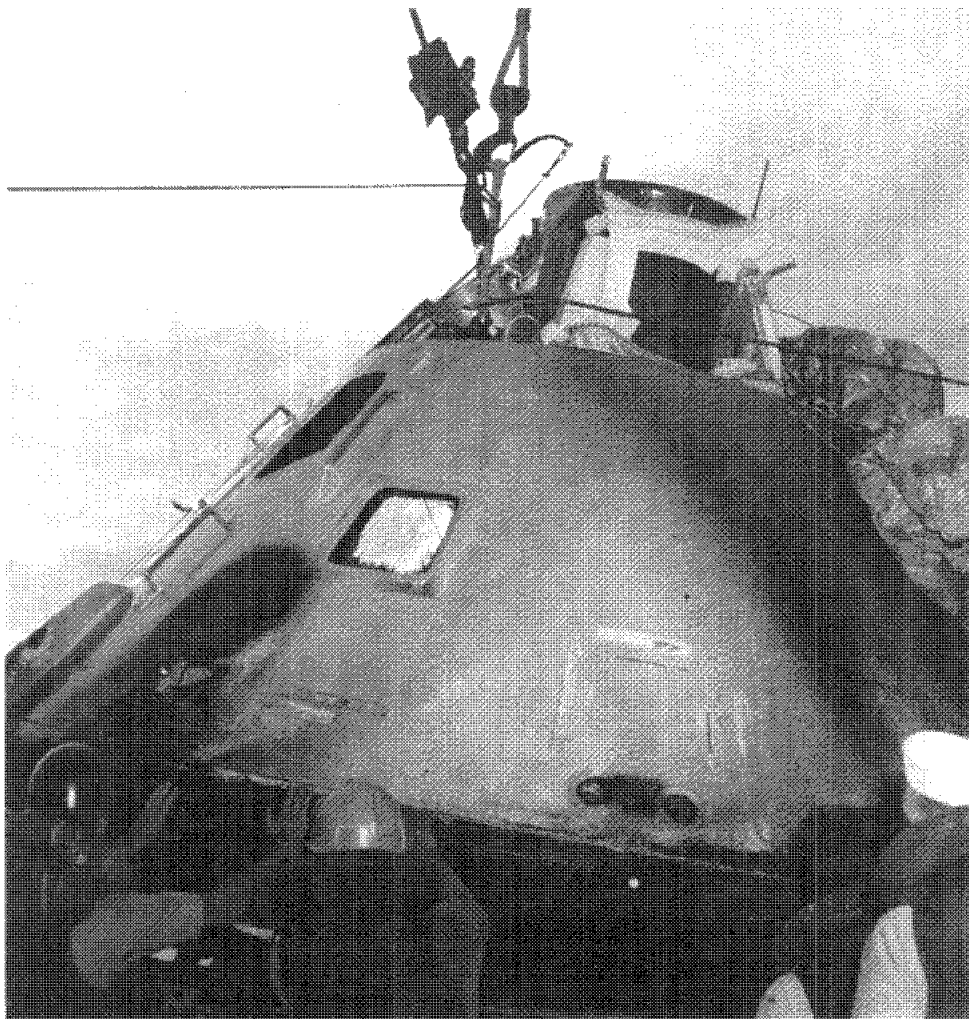
(a) +Z windward side of spacecraft.

Figure 5.4-9.- Conical heat shield.

(b) -Y axis to -Z axis.

(c) -Z axis to +Y axis.
Figure 5.4-9.- Concluded.

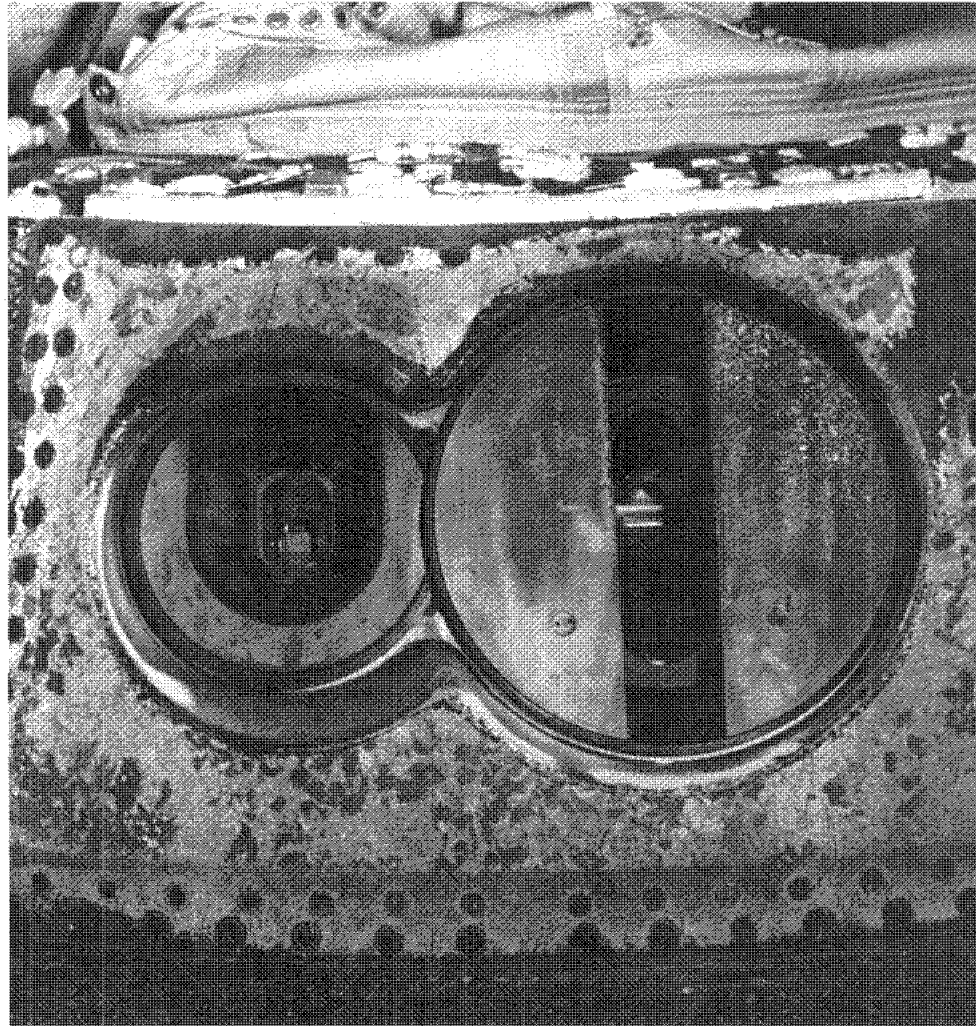
Figure 5.4-10.- Astro-sextant and telescope area.

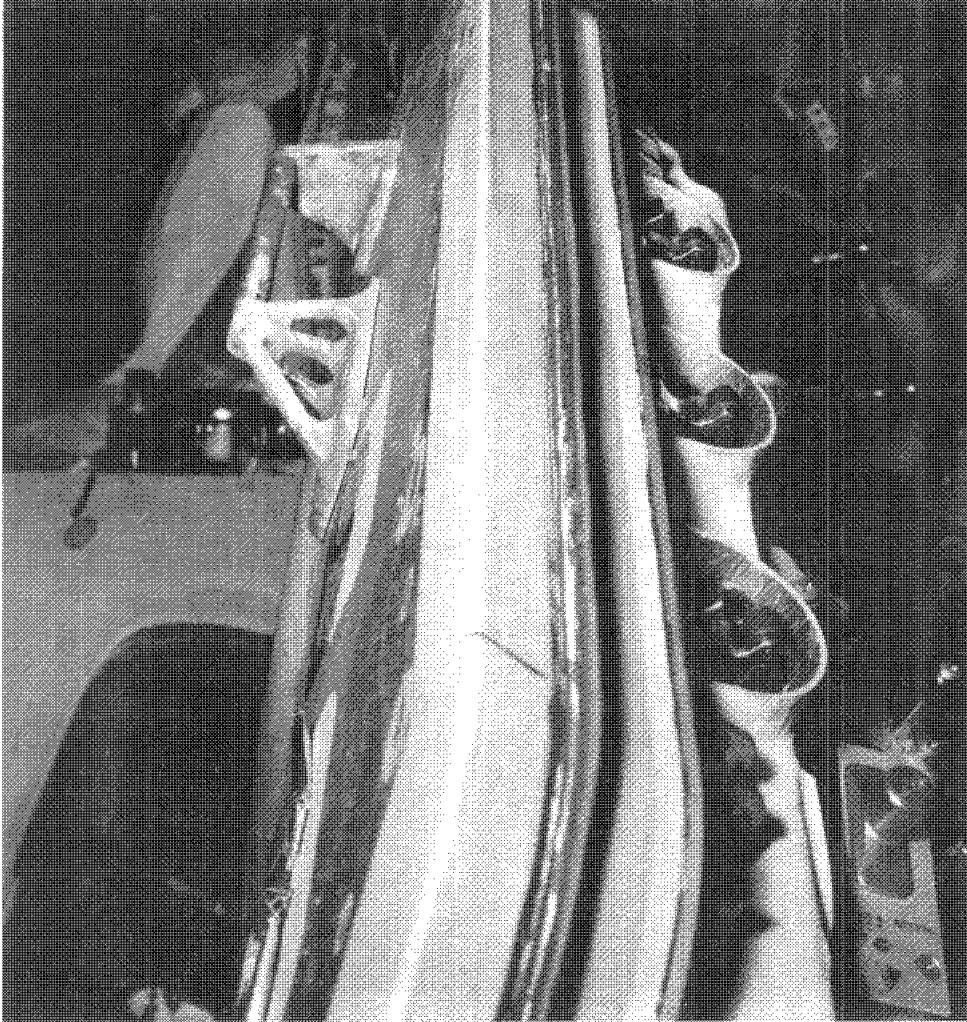
Figure 5.4-11.- Thermal seal of unified hatch.

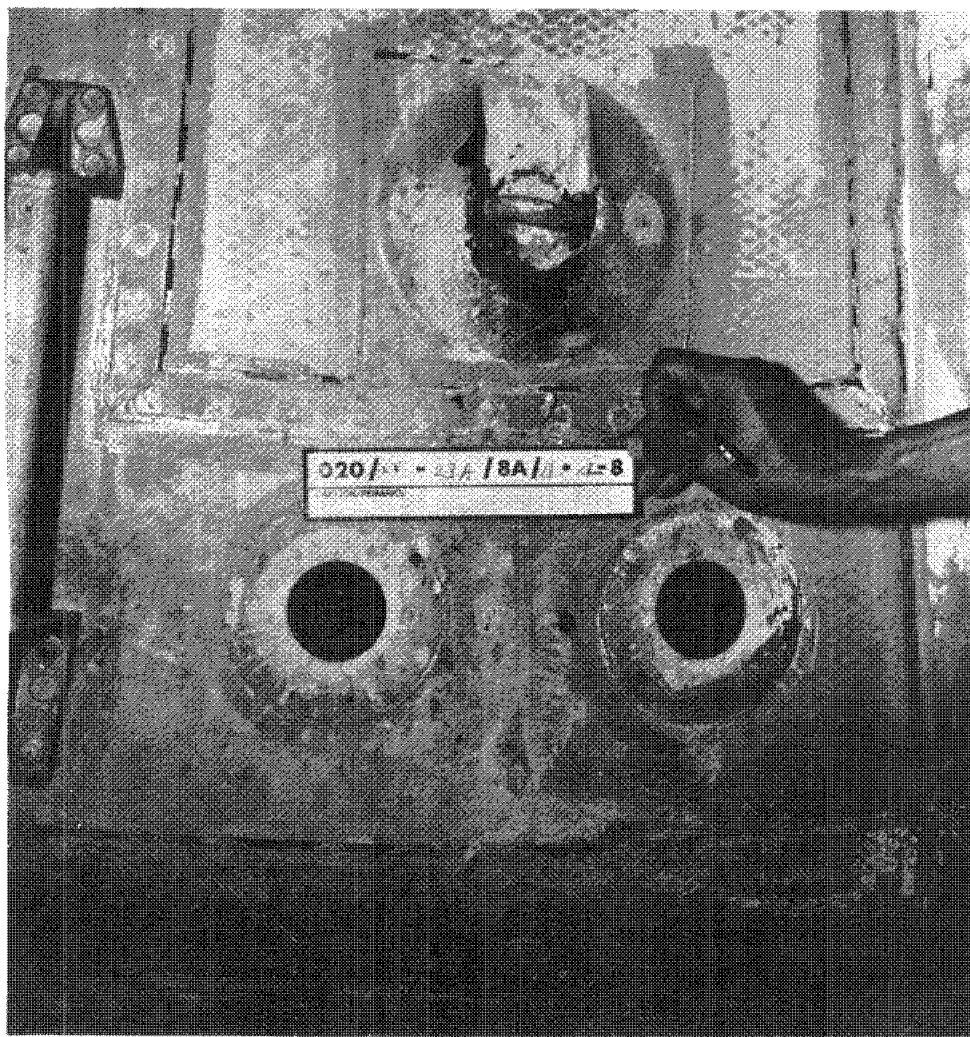
Sea anchor.- The sea anchor attachment ring and adjacent ablator appeared to have experienced only minor heating during entry (fig. 5.4-12). Some ablator damage was incurred after landing.

Figure 5.4-12.- Sea anchor attach ring.

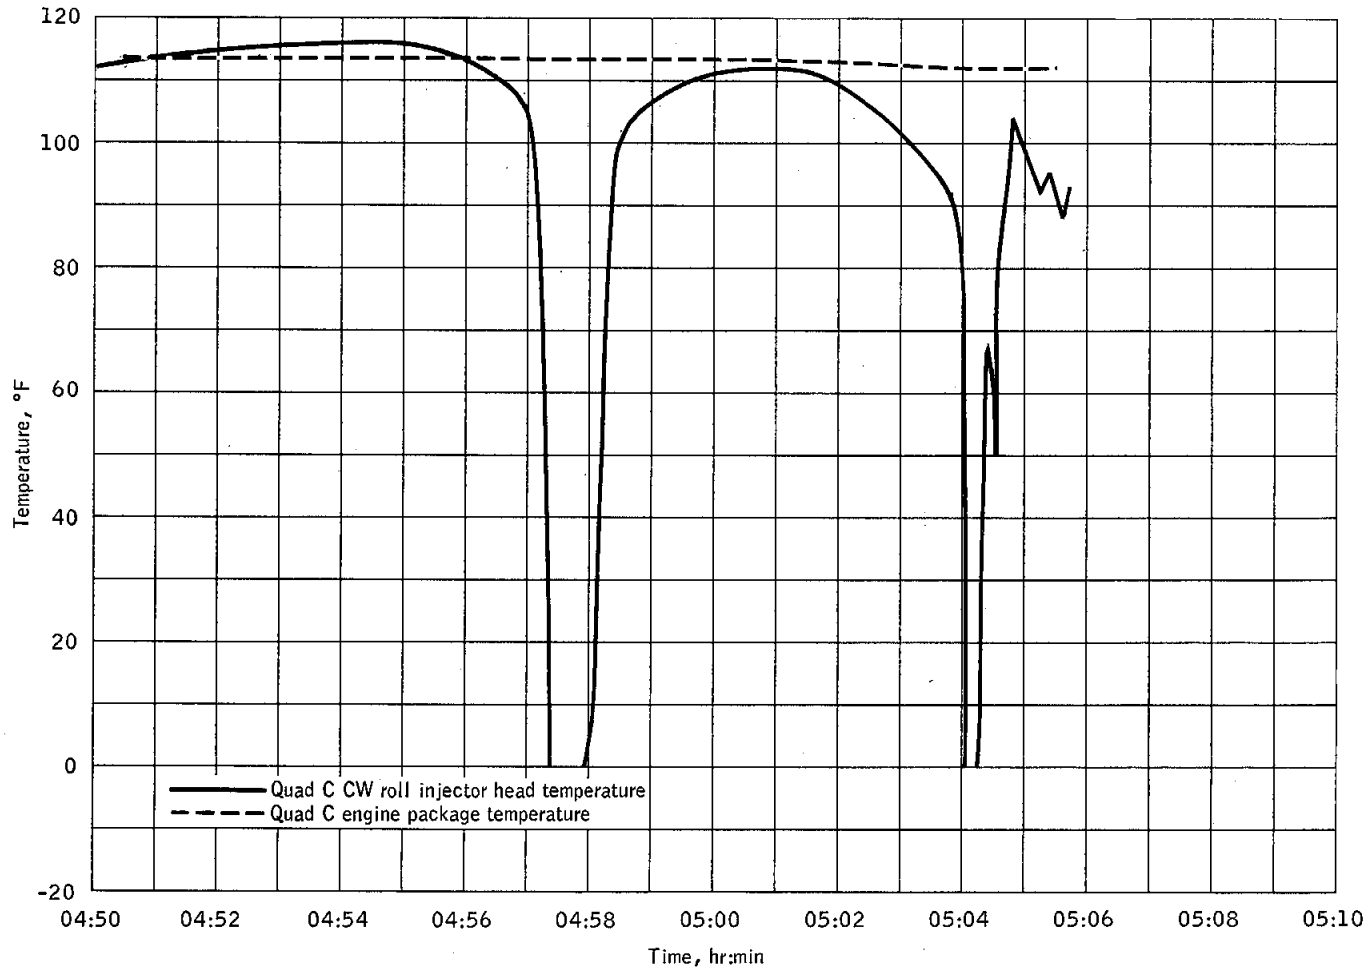
Figure 5.17-5.- Abnormal thermal behavior of quad C CW roll injector head during cold soak.

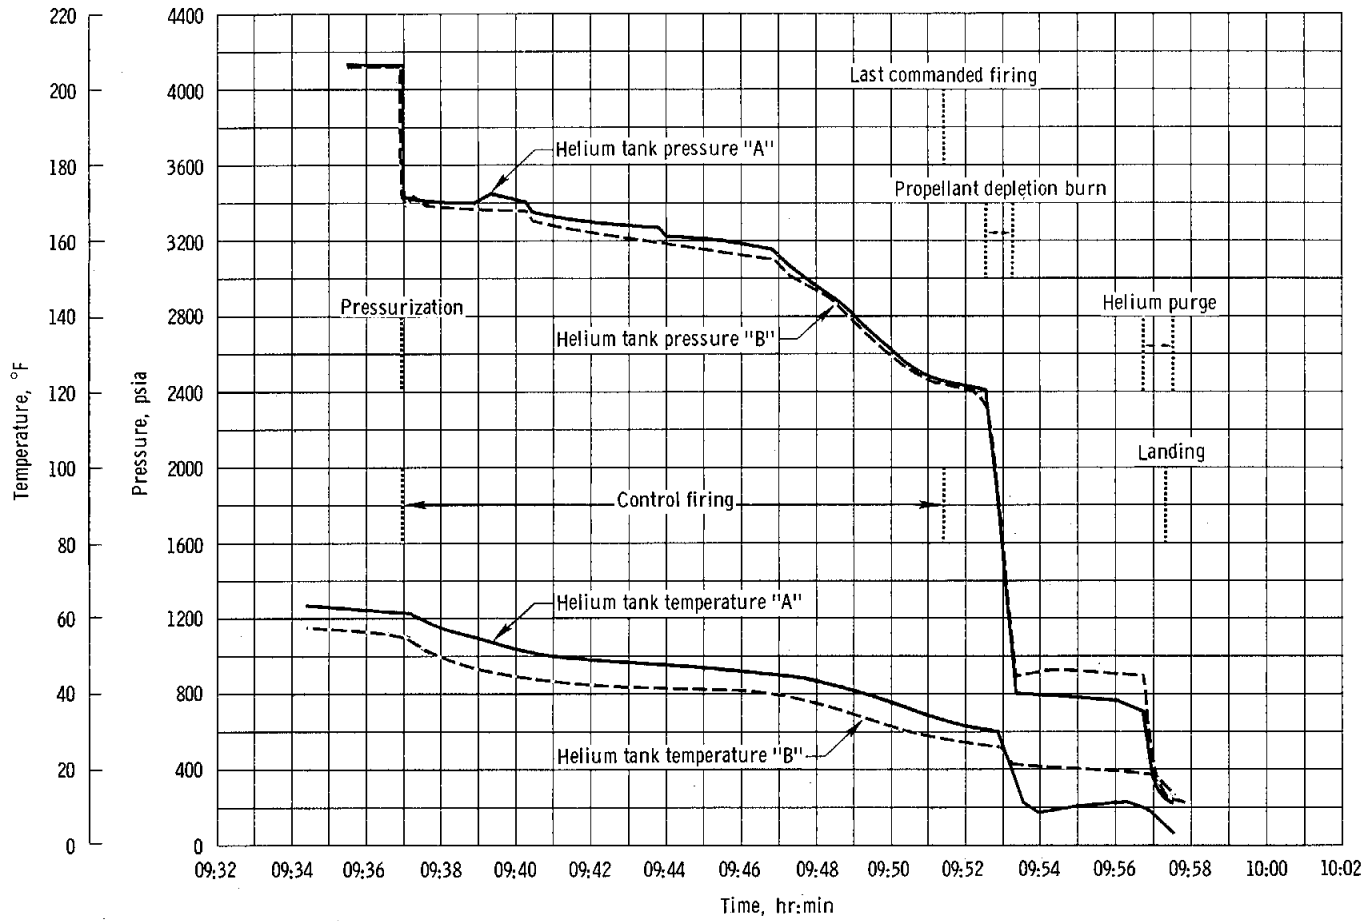
System pressures: System helium pressures from servicing through landing are shown in table 5.17-IX. The helium tank pressures and temperatures during entry are shown in figure 5.17-9. The constant pressure/temperature ratio prior to activation indicated that the system had not leaked. When the helium pressurization systems were activated, the source pressure of each system dropped 680 psi; this decrease, 240 psi greater than that seen during the Apollo 4 mission, was caused by the increased oxidizer tank ullage that resulted from loading 5 pounds less oxidizer in each system. At the time the helium purge was terminated, the A and B system source pressures were 273 psia and 253 psia (referenced to 70° F), respectively. Similar values had been noted during the Apollo 4 mission; the purge system will be modified for future command modules to permit a more rapid purging.

Figure 5.17-9. - Systems A and B helium tank pressure and temperature history for command module reaction control system.

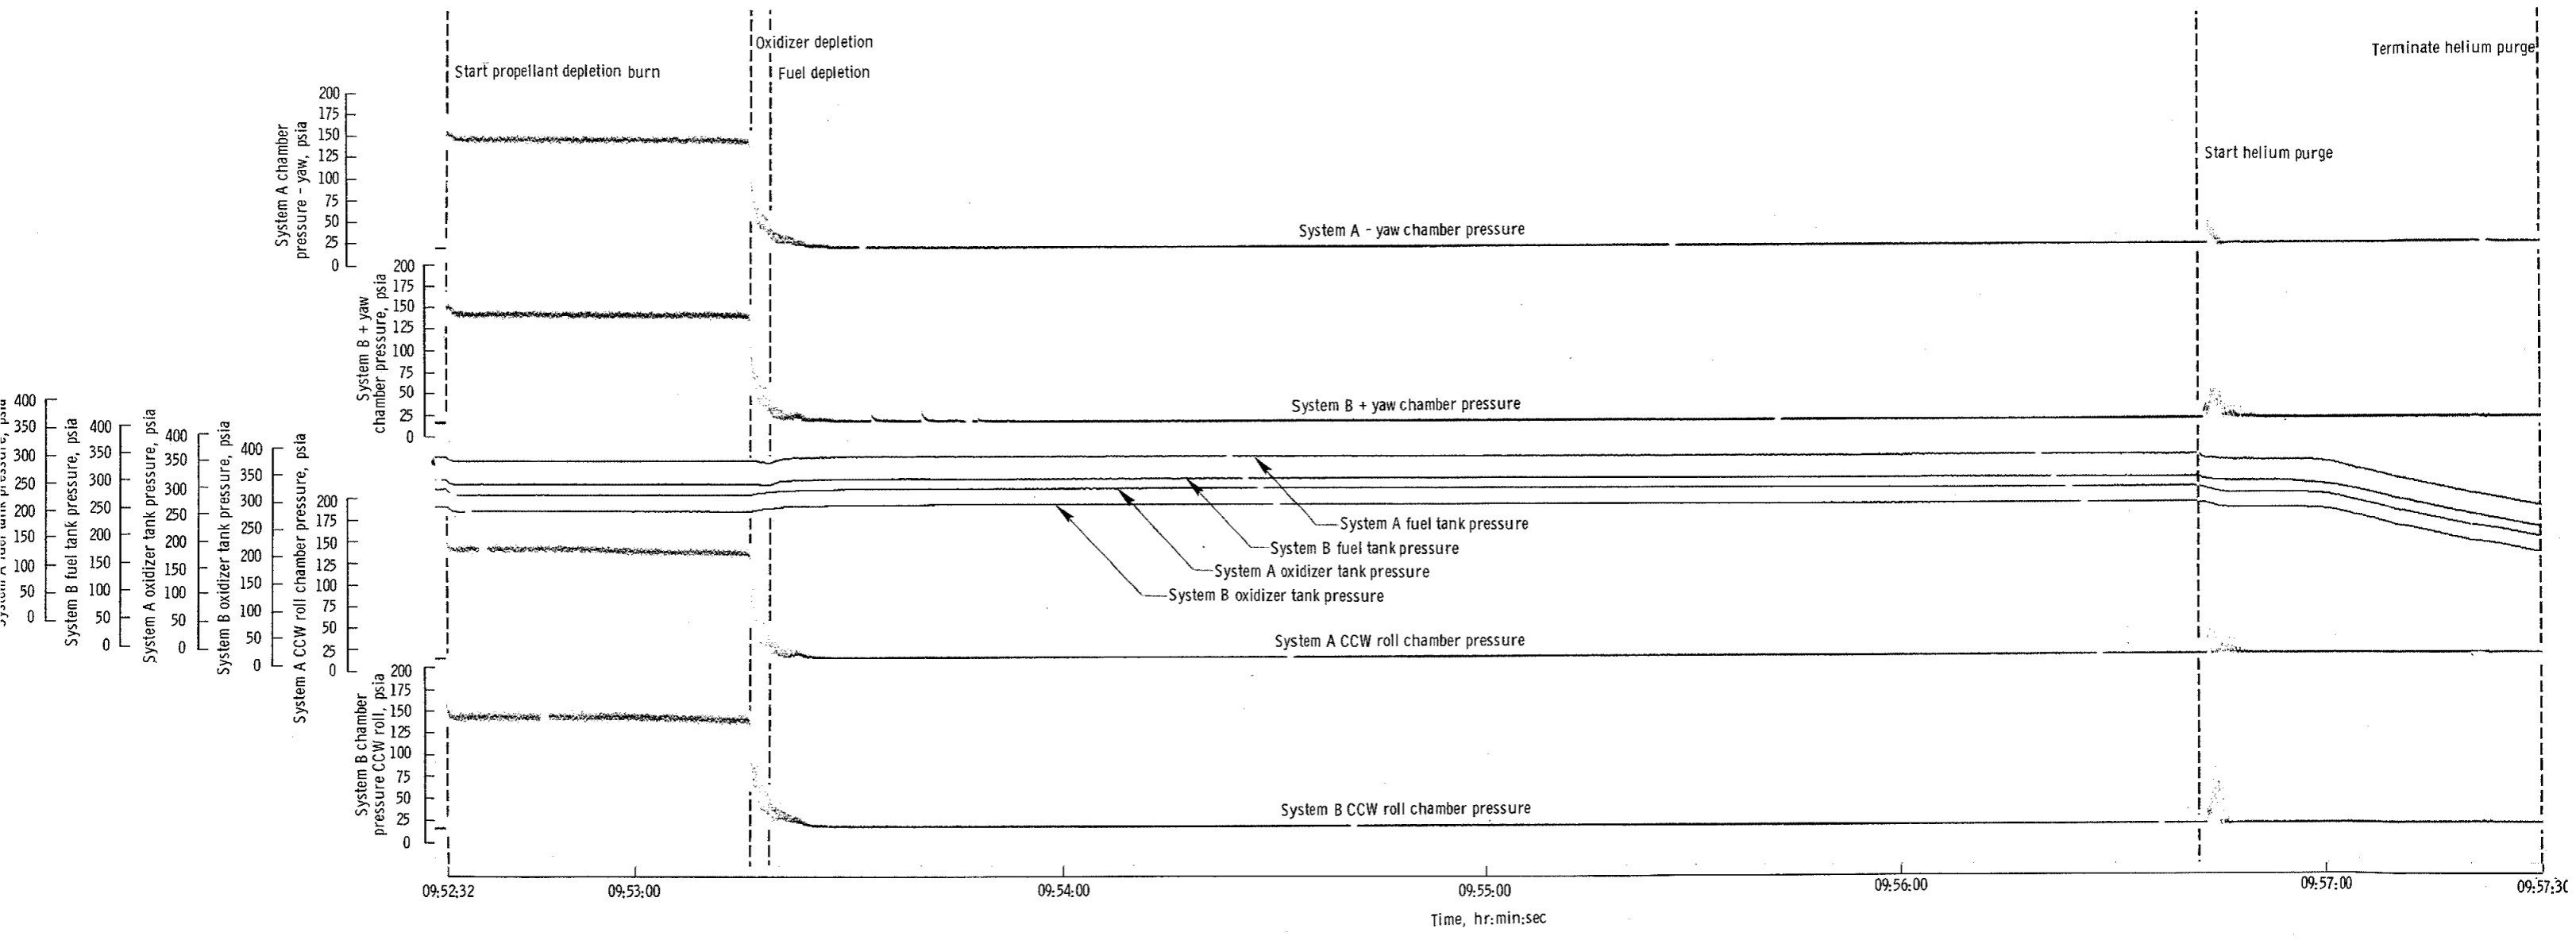
are shown in figure 5.17-11. The oxidizer tank pressure recovered several seconds before the fuel tank pressure, indicating that the usable oxidizer had been depleted before the fuel. Approximately 14.5 pounds of oxidizer remained trapped in the tank and lines of the two systems. The engine chamber pressure buildup during the helium purge indicated that at least part of this trapped oxidizer was burned. During the Apollo 4 mission, the fuel was depleted first, leaving 10.5 pounds of usable oxidizer in addition to the trapped quantity. To reduce the hazard of the unburned oxidizer damaging the parachutes during the Apollo 6 mission, 5 pounds less oxidizer were loaded in each system than had been loaded for previous missions. This oxidizer would have been in excess of that required for combustion of the usable fuel.

Figure 5.17-11. - Propellant depletion burn and helium purge.
