APOLLO 6 MISSION REPORT

MANNED SPACECRAFT CENTER
HOUSTON, TEXAS
MAY 1968

MSC-PA-R-68-9

Prepared by: Apollo 6 Mission Evaluation Team

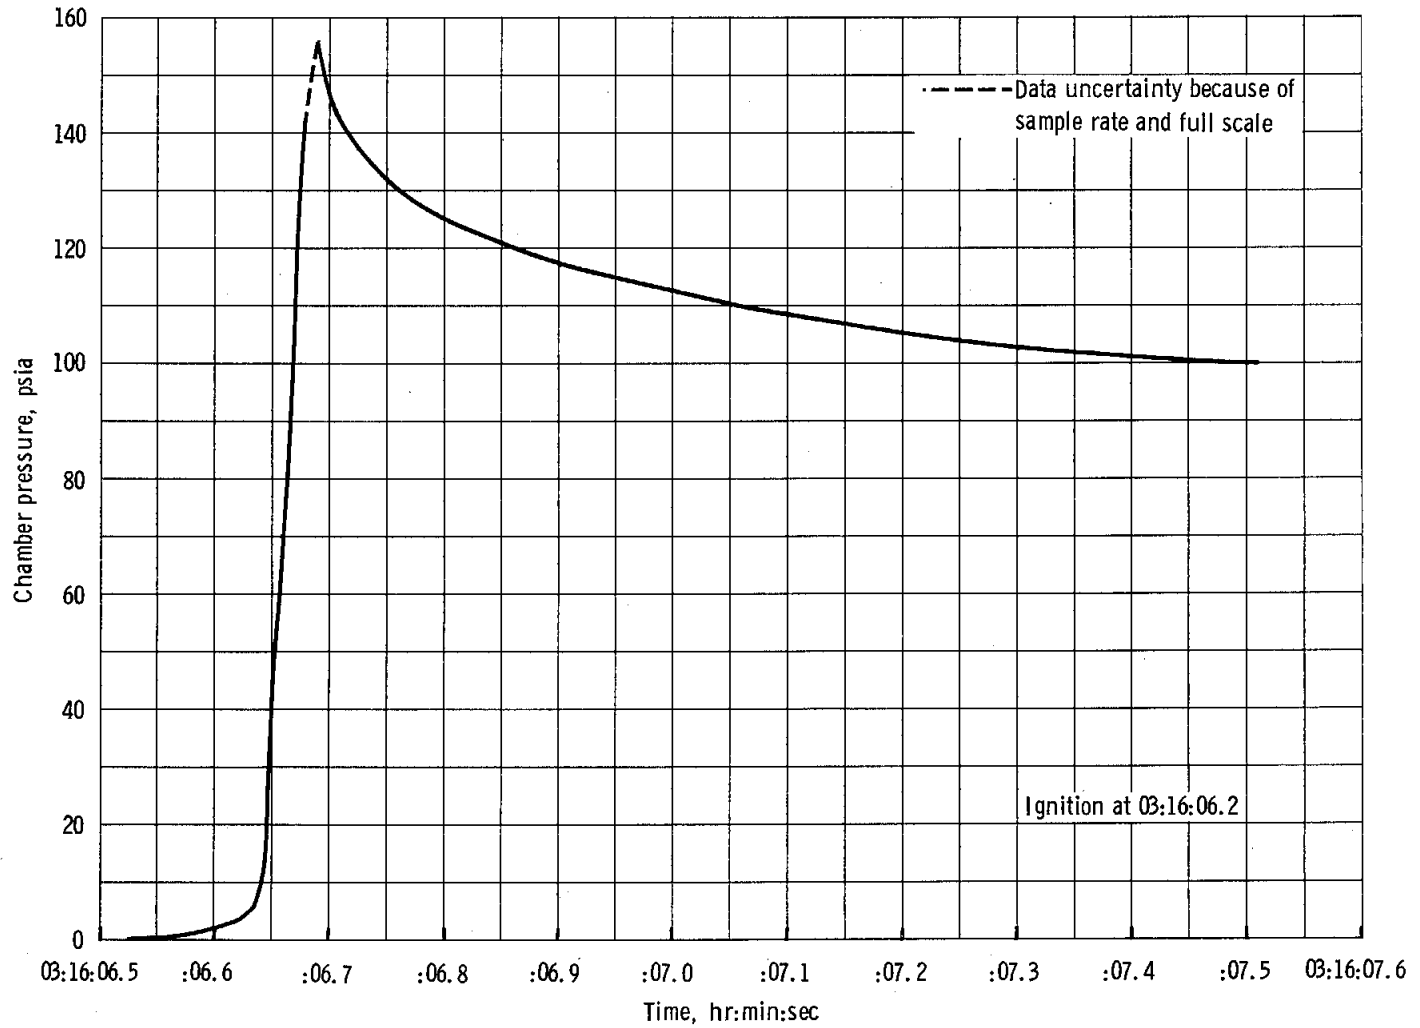
The chamber pressure overshoot shown in figure 5.18-3 has also occurred during other flights. The flight chamber pressure measurement is sampled at the rate of 100 samples per second and has a nominal range of 0 to 150 psia. The maximum transducer output cannot be recorded because of telemetry limitations. For Apollo 4 and Apollo 6, the chamber pressure transducer was mounted on a 2-inch adapter. This change was made to correct thermally induced drifting of the transducer which was apparent on previous flights. The magnitude and the duration of the overshoot with the new mounting have shown a marked increase over that observed for the original mounting. A special series of ground tests will be conducted during the second week of June 1968 to determine whether the indicated overshoot is partially due to instrumentation errors.

Figure 5.18-3. - Service propulsion system chamber pressure during start transient.

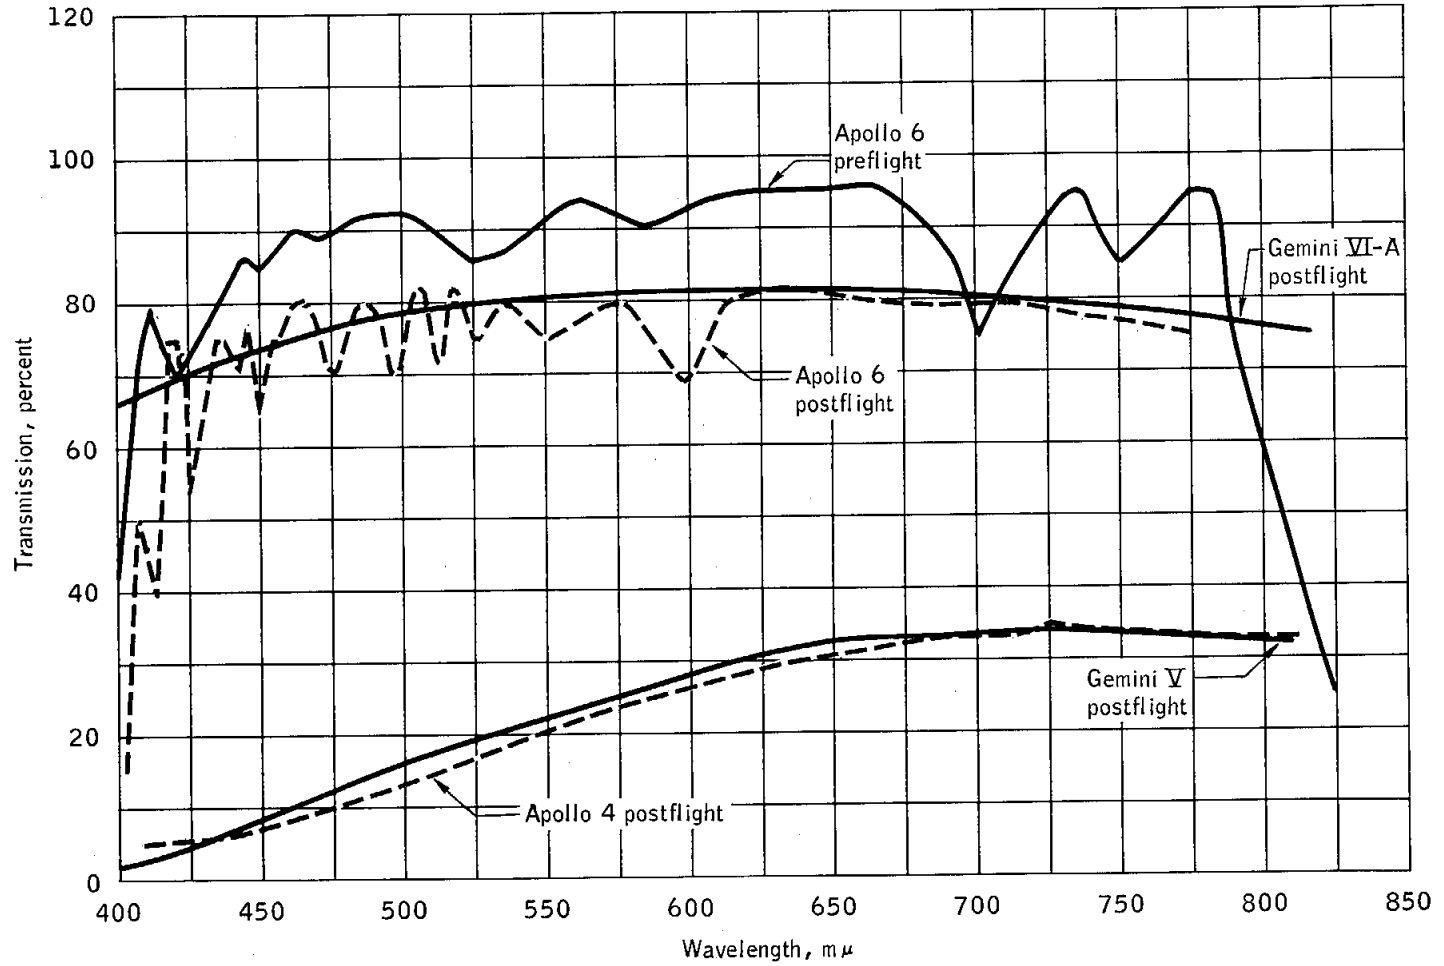
Figure 5.20-5.- Comparison of direct light transmission of Apollo 4 and 6 and Gemini V and VI-A windows.

Postflight direct light transmission analysis was performed on the spacecraft left rendezvous and right side windows. The general light transmission through both windows was 70 to 80 percent. The worst area on the rendezvous window had a light transmission of 60 to 65 percent in the visible wavelength of 450 to 650 millimicrons. The least contaminated area had a general transmission of 85 to 90 percent. The contamination on the right side window was more evenly distributed than that on the rendezvous window and a general direct transmission of approximately 85 percent from 550 to 600 millimicrons and 70 percent from 450 to 550 and 600 to 650 millimicrons (fig. 5.20-5).

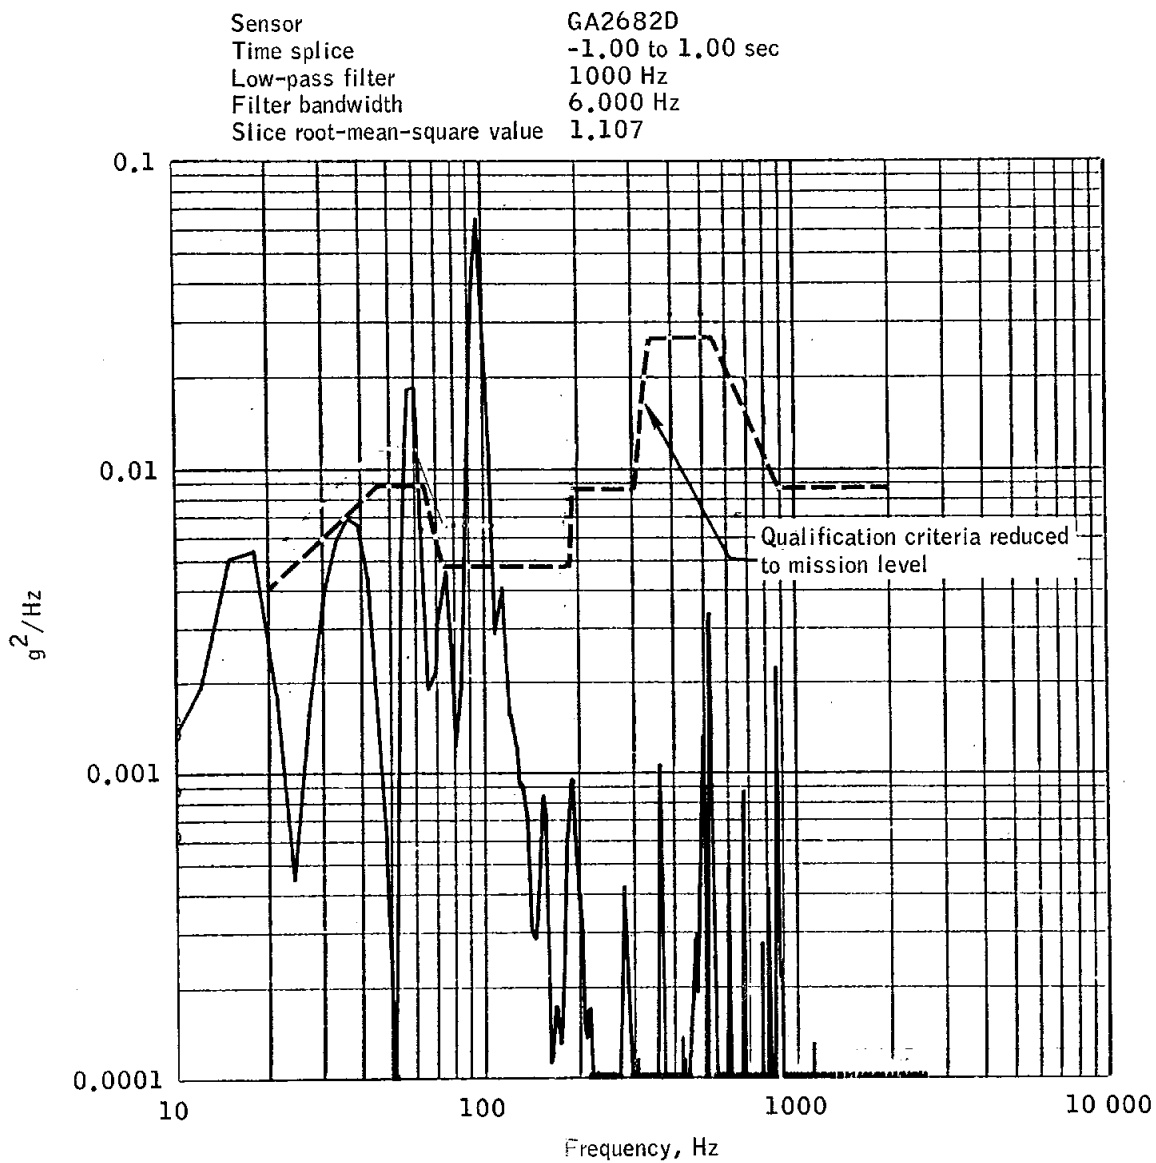
Figure 6.1-1.- Y axis vibration at lift-off, -Z oxidizer tank.

At lift-off, in the transonic region, and in the maximum dynamic pressure region, the oxidizer tank vibration levels exceeded the mission-level vibration criteria by 16 dB and 11 dB at frequencies of 74 Hz and 95 Hz, respectively. Acceptance test values were also exceeded at 58 Hz and 85 Hz during lift-off but by only 3 dB, which is acceptable because of configuration differences between the flight tanks and the LTA-2R tanks. Acceleration spectral densities of the two measurements on top of the descent stage oxidizer tanks are shown in figures 6.1-1 and 6.1-2. Autocorrelation plots of these measurements are shown in figures 6.1-3 and 6.1-4. The presence of the slowly decaying oscillations at 74 Hz and 95 Hz indicate that the data at these frequencies are very narrow band and essentially periodic; therefore, they have no values definable by power spectral density analysis and should not be compared with the random vibration criteria, but with the sinusoidal qualification test levels. The peak value of the LTA-2R data, with all frequencies contributing, was 3.78g for the Y axis and 5.06g for the Z axis. The oxidizer tank sinusoidal qualification tests exposed the top of the tanks to 44g at 90 Hz. It was expected that frequencies of the qualification test and the flight measured peaks would not be identical because the oxidizer tanks on the LTA-2R were boilerplate construction and were not completely filled with fluid. Therefore, the qualification tests are considered adequate for demonstrating the ability of the oxidizer tanks to withstand the vibration levels measured on LTA-2R.

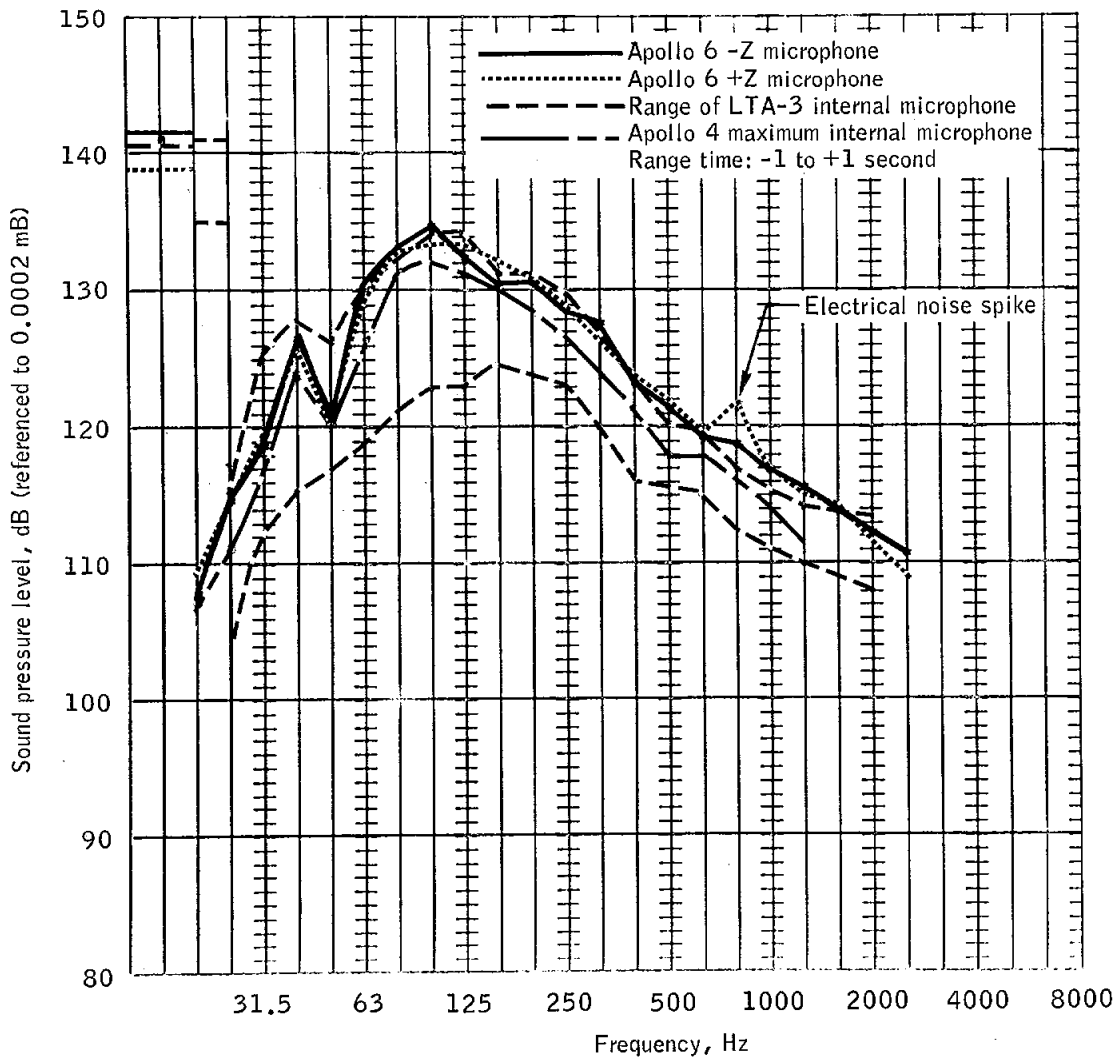
Figure 6.1-5.- Adapter/LTA-2R internal sound pressure levels compared with Apollo 4 and LTA-3.

Figure 6.1-5 compares the Apollo 6 lift-off acoustic levels with those measured during the Apollo 4 mission and the LTA-3 ground tests. The discontinuity in the plus Z measurement at 845 Hz is due to electrical noise present prior to launch. The Apollo 6 overall level was approximately 2 dB higher than the Apollo 4 level and approximately 1 dB above the upper envelope of the LTA-3 levels. The variation between the two Apollo flights can be attributed to the differences in the first-stage engines and variations in the atmospheric conditions. The variation in acoustic absorption between the LTA-2R and a flight-type lunar module accounts for the differences between the Apollo 6 and the LTA-3 levels. During tests of the adapter/LTA-3 configuration, absorption measurements were made with an empty adapter, an adapter plus the LTA-3 without thermal shielding, and an adapter plus the LTA-3 with thermal shielding. The empty adapter showed 120 sabins of absorption, the adapter plus the LTA-3 showed 240 sabins, and the adapter plus the LTA-3 with thermal shielding showed 300 sabins. The LTA-2R should have absorption values between the empty adapter values and the adapter plus the LTA-3 without thermal shielding values. Assuming an average value of 180 sabins for the LTA-2R configuration, a 2-dB reduction in the Apollo 6 levels would be expected had it contained a flight-type lunar module. Therefore, it can be concluded that the acoustic levels measured during the Apollo 6 flight did not exceed the LTA-3 test levels when adjusted for variations in acoustic absorption.

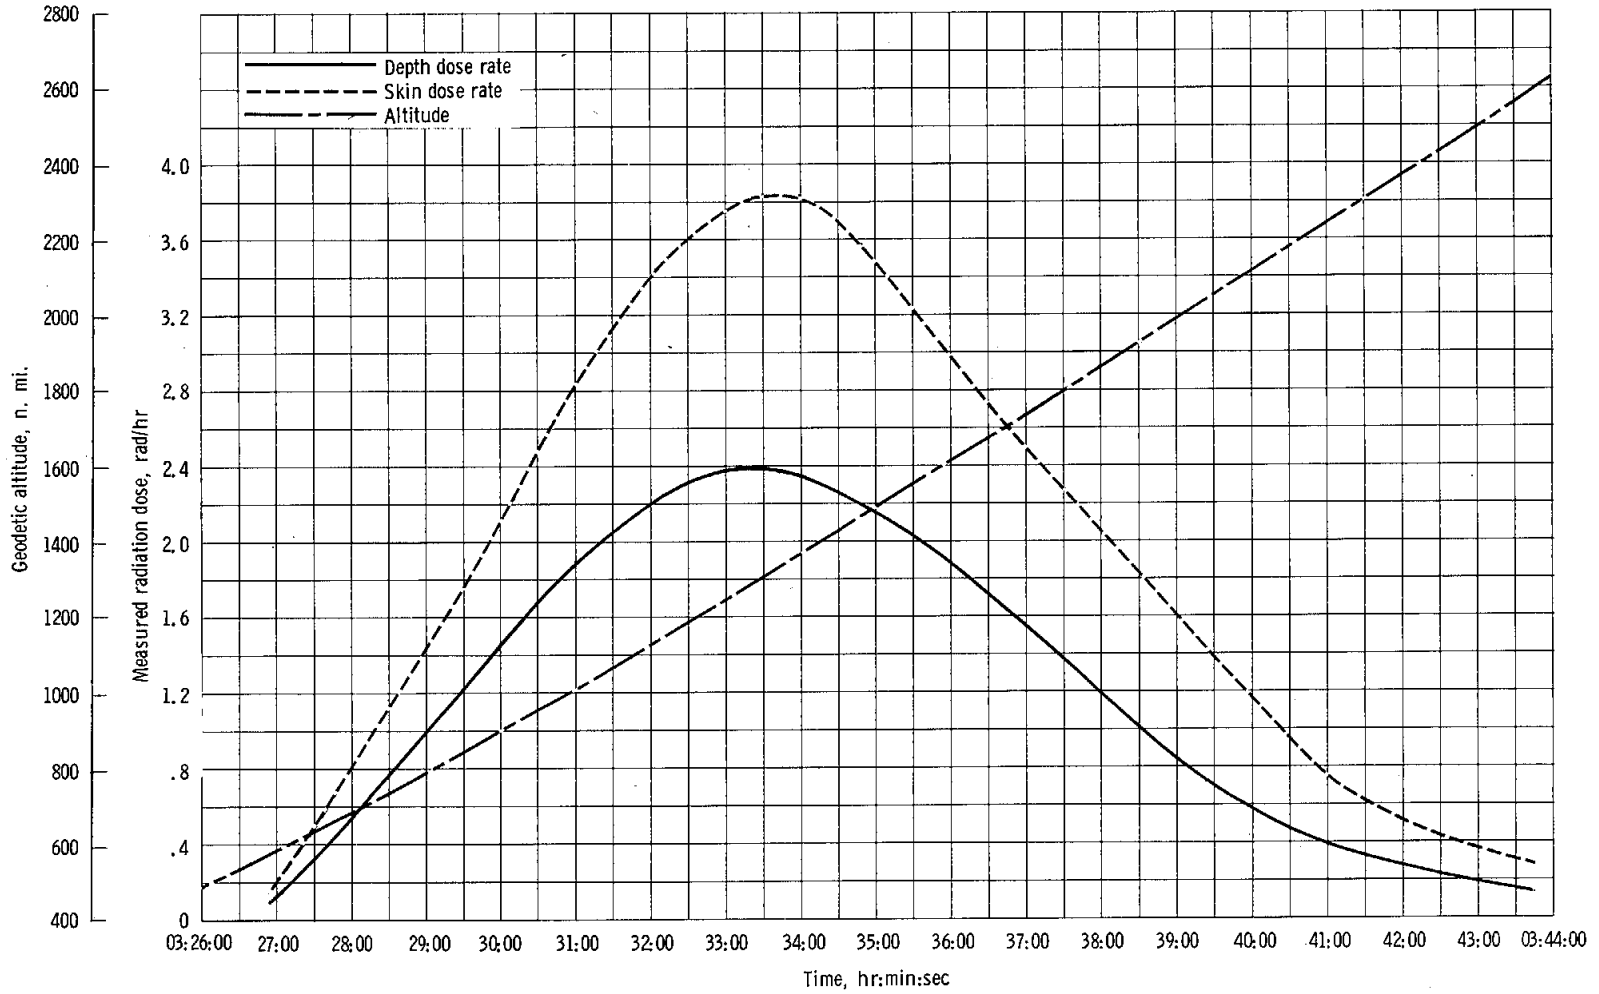
Figure 10-1. - Van Allen dosimeters measured dose rates compared with geodetic altitude during the ascent to apogee.

During ascent to high apogee at a geodetic altitude of approximately 1300 n. mi., the Van Allen belt dosimeters measured peak dose rates of 3.8 rad/hr and 2.4 rad/hr for the skin and depth doses, respectively (fig. 10-1). During descent from high apogee, the skin and depth outputs switched range intermittently before the voltage outputs reached the pre-set switch points, and the data were questionable. The switching anomaly occurred in isolated instances during the ascent to apogee but not frequently enough to be a problem. This anomaly is discussed in section 12.0.
