MSC-00126

APOLLO 10 MISSION REPORT

MANNED SPACECRAFT CENTER
HOUSTON, TEXAS
AUGUST 1969

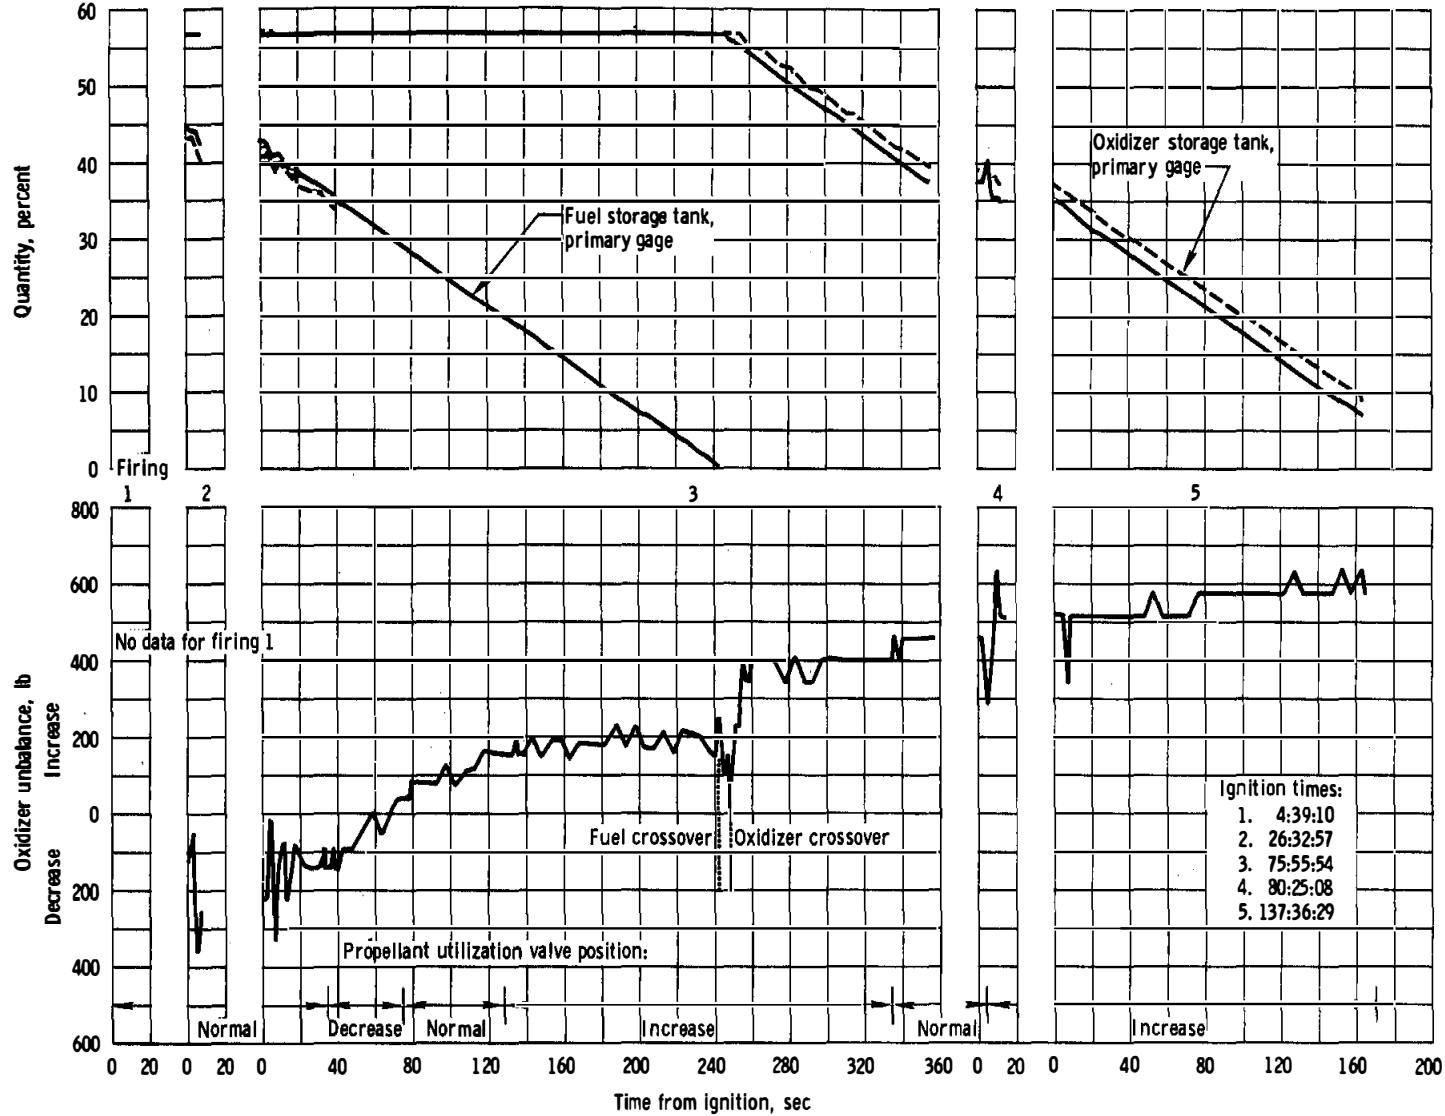
Figure 7.8-1. - Gaging system quantities and propellant unbalance.

Figure 7.8-1 shows the telemetered gaging quantities and telemetered unbalance that was indicated to the crew at selected times, and the approximate times at which the position of the propellant utilization valve was changed. The computed indicated unbalance shown in the figure essentially agrees with that reported by the crew. The telemetry data show that the unbalance indications prior to crossover were lower than the actual unbalance. First, the minus-0.4 percent adjustment bias in the oxidizer tank primary gage caused an increasing negative error in the tank reading as the oxidizer level approached zero. This zero adjustment bias was incorporated to prevent erroneous storage-tank readings after crossover, as was experienced during Apollo 9. At the bottom of the tank, the error would therefore be approximately 97 pounds. Secondly, the oxidizer level

At the end of the fifth firing, the crew reported displayed quantity readings of 9.2 percent for oxidizer and 6.7 percent for fuel, with the unbalance meter off-scale (greater than 600 pounds) on the increase side. These values indicate that the unbalance continually increased from the end of the third firing, even though the valve was in the increase position for almost the full duration of the fifth firing.

Based on the telemetered gaging data and predicted effects of the propellant utilization valve positions, mixture ratios of about 1.52 for the normal valve position were derived, compared with an expected ratio of 1.58. The expected ratio was lower than for most engines to account for results from the actual engine acceptance test. Nonetheless, the flight mixture ratio was approximately 4-percent lower than the expected value at the normal position of the propellant utilization valve. The reason for the downward shift in mixture ratio is unexplained, but an analysis for the engine to be used on the next flight shows more than adequate margin with a shift of this magnitude. However, the propellant utilization valve operated normally and provided the expected mixture ratio changes as indicated by the changes in oxygen interface pressure and verified by computer simulations.

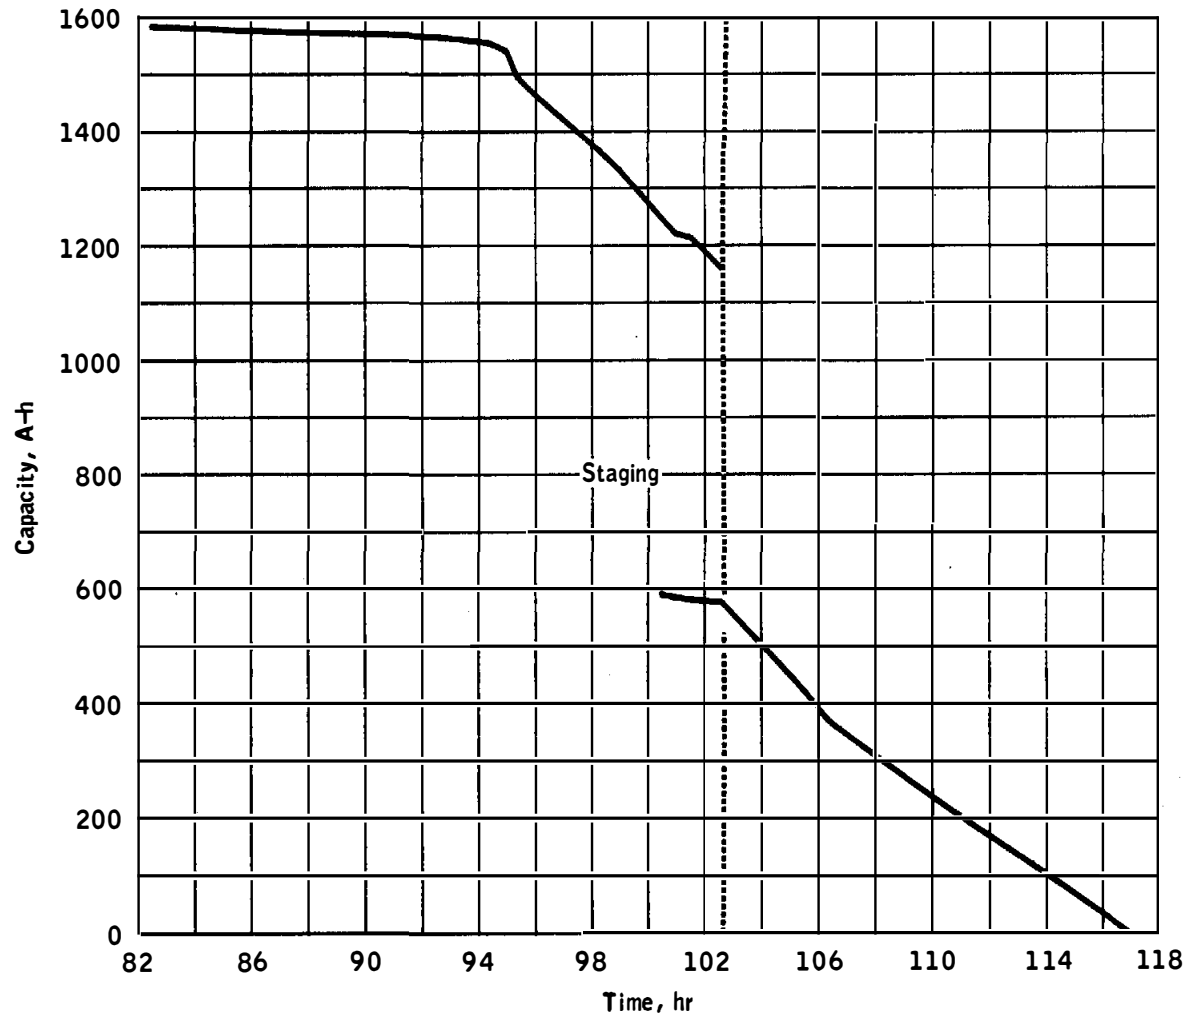
Figure 8.3-1.- Battery capacity remaining.

The descent, ascent, and pyrotechnic batteries performed satisfactorily. At staging, the descent batteries had supplied 440 A-h of a nominal total capacity of 1600 A-h. The difference in load-sharing at staging was 12 A-h on batteries 1 and 2 and 16 A-h on batteries 3 and 4. On Apollo 9, these differences, at the same discharge level, were 18 and 28 A-h, respectively. A capacity history is shown in figure 8.3-1.

At the completion of the ascent propulsion firing to depletion, the two ascent batteries had delivered a total of approximately 318 A-h; the rated capacity was 296 A-h per battery at 28 volts. After the firing, the ascent batteries were allowed to deplete with the two dc buses tied together. The battery voltages remained above 28 volts until battery 5 had delivered 346 A-h and battery 6 had delivered 330 A-h.

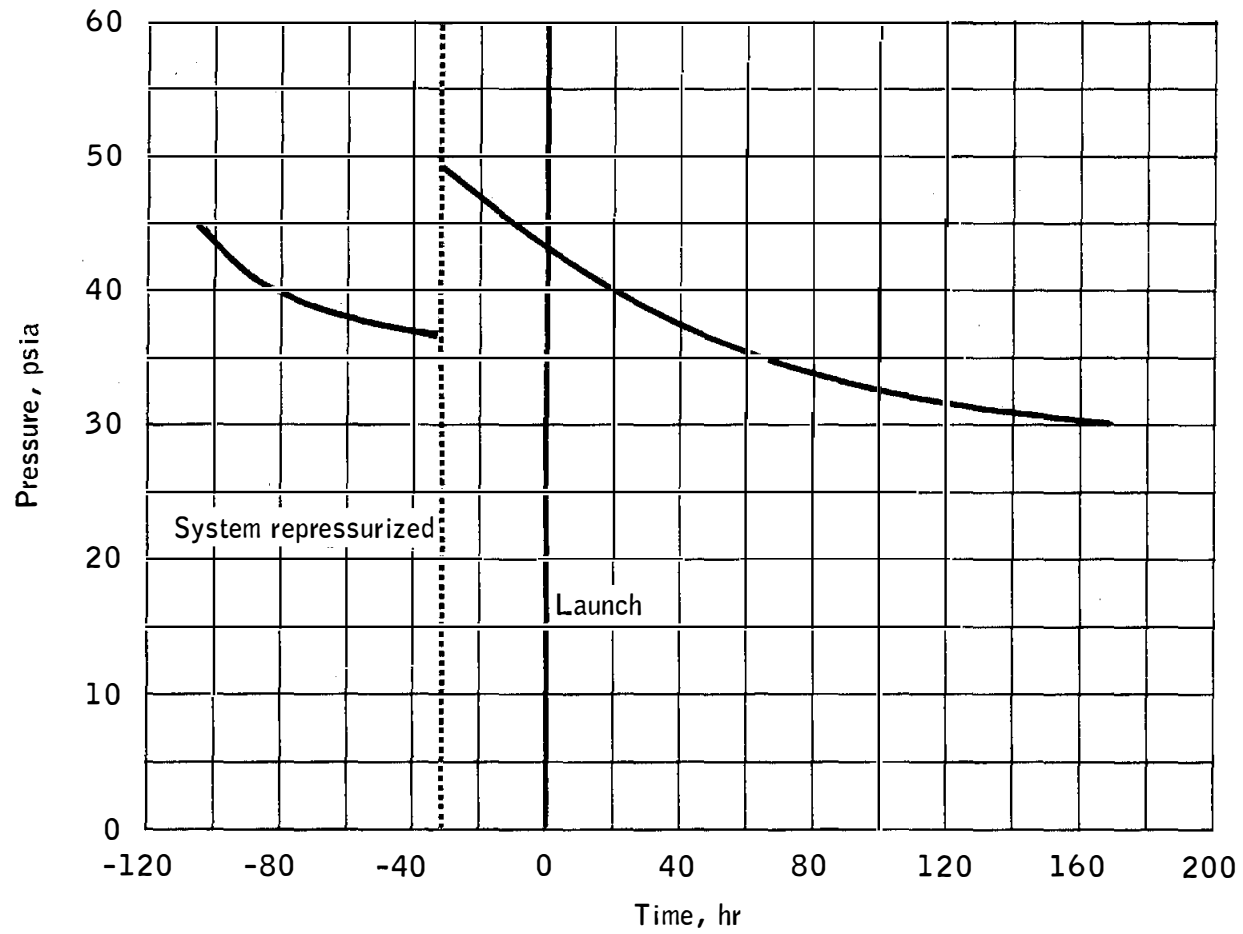
Figure 15-1.- Helium manifold pressure in reaction control system A.

Figure 15-1 shows the system pressures for both the prelaunch and mission periods. The leak rate decreased as the mission progressed, reaching 0.04 psi/hr by the end of the mission. Only part of this decrease resulted from the reduced system pressure; thus, the leak corrected itself to some extent and/or the characteristics of the helium changed as it became diluted by propellant permeating the bladder.

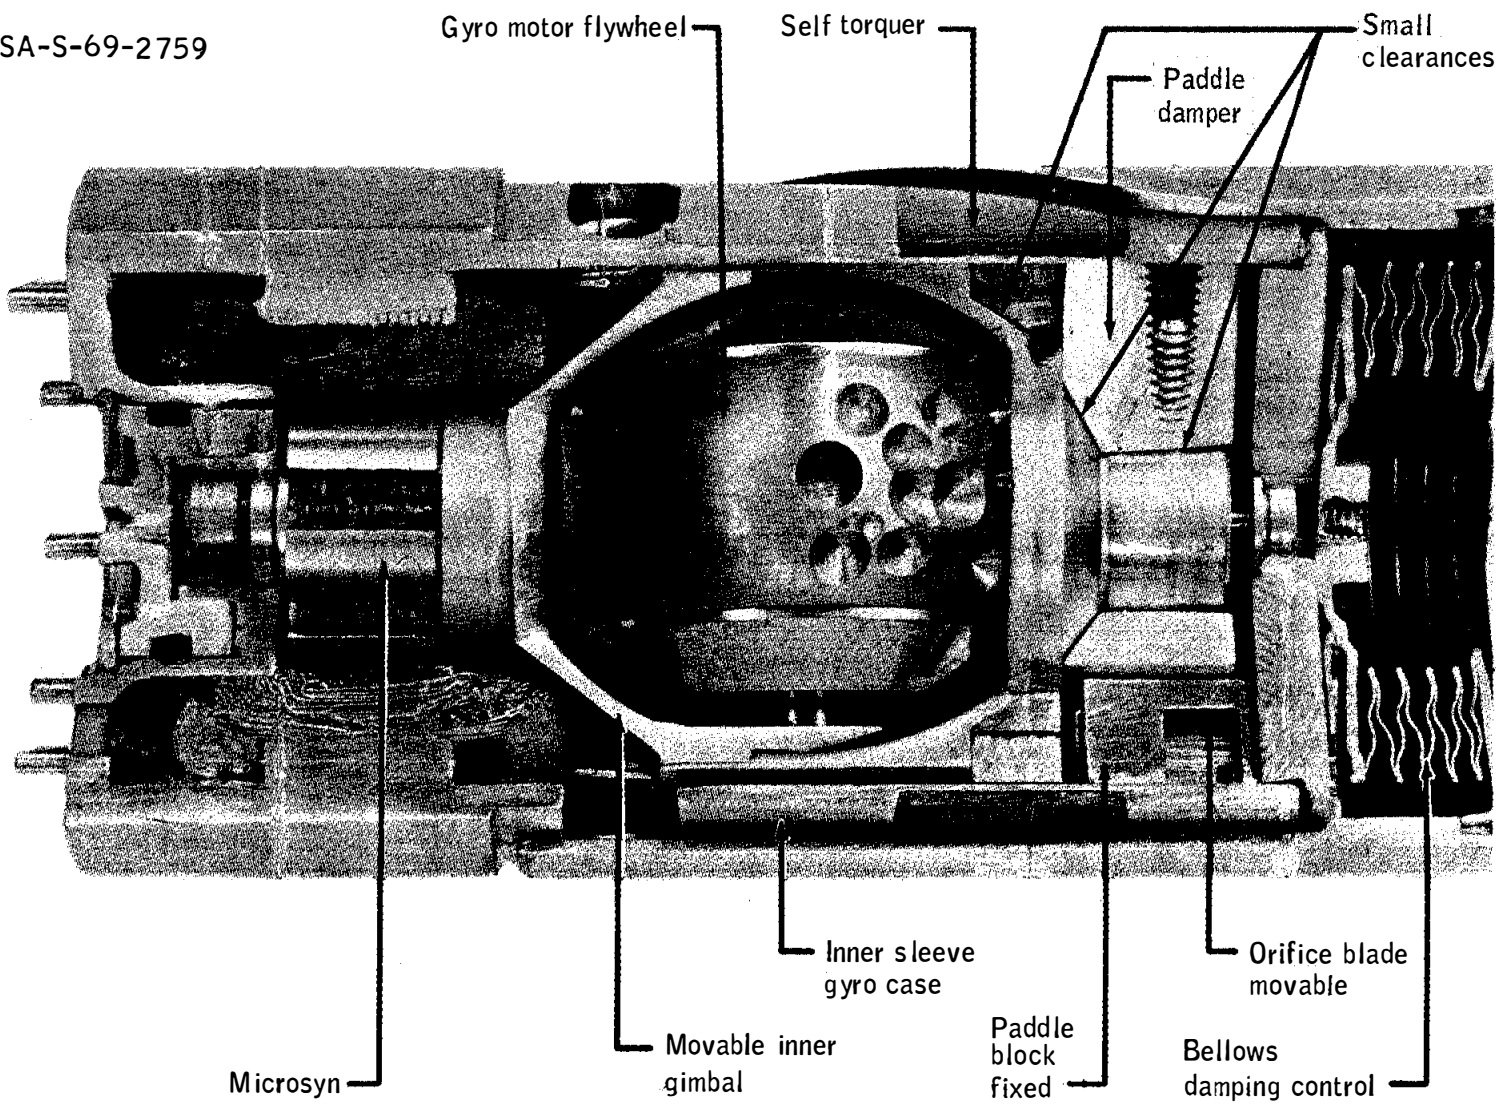
Figure 15-31.- Cross sectional view of rate gyro.

The rate gyro is a spring-restrained, single-degree-of-freedom unit with the spring force being supplied by a torsion bar (fig. 15-31). The wheel assembly is partially floated in a silicon damping fluid. Damping is supplied by a paddle wheel which pumps fluid through a temperature-controlled orifice. Three gyros are mounted orthogonally in a rigid block and placed in the spacecraft such that each gyro input axis is parallel to a spacecraft axis.

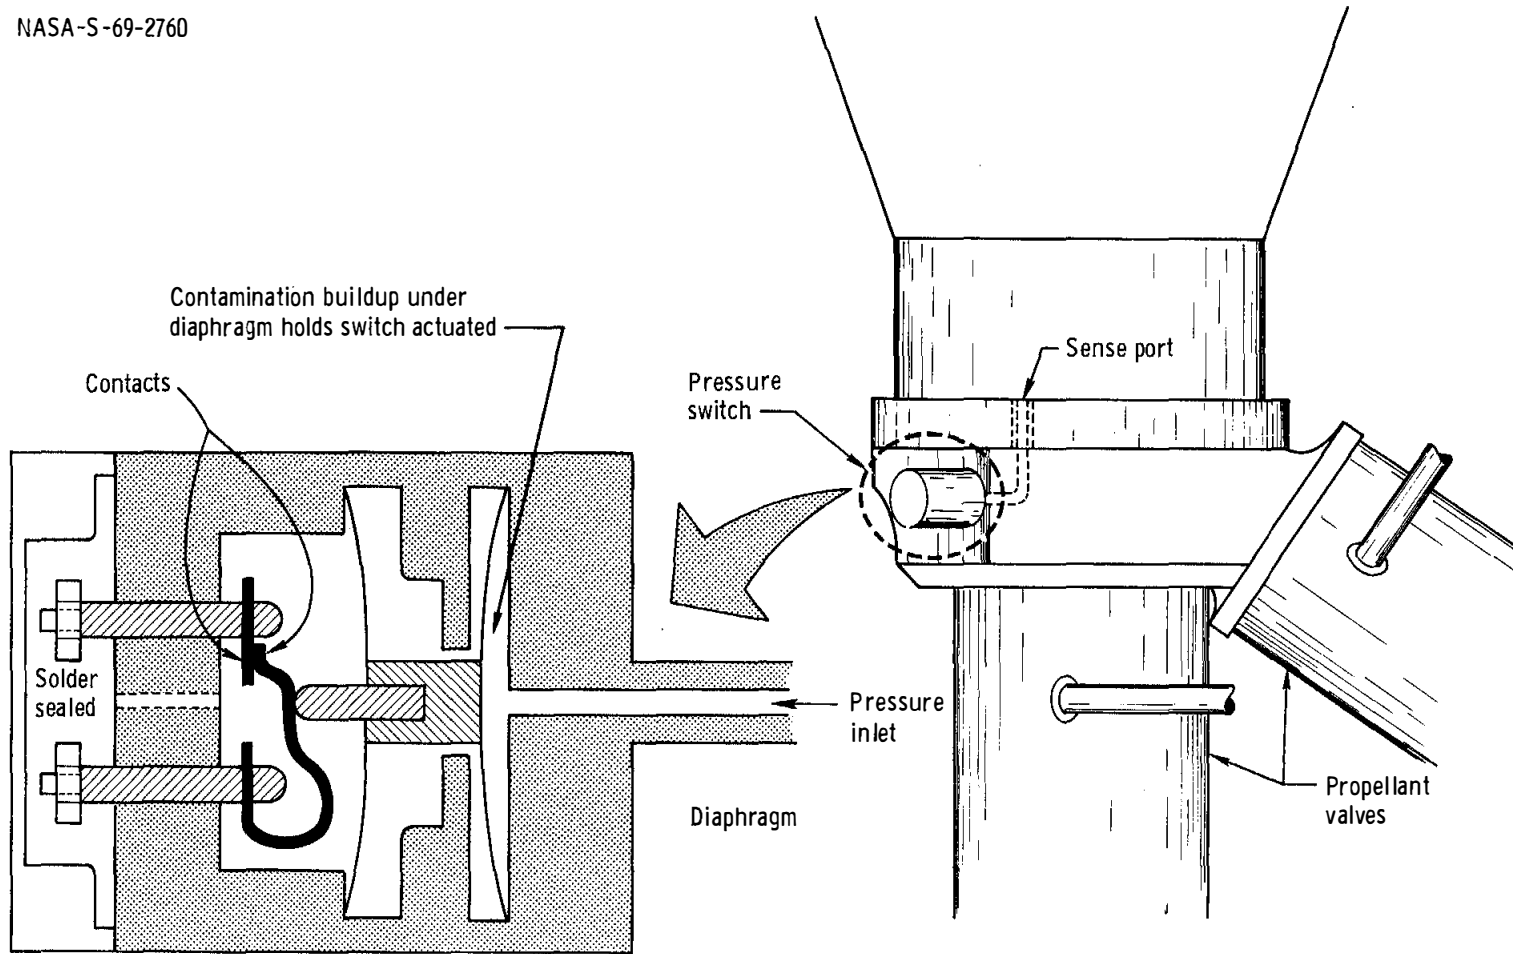
Figure 15-32. - Lunar module reaction control system thrust chamber switch.

The failure mode for these five switches is believed to be the same as that of one LM-3 unit and several others during ground testing. Particulate contamination and/or propellant residue is forced under the switch diaphragm by chamber pressure and holds the diaphragm deflected and the electrical contacts closed (fig. 15-32). The small stroke of the diaphragm (0.007 inch) and the low diaphragm restoring force generated by the return spring make the switch extremely susceptible to failure by contamination.

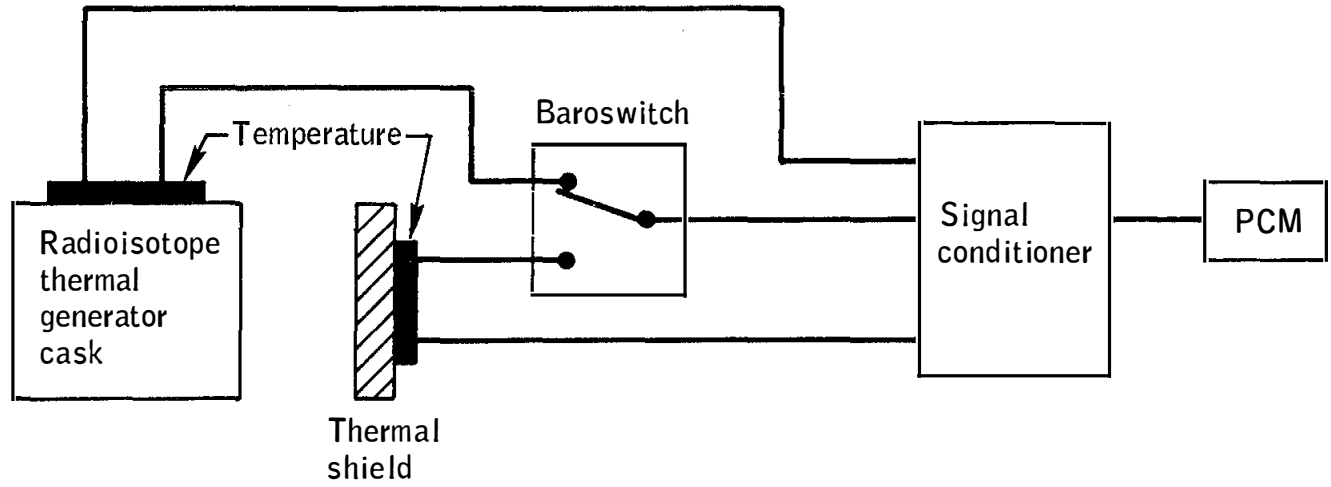
Figure 15-33.- Cask temperature.

Cask thermal shield temperature.- The temperature measurement of the thermal shield for the radioisotope thermal generator cask read upper limit throughout the lunar module portion of the flight. The telemetry is switched to this measurement from cask temperature by a baroswitch at 10 000 foot altitude (fig. 15-33).

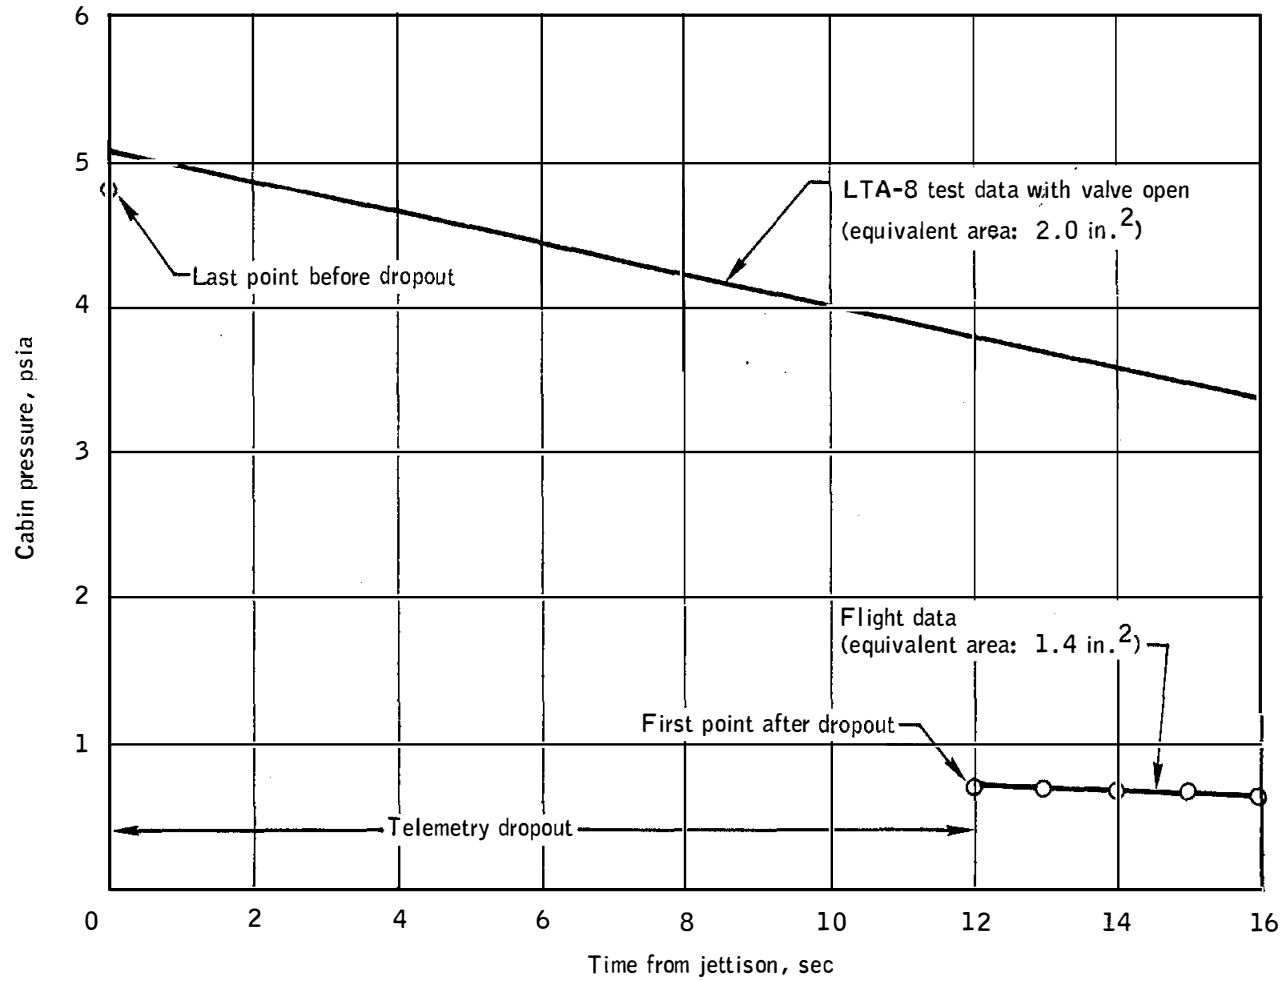
Figure 15-34.- Measured cabin pressure during jettison.

During the ascent stage separation from the command module, the lunar module cabin pressure dropped rapidly, as measured by three separate transducers. Telemetry data were lost for 12 seconds beginning at the initiation of separation. As shown in figure 15-34, the cabin pressure was 4.86 psia at the initiation of separation and 0.70 psia at the end of the telemetry dropout and continued to decay slowly.

In summary, the analyses indicate that the loading on the lunar module hatch at separation exceeded the capability of the latch. The hatch then opened and closed resulting in a cabin pressure decay as shown in figure 15-34 and separation distance and relative accelerations as shown in figures 15-35 and 15-36.

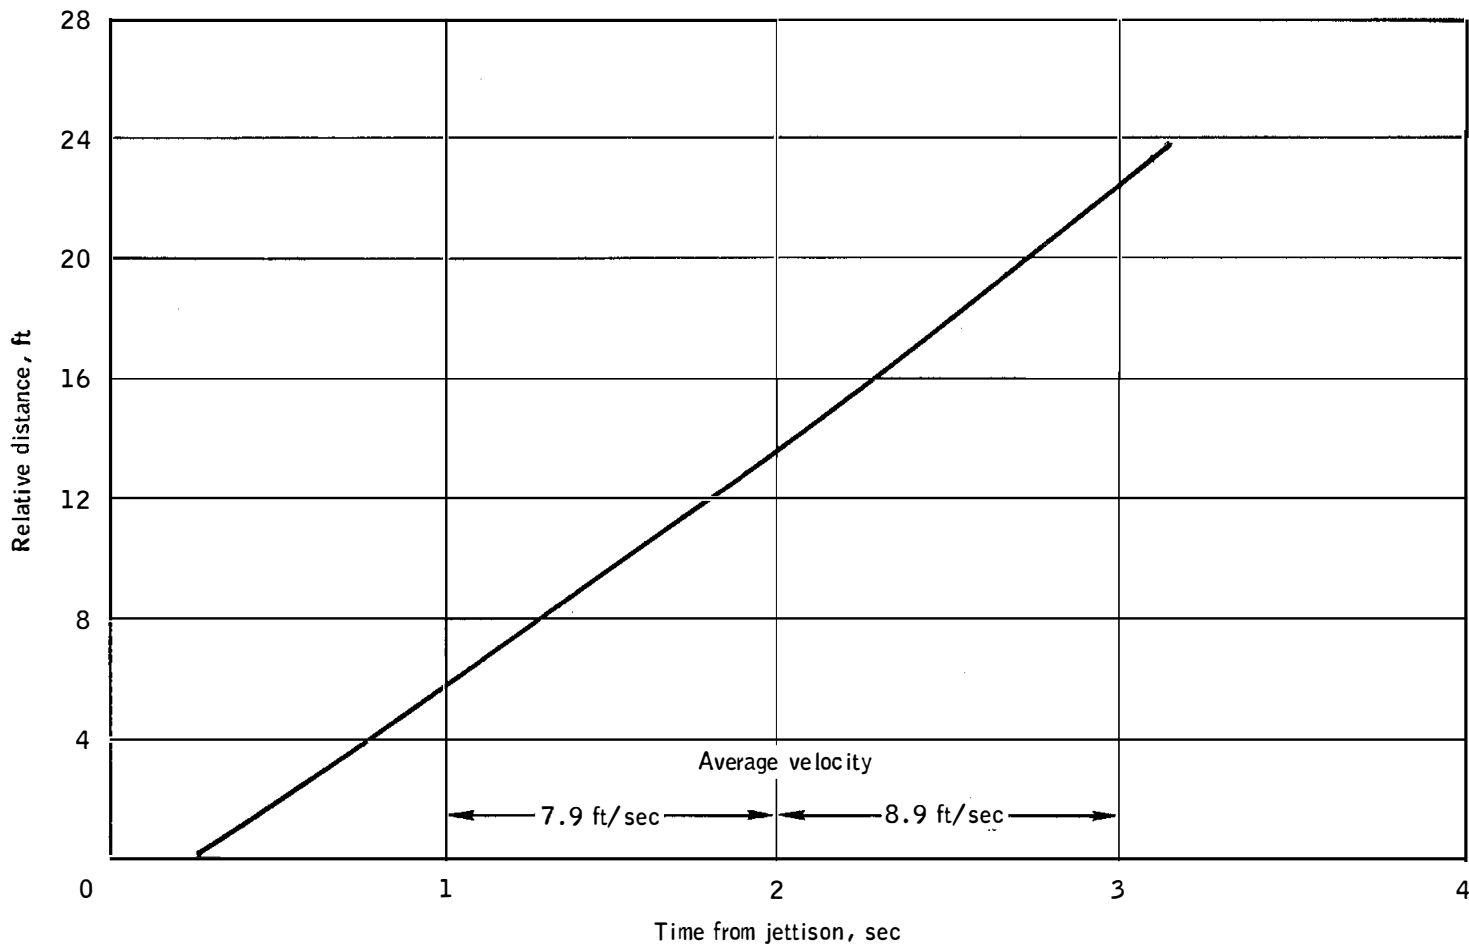
Figure 15-35.- Relative separation distance .

The film was used for determining a history of relative separation distance between the command module and the lunar module (fig. 15-35). A time history of relative acceleration, or the required pressure force, was then estimated from the data, as shown in fig. 15-36. The maximum acceleration of 50 ft/sec/sec shown is considerably in excess of the acceleration caused by separation pyrotechnic effects. However, the acceleration history shown in figure 15-36 can be obtained by dumping the cabin pressure in the first 0.3 second of separation. A 4-psi drop in cabin pressure in 0.3 second requires a constant venting area of 290 square inches. The impulse from dumping cabin pressure through the hatch is consistent with the direction and magnitude of the lunar module velocity change (5 ft/sec in minus X direction) noted from the flight data. Further, the upper hatch is the only item on top of the lunar module that could open and close, allowing the cabin to vent while satisfying the pressure history. The hatch has a maximum area of 838 square inches, which is more than enough to vent the cabin from 4.8 to less than 1.0 psia in 0.3 second.

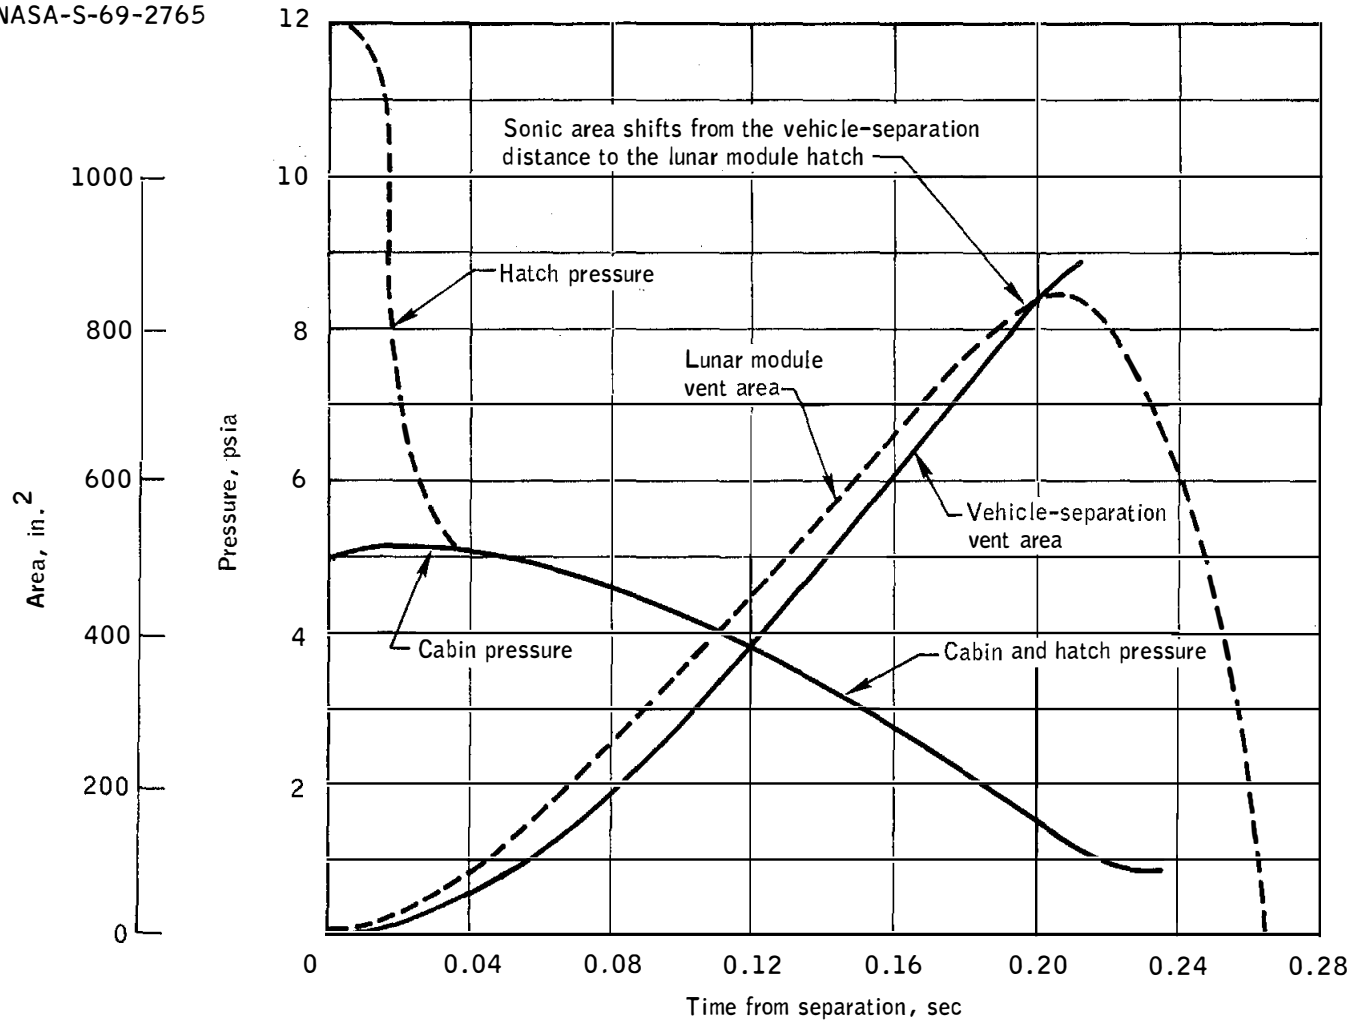
Figure 15-37.- Pressures and vent areas during separation sequence.

it completely. The remaining gap of about 1.4 square inches allowed a slight pressure decrease, as indicated by cabin pressure data. Figure 15-37 presents a history of hatch area that allows the cabin pressure to decrease rapidly and also yields an acceleration time history which agrees with figure 15-36.

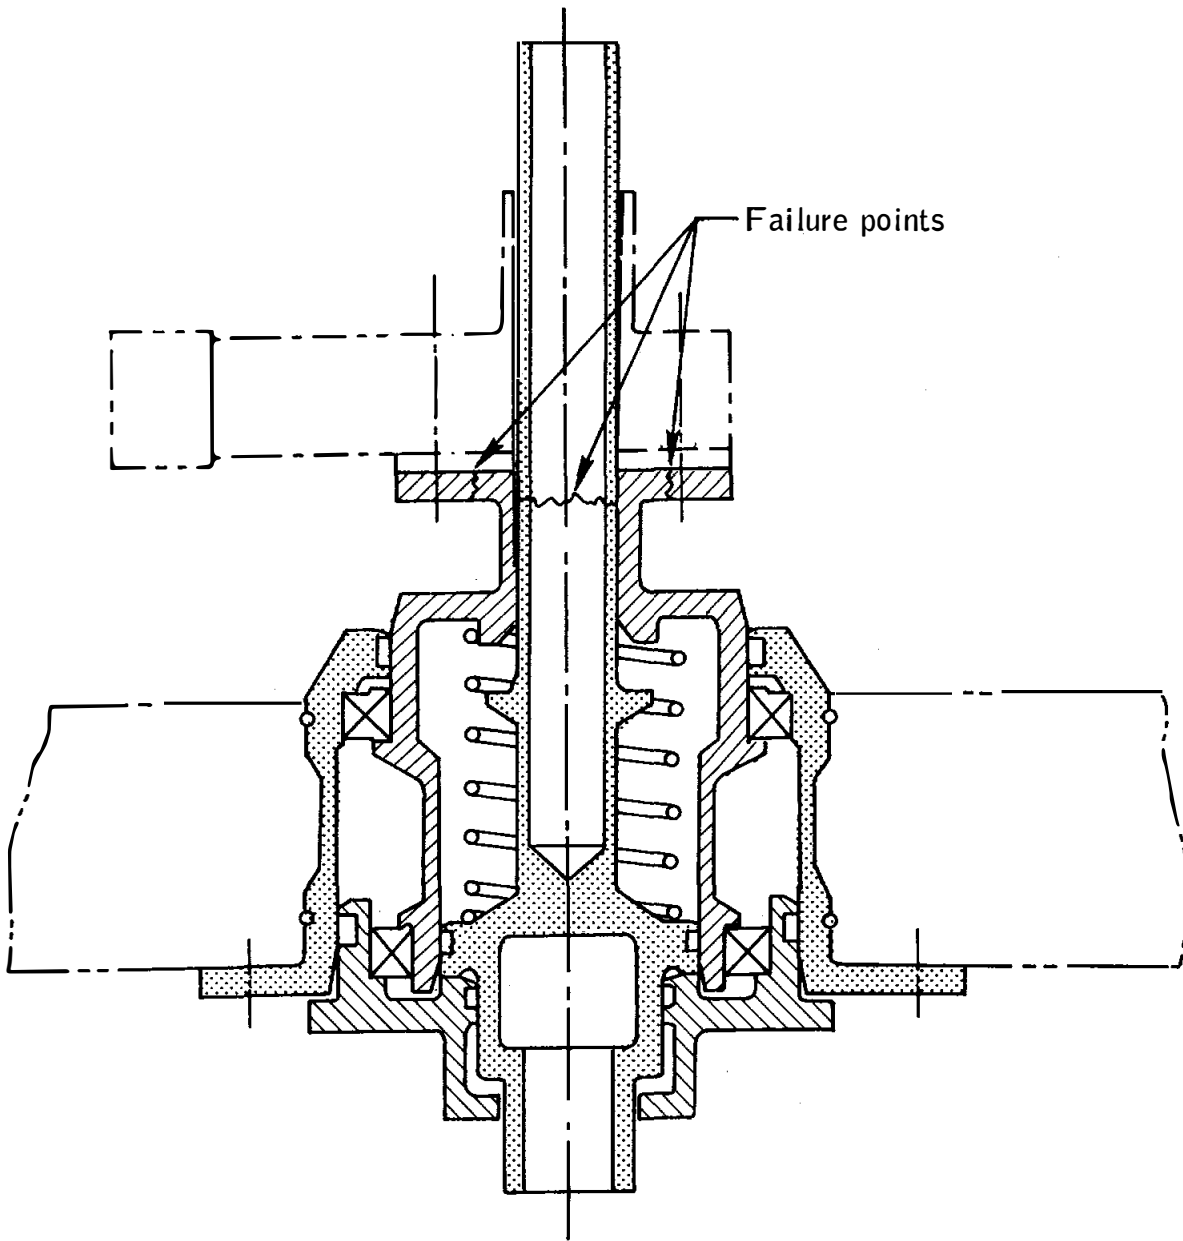
Figure 15-38.- Lunar module hatch latch.

The hatch and latch assembly was statically pressure-tested to failure. At a differential pressure of 4.1 psi, the latch failed as indicated in figure 15-38.

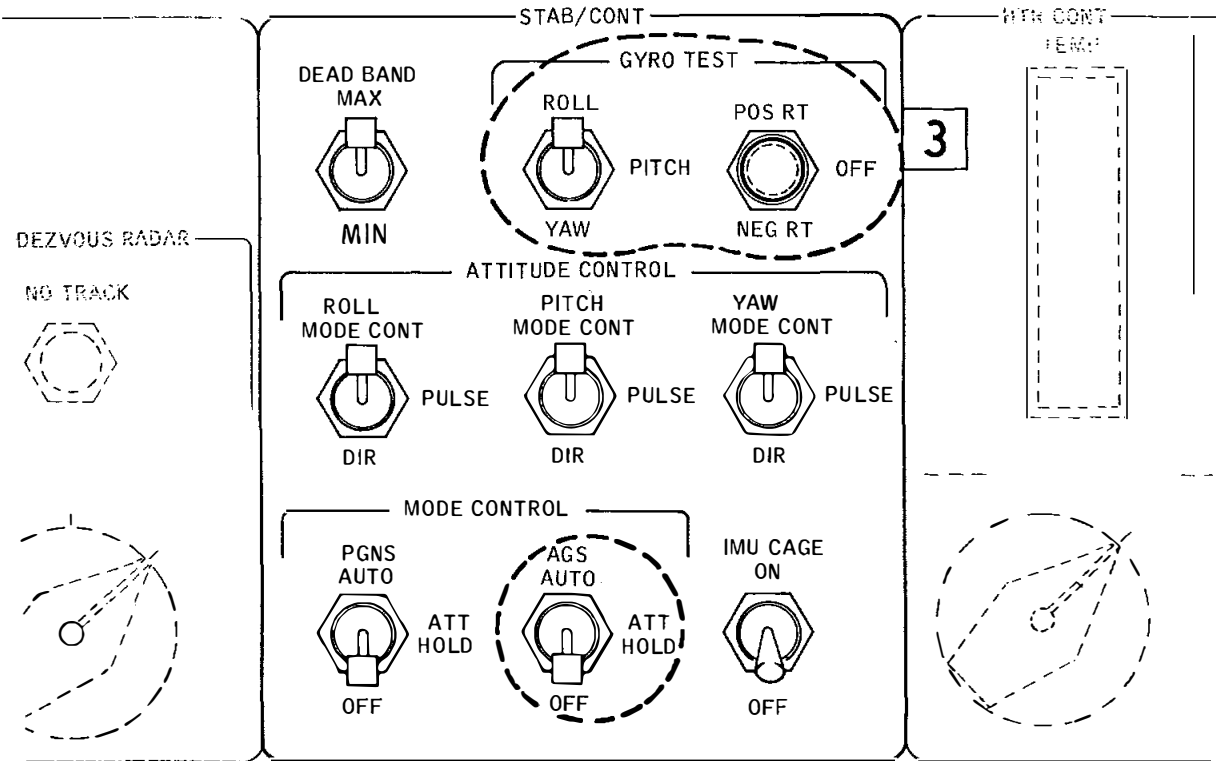
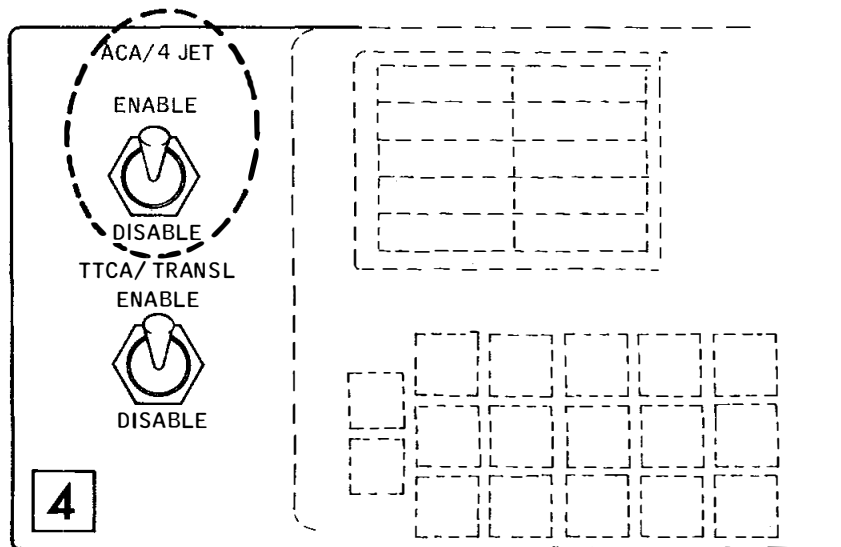
Figure 15-41. - Lunar module guidance switch locations.

The attitude control switches on panels 3 and 4 are shown in figure 15-41, and a simplified functional switching diagram is shown in figure 15-42. Approximately 4 minutes before staging, with the guidance select switch in AGS and the attitude control switches in PULSE, the crew verified that the abort guidance mode control switch was in ATT HOLD since the intent was to perform staging in AGS ATT HOLD. After some discussion, they selected MAX deadband to save propellant.

Switches.-- Functions in each of the anomalous areas are controlled by switches (see fig. 15-41).

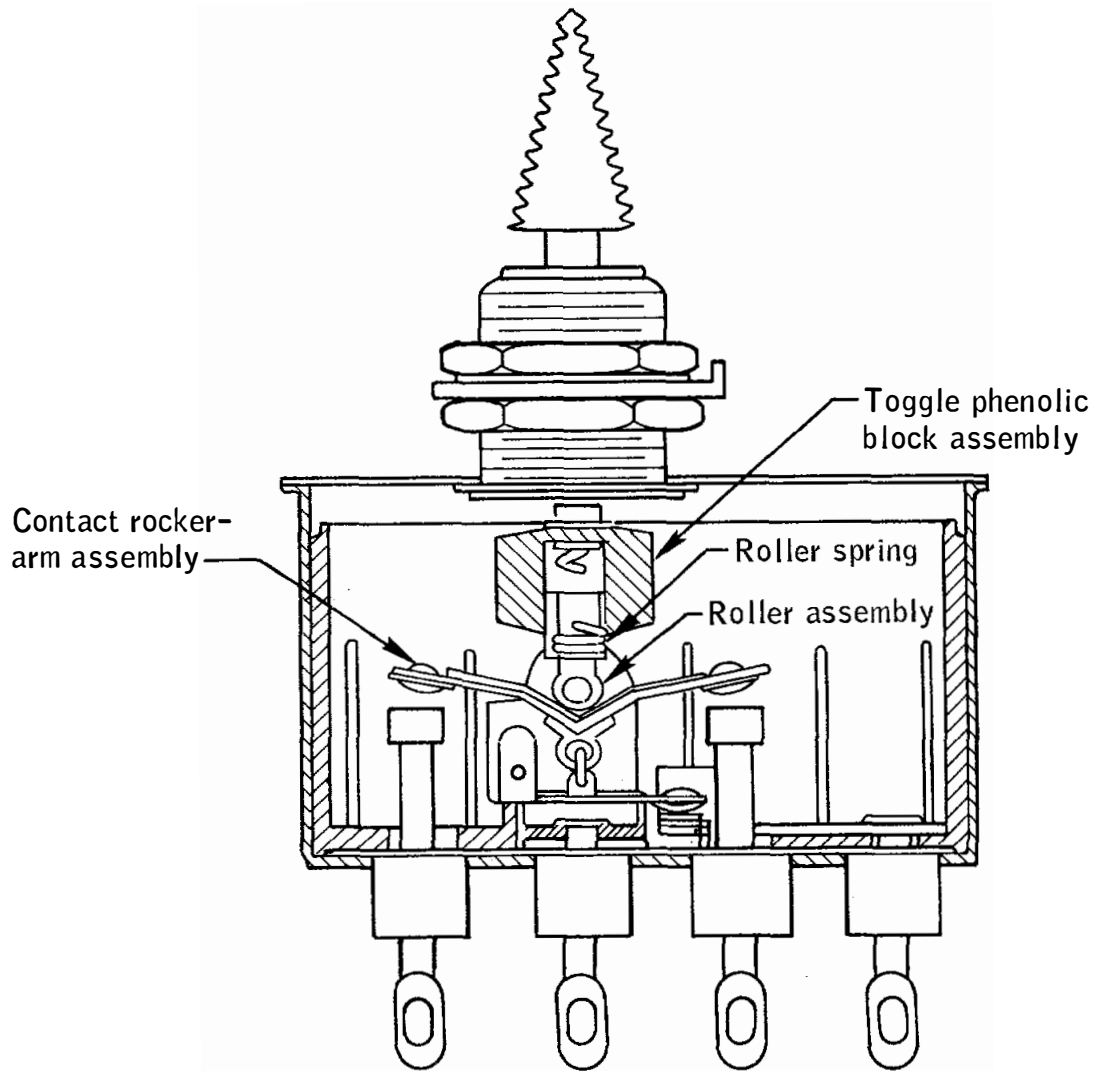
Figure 15-43.- Abort guidance mode control switch.

The abort guidance system mode control switch, on panel 3, was used several times before and after staging with no evidence of abnormality. To produce the flight results requires the contacts to transfer on at least two of the three poles of this switch. No known failure modes in the switch would produce this type of failure. Two failure modes postulated would allow the contact rocker arms to become free-floating. However, testing under a simulated flight environment has shown that because of frictional forces at the contact arm pivot point, the free-floating contacts will not transfer (see fig. 15-43). The observed anomaly would have required the simultaneous motions of two rocker arms.

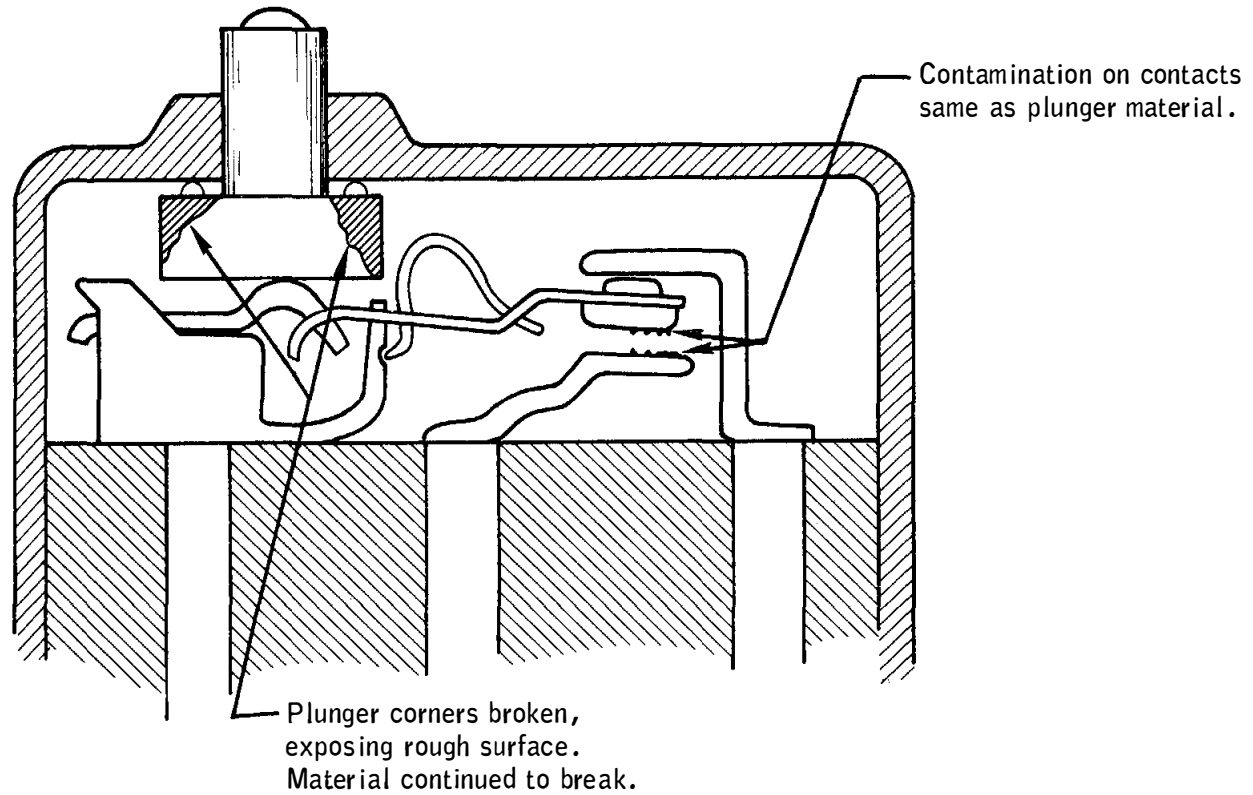
Figure 15-47.- Magazine interlock switch.

At approximately 173 hours, during transearth coast, the command module 16-mm camera ceased to operate in the pulse mode because the magazine interlock microswitch failed. The switch was not a high reliability item and failed because of internal contamination and a faulty plunger (fig. 15-47).
