NASA TN D-7992

APOLLO EXPERIENCE REPORT -
GUIDANCE AND CONTROL SYSTEMS:
MISSION CONTROL PROGRAMMER FOR
UNMANNED MISSIONS AS-202,
APOLLO 4, AND APOLLO 6

Gene F. Holloway
Lyndon B. Johnson Space Center
Houston, Texas 77058

NATIONAL AERONAUTICS AND SPACE ADMINISTRATION • WASHINGTON, D. C. • JULY 1975

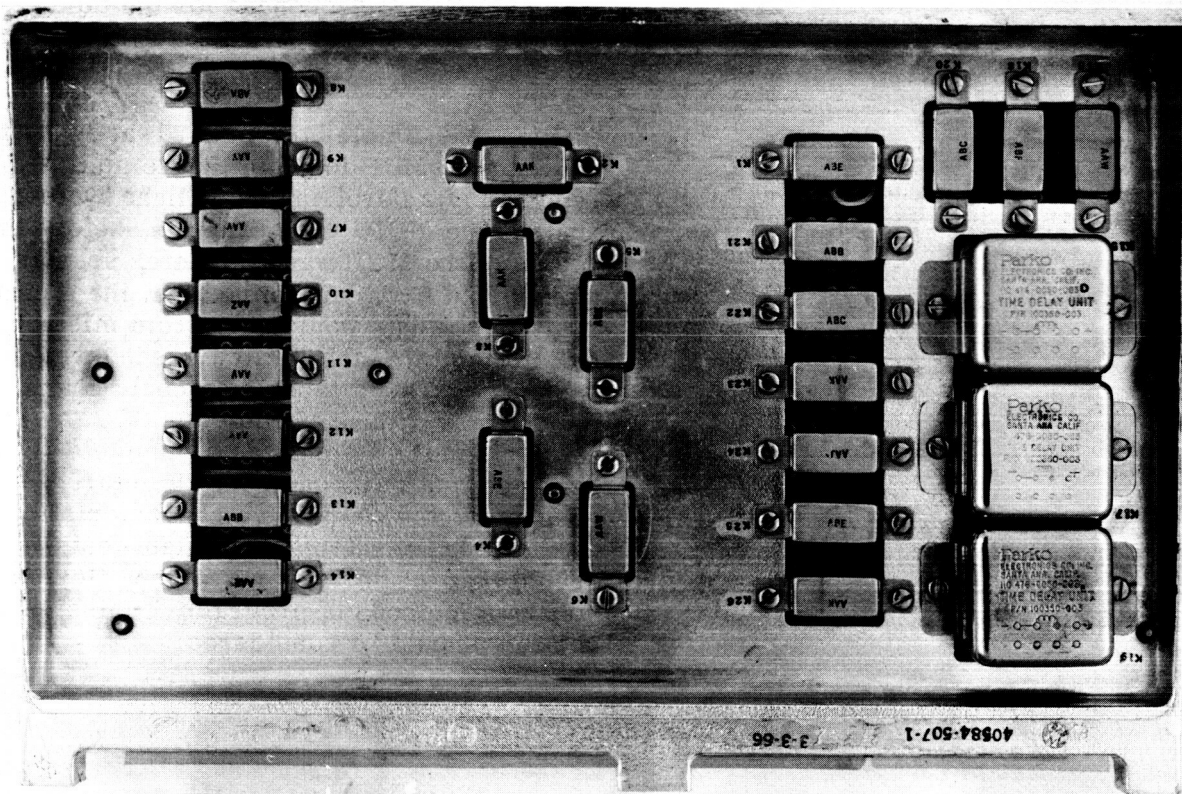
Figure 11. - Bracket showing relays and time-display mountings.

1. The planned trajectories for the Apollo 4 mission indicated a possibility of spacecraft skipout during the entry phase. The MCP originally had latching relays to prevent the loss of the 0.05g signal once it was obtained. During the Apollo 4 mission, the 0.05g signal could be obtained, lost during skipout, and then obtained again; therefore, the latching relay had to be replaced with a momentary relay.

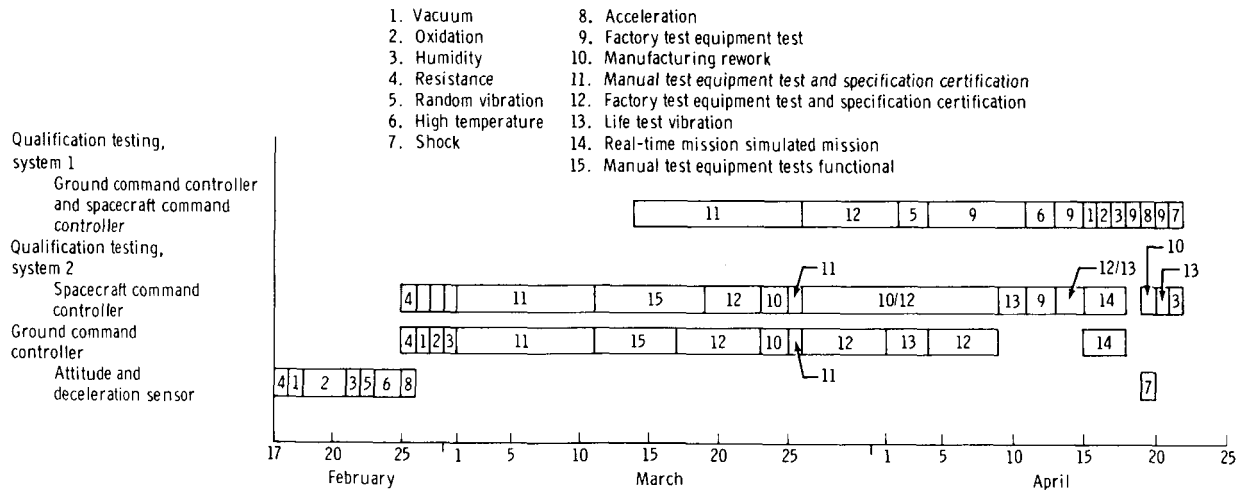
Figure 13.- Qualification testing sequence.

A detailed schedule of the qualification testing sequence is shown in figure 13. Items 1 to 15 in figure 13 represent keywords for coding the test activity during any specific test period. For example, from March 10 to March 15, during the qualification test of system 2, the activity was 15 (MTE functional tests). As the test results are discussed in the following paragraphs, the test sequence can be established by referring to figure 13.

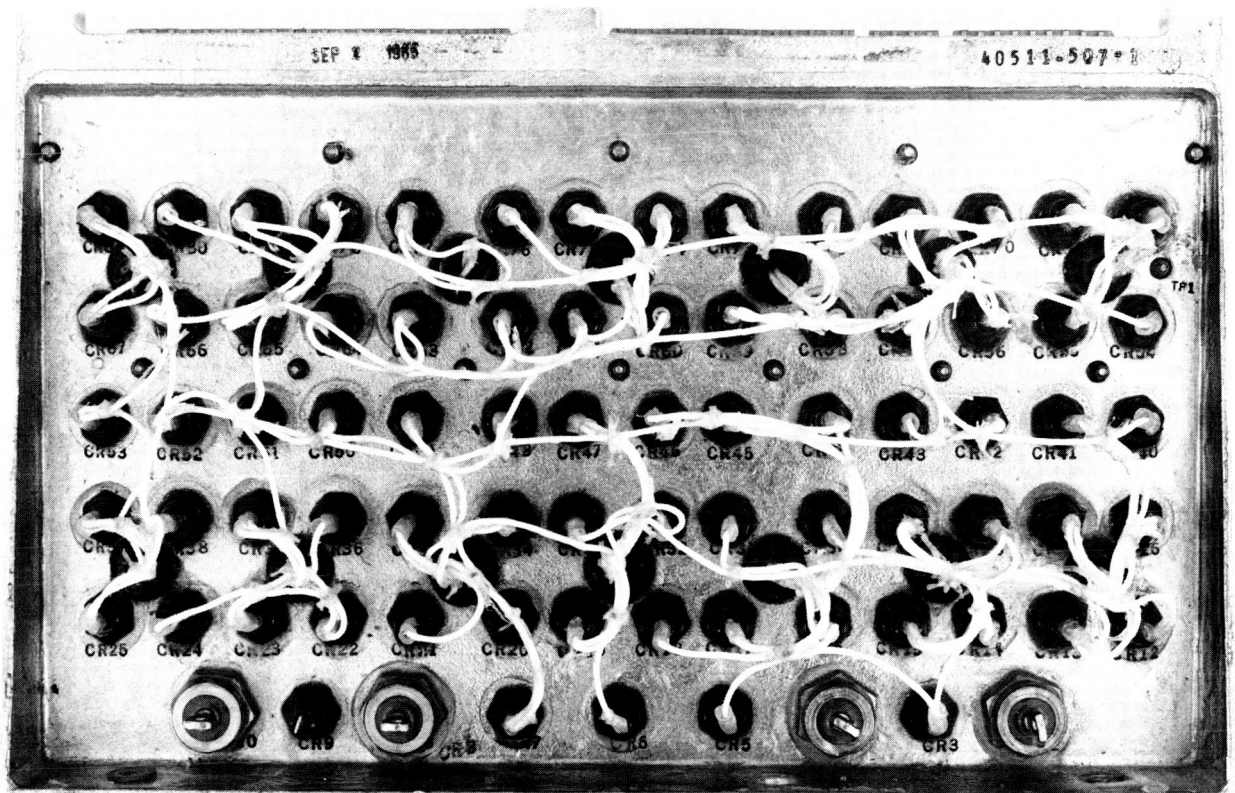
Figure 16. - Typical diode mounting bracket.

The second significant problem was detected during the humidity and posthumidity functional test portions of the qualification program. The reverse impedance of the MCP diode quads was below the specification limits after the 16-hour humidity test. These impedances were within the specified value (greater than 700 kilohms) after about 1 hour of drying. The diodes in the SCC were affected after being exposed to 95 ± 5 percent relative humidity; but, for normal unmanned flight, humidity was not expected to be a problem. The corrective action was to provide added protection by applying polyurethane (polycoat) to the control assemblies containing the diode quads (fig. 16). On April 22, 1966, after the polyurethane was applied to the control assemblies in qualification unit 2, the unit was retested in the humidity environment and satisfactorily met the specifications. The qualification tests were completed on April 23, 1966, and the test report was released on May 31, 1966.
