NATIONAL AERONAUTICS AND SPACE ADMINISTRATION

APOLLO 8 MISSION REPORT

MANNED SPACECRAFT CENTER
HOUSTON, TEXAS
FEBRUARY 1969

Mission Evaluation Team

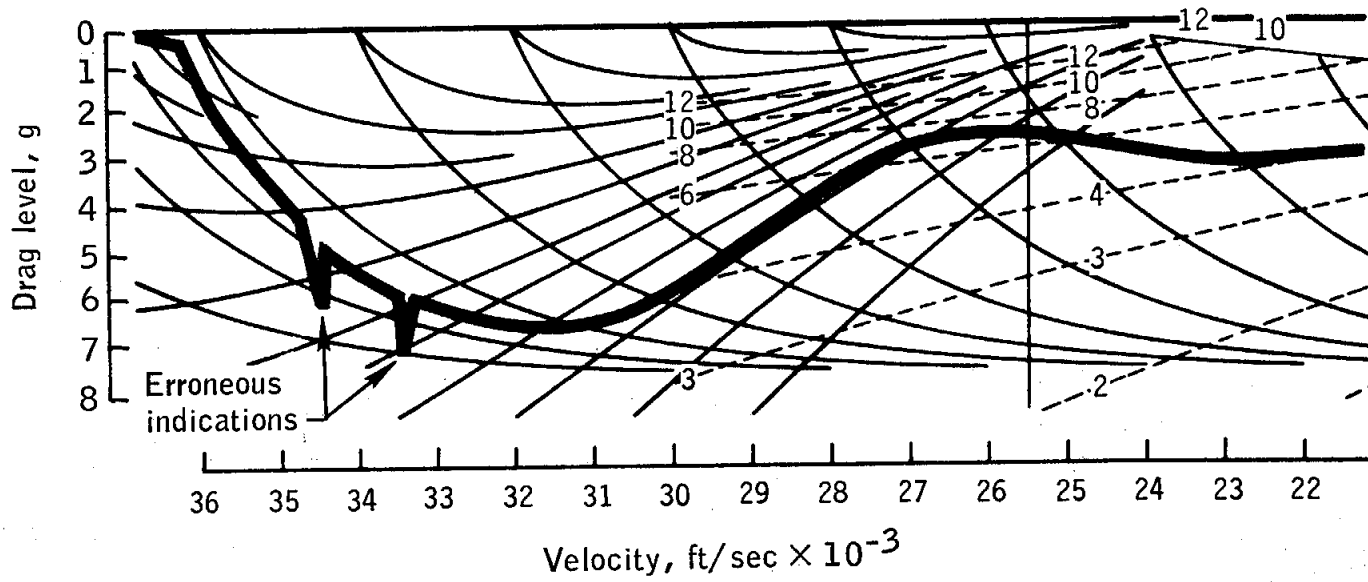
1. During the spacecraft/S-IVB separation sequence, the delta V counter jumped 100 ft/sec.
2. For the third midcourse correction, a delta V of 5 ft/sec was entered into the entry monitor system. The system counted to zero at delta V cutoff; however, it continued to count after the maneuver and was finally turned off by the crew.
3. At times when the mode switch was rapidly switched from "stand-by" to "automatic," the delta V counter jumped 19 to 20 ft/sec.
4. For the initial entry phase, the g/velocity trace on the entry scroll showed two short, incorrect g transients (fig. 12-1). Operation of the scroll assembly was normal in all other respects.

The entry monitor system was removed from the spacecraft, and no abnormal indications were observed in functional tests. However, during tilt-table tests, abnormal accelerometer outputs were observed when random 0.25g pulses were produced at approximately 0.8g. Detailed testing and inspection of the accelerometer disclosed a bubble in the damping fluid. The bubble may explain the behavior of the g trace during entry and the random pulses during the tilt-table test. The bubble may also be associated with the problem after the midcourse correction, in that it has been demonstrated that the time for the accelerometer to drive to null greatly increases when a bubble is present.

The accelerometer case contained 1 cubic centimeter less fluid than when it was originally filled. Indications near the fill port are that damping fluid had leaked around the O-ring seal. The seal has been changed from a screw to a plug type for units to be flown on spacecraft 106 and subsequent.

Figure 12-1.- Entry monitor system scroll.

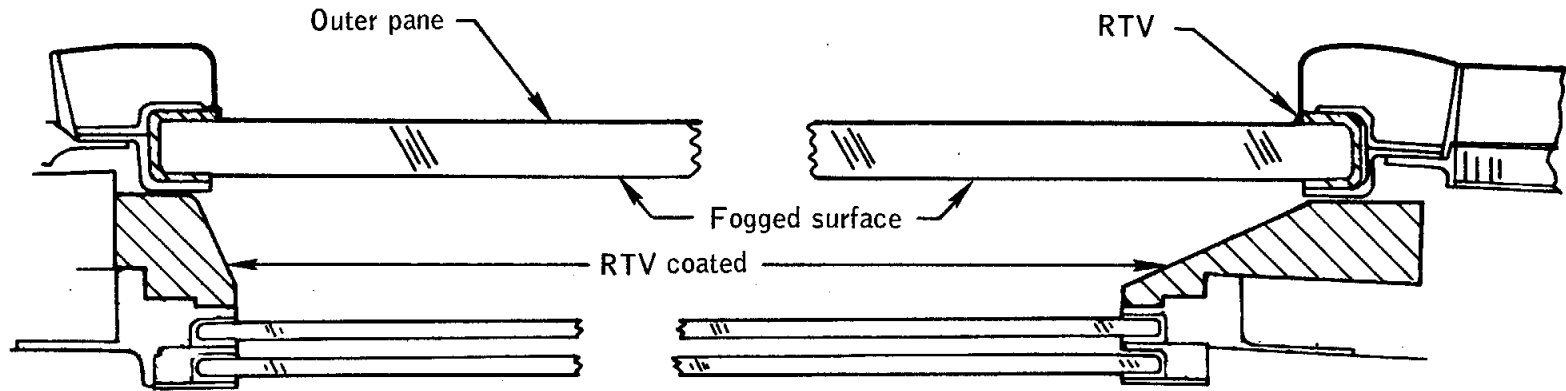
Visibility through the hatch window was degraded to the point that the window was useless for visual observation and photography after approximately 6 hours. The two side windows (1 and 5) were fogged but to a lesser degree. The two rendezvous windows (2 and 4) remained usable throughout the flight. These conditions were consistent with what was expected as a result of the Apollo 7 window fogging analysis, which showed the primary cause to be outgassing of silicone oils from the RTV sealing material.

Figure 12-2 shows a cross section of the side windows, including the typical installation of the three windows and the location of the modification. The modification consists of a new RTV curing process to greatly reduce the residual oils.

Figure 12-2.-Side window cross section (also typical for hatch window).

During ground tests with the unbaked hatch window installation in a simulated flight environment, excessive deposits were produced on the inner surface of the heat shield pane within half a day. Under identical test conditions, a hatch window, cured under the new process, was subjected to a 10-day test. This test demonstrated the success of the new curing process in eliminating deposits of the silicone oils. About 2 square inches of condensation, from the moisture between the pressure panes, appeared temporarily. On flight windows, the space between panes is filled with dry nitrogen. A test under more extreme conditions has been completed to verify the adequacy of the modification for lunar missions, and preliminary results also indicate successful performance.

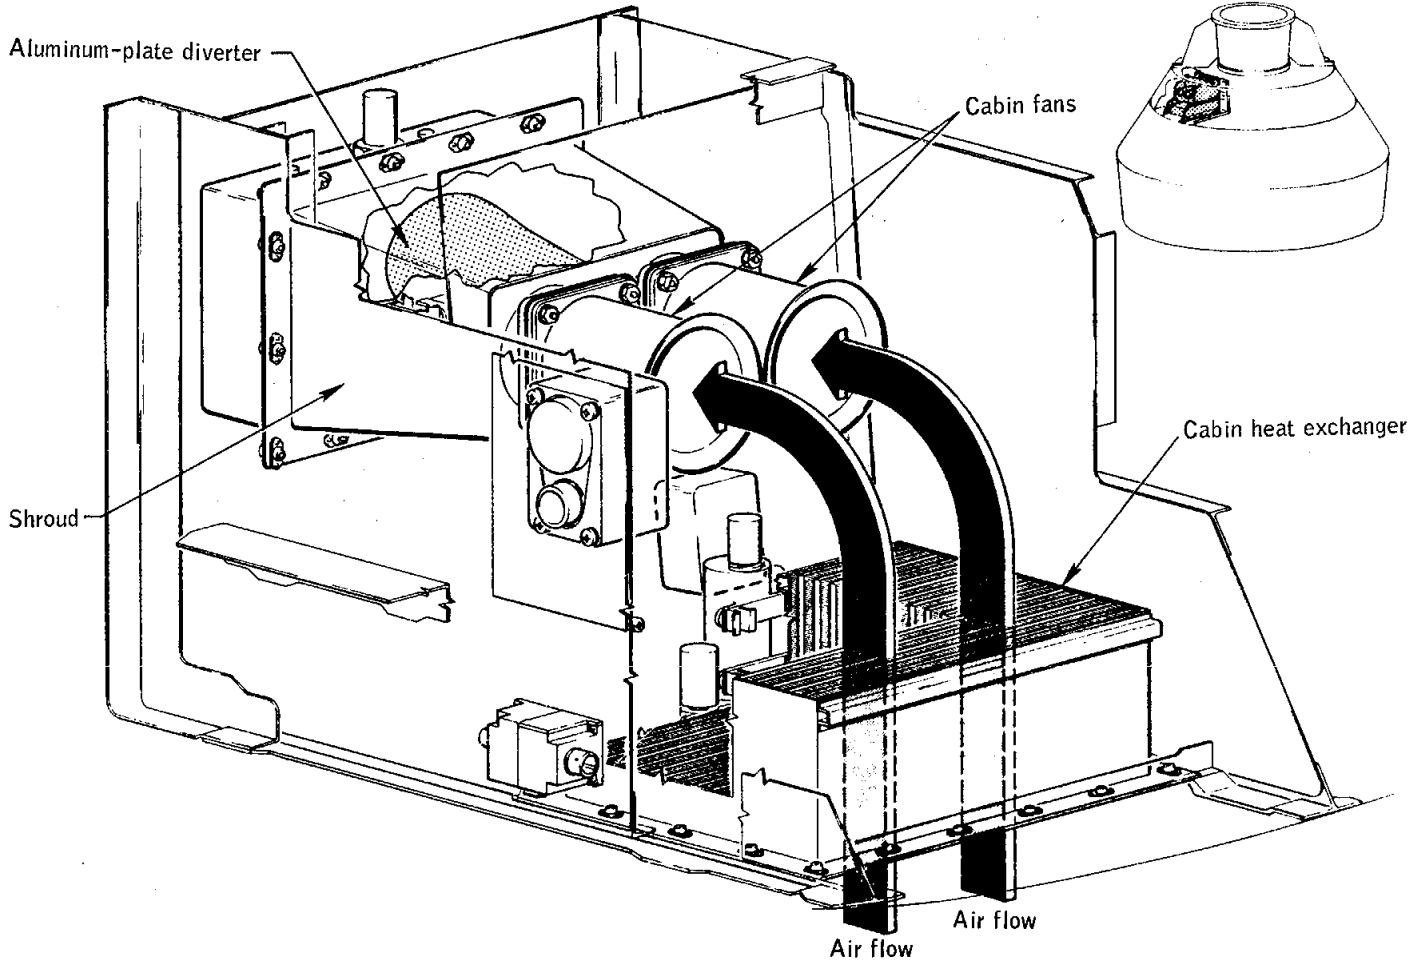
During the sixth day of the mission, the cabin fans (fig. 12-3) were momentarily turned on, and the crew reported that both were noisy.

No blade or bearing damage was detected, and the blades moved smoothly and stopped slowly. No loose objects were found in the plenum chamber and none of the blades were nicked; loose objects and nicked blades on spacecraft 101 (Apollo 7) produced objectionable noise on that flight.

Figure 12-3.- Cabin fan installation.

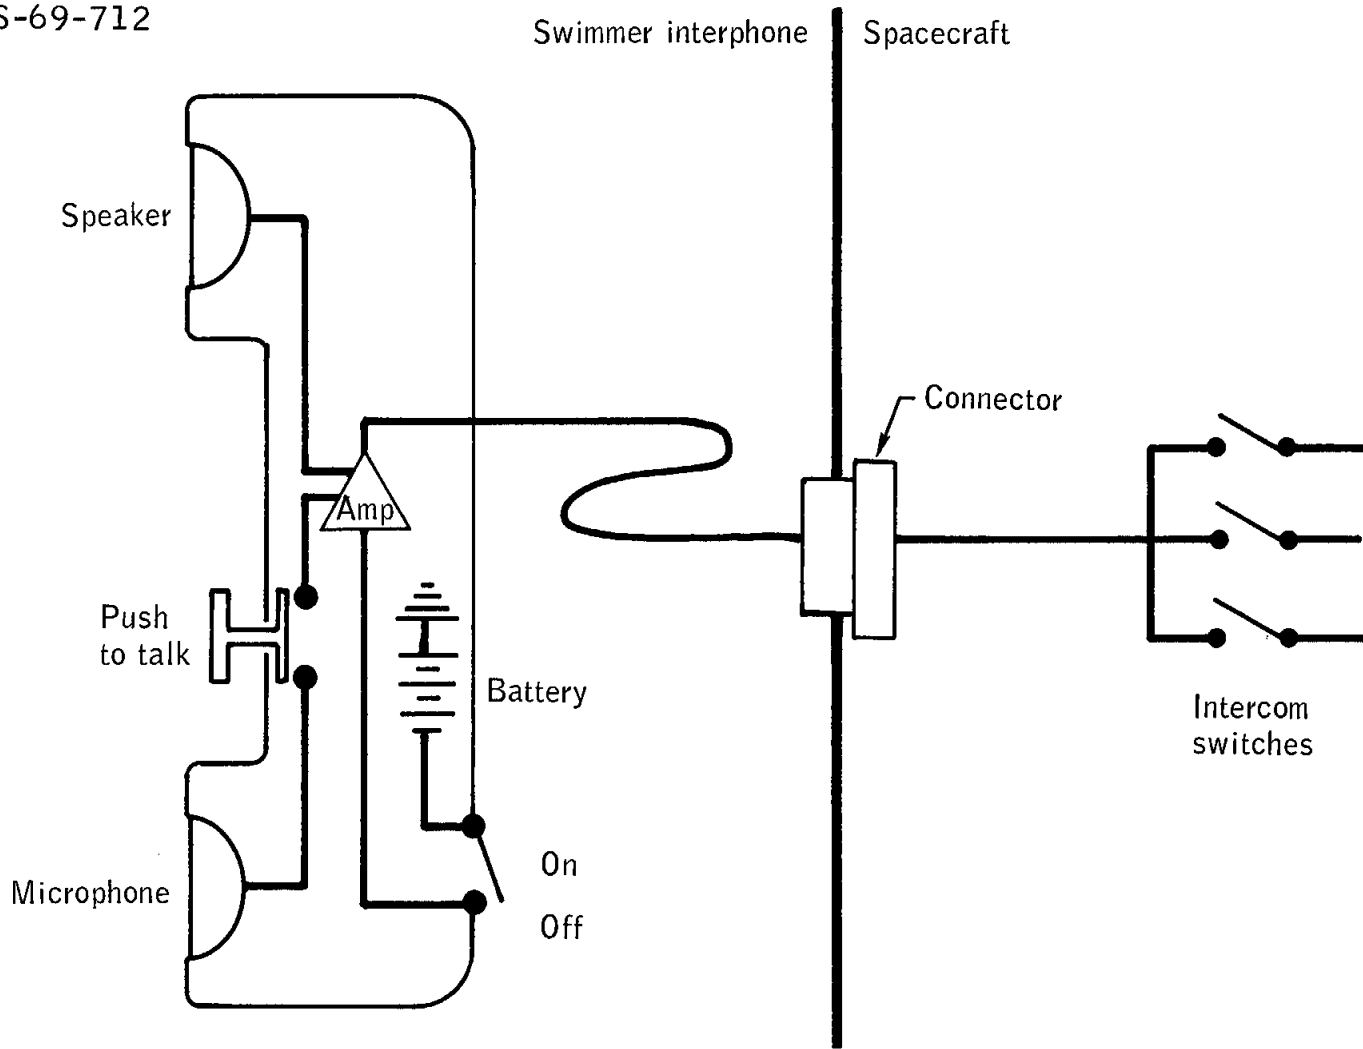
During recovery operations, the swimmers were unable to communicate with the crew via the intercommunications system. The crew reported that the spacecraft intercom switches were in the proper position. As shown in figure 12-6, the swimmer interphone, which plugs into the spacecraft, has a push-to-talk switch and an ON-OFF switch.

Figure 12-6.- Swimmer interphone.

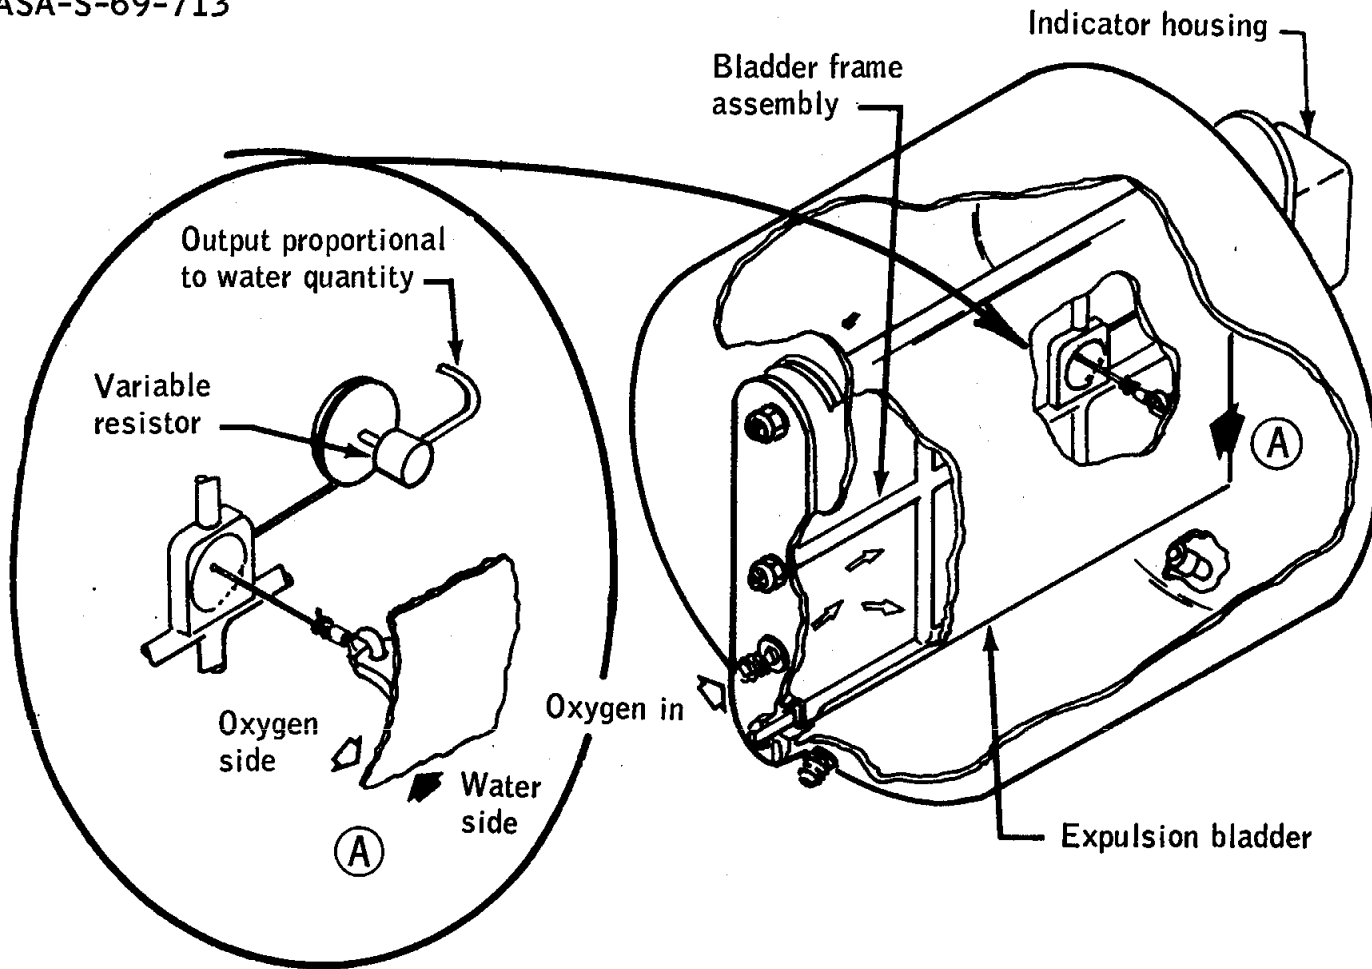
Examination of the disassembled unit (fig. 12-7) revealed corrosion in the indicator housing, on the variable resistor, and on the actuator pulley, indicating moisture had been present in the oxygen side of the tank pressurization system. The actuator line was broken, probably as a result of postflight calibration with the pulley shaft frozen from corrosion. Analysis of the residue in the area indicated that the contaminant was urine and possibly water from the waste water tank. The contamination could have come through the oxygen bleed filter and orifice (fig. 12-8) into the indicator housing and bladder.

Figure 12-7.- Potable water tank.

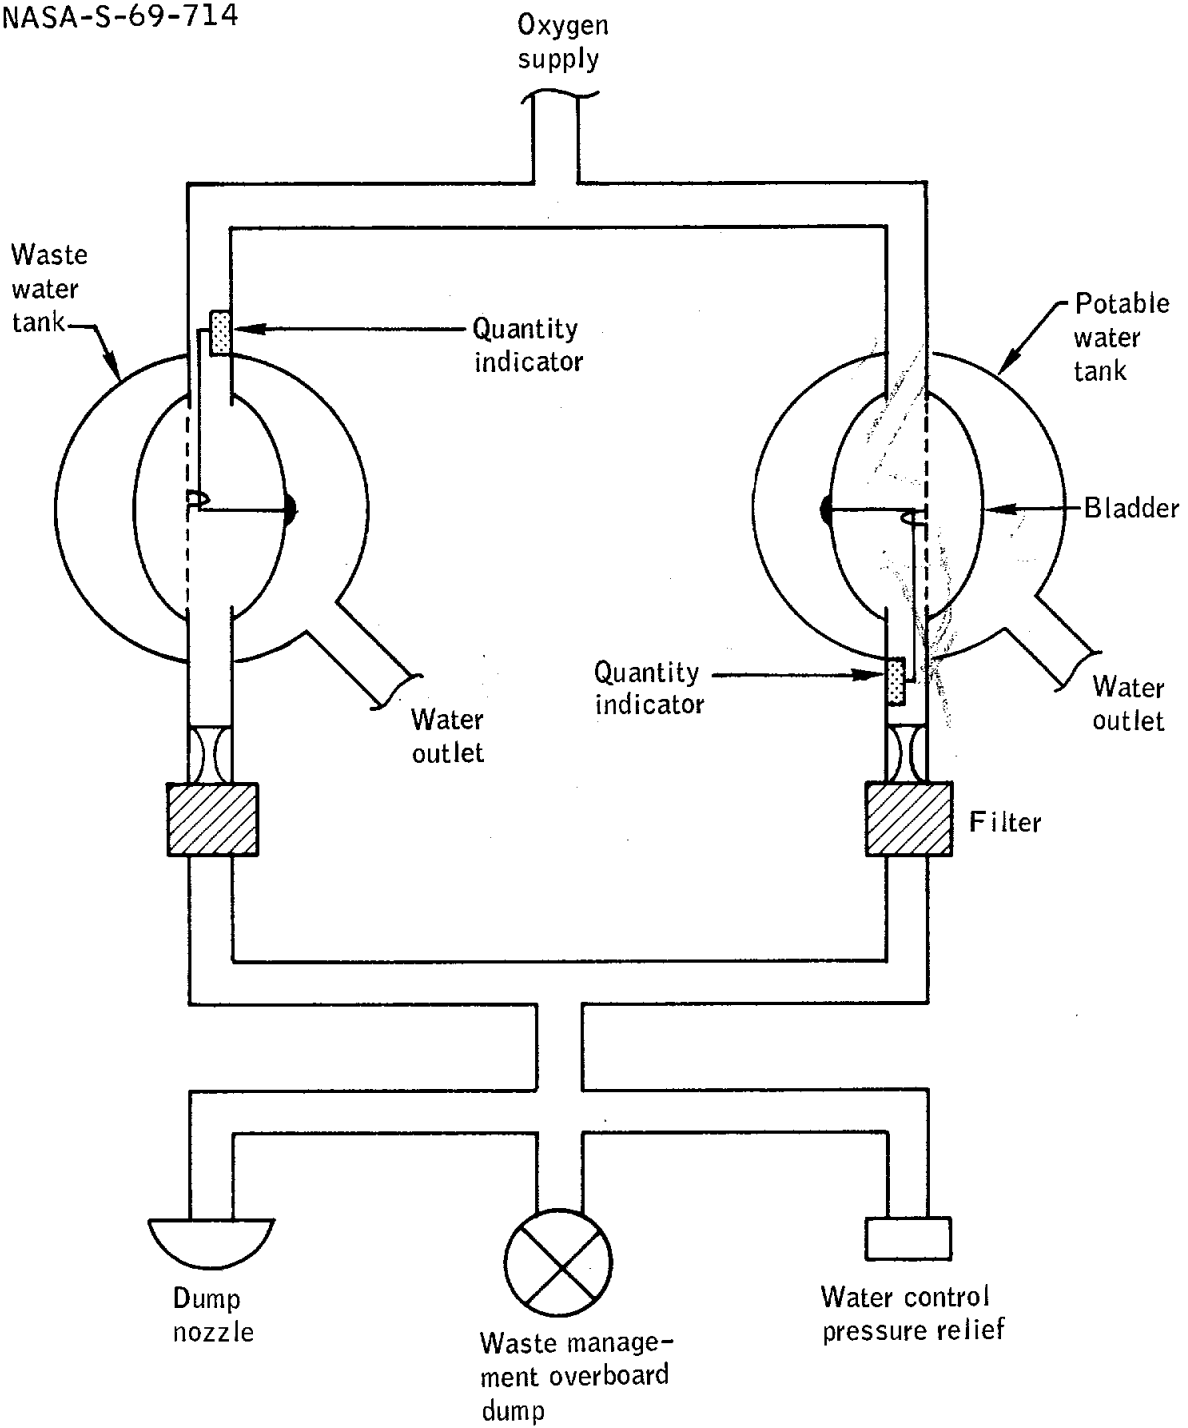
Figure 12-8.- Water tank pressurization system.

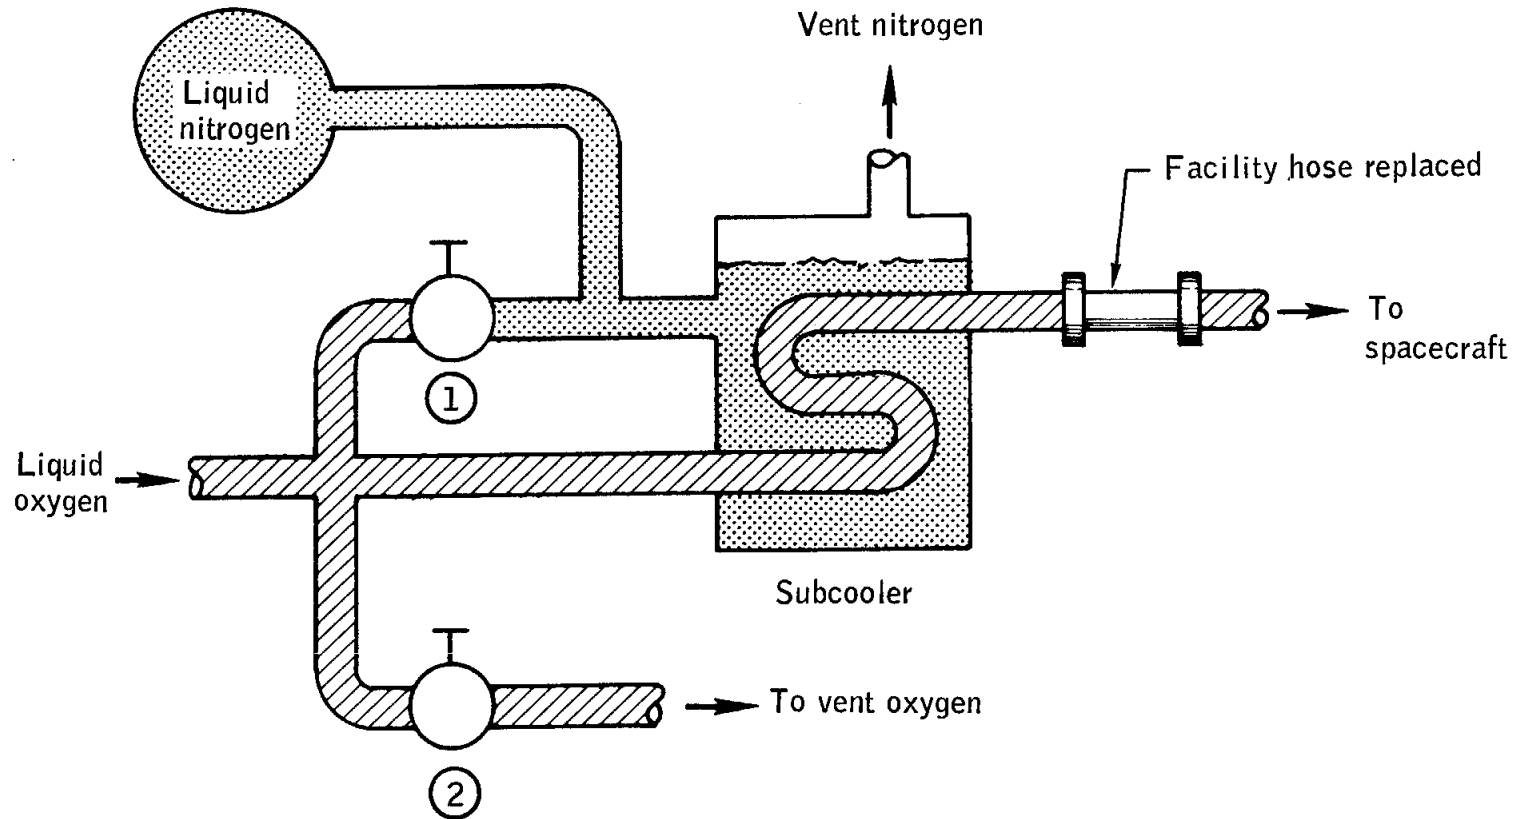
Figure 12-9 shows only the basic system elements associated with the problem.

During normal servicing operation, liquid oxygen flows through a subcooler, which is chilled by liquid nitrogen. Valves 1 and 2 are closed during this operation.

While servicing liquid oxygen, a leak developed in a facility liquid oxygen line, causing a safety shutdown. To preclude overpressurization because of stagnant liquid oxygen, the system was vented using the normal shutdown procedure. This procedure was incorrect in one area, which called for opening valve 1 instead of valve 2. This error allowed liquid nitrogen to flow through valve 1 into the liquid oxygen supply line. Procedures have been corrected and verified by test. This anomaly is closed.

Figure 12-9.- Simplified schematic of cryogenic oxygen servicing unit.
