NASA SP-238

APOLLO 11

Mission Report

PREPARED BY
MISSION EVALUATION TEAM
NASA MANNED SPACECRAFT CENTER

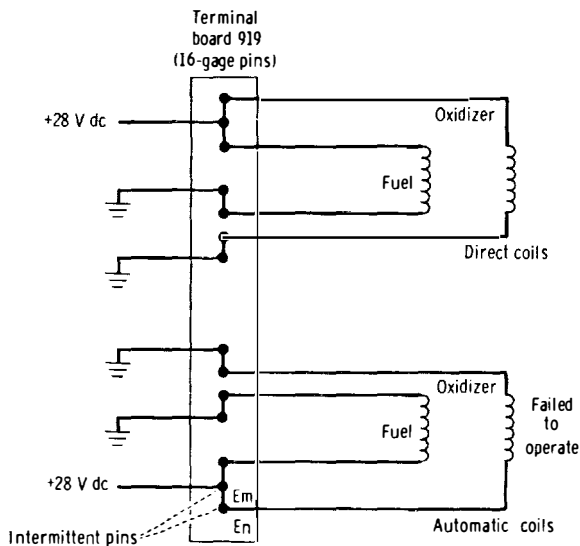
Figure 16-3.- Terminal board schematic for minus-yaw engine, command module reaction control system 1.

At the launch site, another engine undergoing checkout had failed to respond to commands during the valve signature tests. The problem was isolated to a faulty terminal board connector. The faulty terminal board was replaced, and the systems were re-tested satisfactorily. Because of this incident and because of the previous history of problems with terminal boards, these connectors were prime suspects when engine problems occurred.

Postflight tests showed that two pins in the terminal board (fig. 16-3) were loose and caused intermittent continuity to the automatic coils of the engine valve. This type

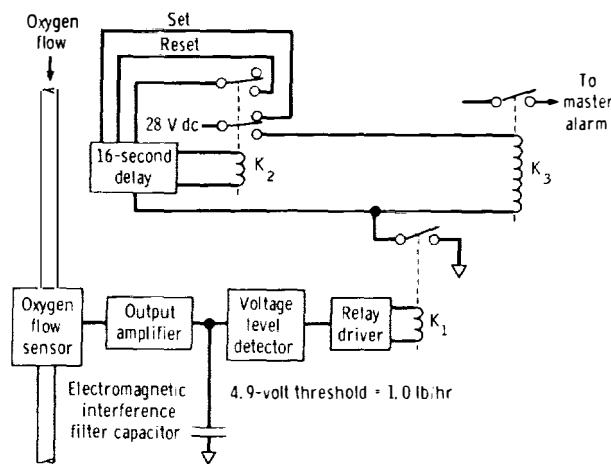
Figure 16-4.- Oxygen flow sensing circuit.

Oxygen flow master alarms.- During the initial lunar module pressurization, two master alarms were activated when the oxygen flow rate was decreasing from full scale. The same condition had been observed several times during altitude chamber tests and during subsequent troubleshooting. The cause of the problem could not be identified before launch, but the only consequence of the alarms was the nuisance factor. Figure 16-4 shows the basic elements of the oxygen flow sensing circuit. Note in figure 16-4 that, for a master alarm to occur, relay K1 must hold in for 16 seconds, after which time relays K2 and K3 will close, activating a master alarm.

The capacitor shown in figure 16-4 is actually a part of an electromagnetic interference filter and is required to prevent fluctuation of the amplifier output to the voltage detector. Without the capacitor, a slow change in flow rate in the vicinity of the threshold voltage of relay K1 will cause relay K1 to open and close continuously (chatter). Relay K2 has a slower dropout time than relay K1; therefore, if relay K1 is chattering, relay K2 may not be affected, so that the 16-second time delay continues to time out. Consequently, master alarms can be initiated without resetting of the 16-second timer.

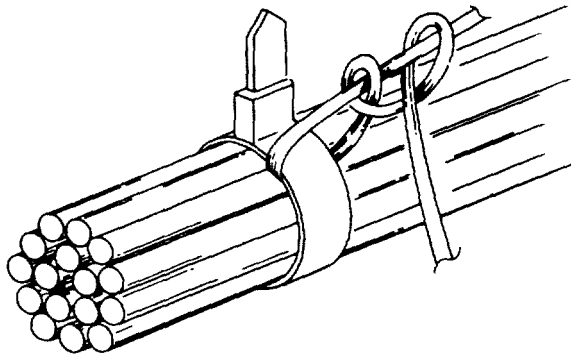
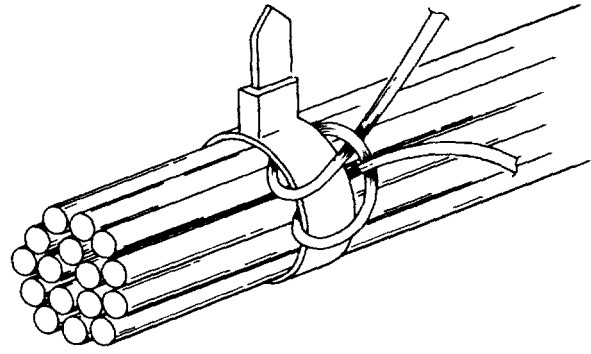
Figure 16-6.- Tie-wraps on lanyards.

Forward heat shield mortar lanyard untied.- During postflight examination of the Apollo 11 spacecraft, an apparent installation error was found on the mortar umbilical lanyard of the forward heat shield. That is, all but one of the tie-wrap knots were untied. This series of knots secures the tie-wraps around the electrical bundle, and its function is to break the wraps during heat shield jettison.

The knots should be two closely tied half-hitches that secure the tie-wrap to the lanyard (fig. 16-6). Examination of the Apollo 10 lanyard indicated that these knots were not two half-hitches but a clove hitch (fig. 16-6). Spacecraft 110 and 111 were examined, and it was found that a clove hitch was erroneously used on these vehicles also.

After the lanyard breaks the tie-wraps, if the fragment of tie-wrap pulls out of the knot, the clove hitch knot can untie, thus lengthening the lanyard. Lengthening this lanyard as the umbilical cable pays out can allow transfer of some loading into the umbilical disconnect fittings. Should a sufficient load be transferred to the disconnect fitting to cause shearpins to fail, the mortar umbilical of the forward heat shield could be disconnected prior to the mortar firing. This disconnection would prevent deployment of the forward heat shield separation-augmentation parachute, and there would be a possibility of forward heat shield recontact with the command module. Examination of the forward heat shield recovered from Apollo 10 confirmed that the mortar had fired and that the parachute was properly deployed.

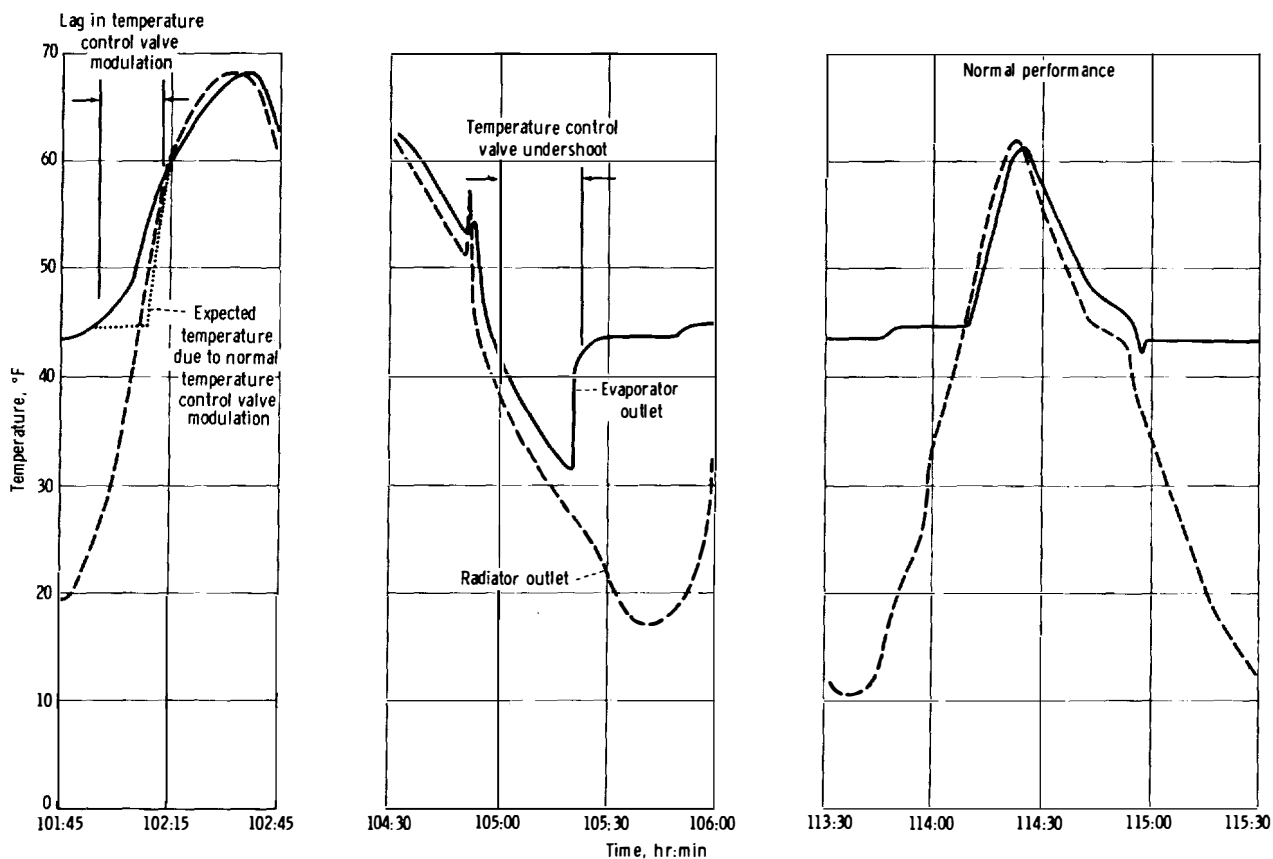
Figure 16-8.- Comparison of radiator and evaporator outlet temperatures.

Two problems occurred on Apollo 11 during lunar orbit operations. First, as the temperature of the water/glycol returning from the radiators increased, the temperature control valve did not close fast enough; thus, an early rise was produced in evaporator outlet temperature. Second, the evaporator outlet temperature decreased to 31° F during revolution 15 as the radiator outlet temperature was rapidly decreasing (fig. 16-8). Figure 16-8 also shows normal operation of the valve and control system after the problem. Both anomalies disappeared at approximately the time during revolution 15 that the glycol evaporator temperature inlet switch was cycled by the crew. The temperature control valve and related control system continued to operate satisfactorily for the remainder of the mission.

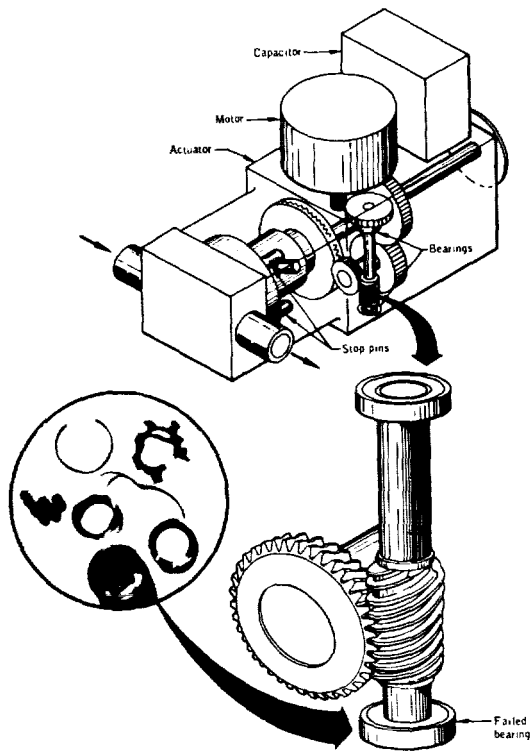
Figure 16-9.- Temperature control valve.

The control valve was removed from the spacecraft, disassembled, and inspected. A bearing within the valve gear train was found to have its retainer disengaged from the race so that the retainer interfered with the worm gear travel (fig. 16-9).

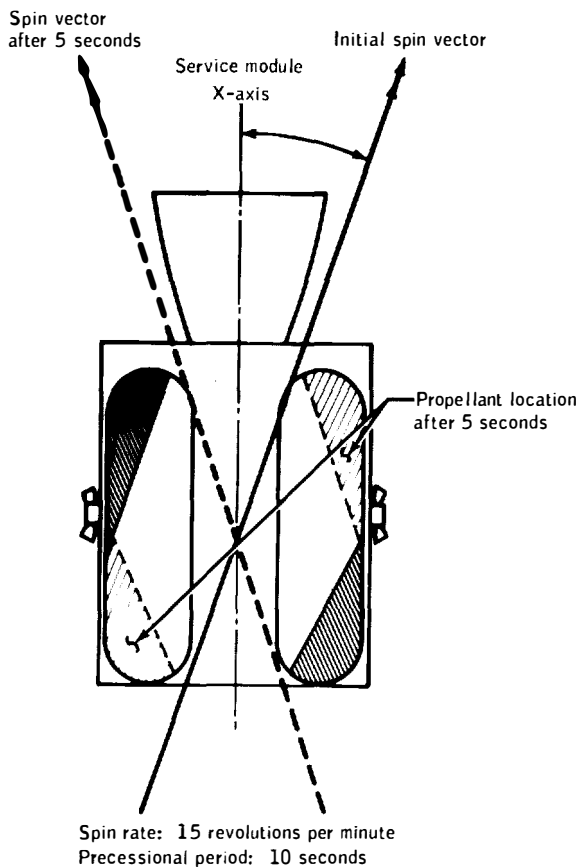
Figure 16-10.- Propellant sloshing effects.

Analysis of propellant sloshing shows, however, that the service module can become unstable, which results in low net separation velocities. Pictorial representation of the sloshing is shown in figure 16-10. The analyses indicate that tip-off moments applied to the service module at jettison cause the spin vector to precess about the service module X-axis. The precession excites longitudinal sloshing of the propellants in the tanks. Initial propellant locations are shown in heavy shading in figure 16-10. When the spin vector precesses to the other side of the X-axis, the propellants are driven to the other ends of the tanks, as shown in light shading. The sloshing then causes the spin vector to approach a position normal to the service module X-axis. The sloshing effects can cause a reduction in separation velocity, and during the 300-second thrusting period, the service module attitude can be reversed 180°. This condition introduces a remote possibility of recontact between the service module and the command module.

Analysis showed that the optimum separation velocity for a range of propellant loads can be obtained by restricting the roll thrusting to a period of 2 seconds and the X-axis thrusting to a period of 25 seconds. Therefore, beginning with the Apollo 13 mission, the service module jettison controller was modified to give the following jettison sequence.

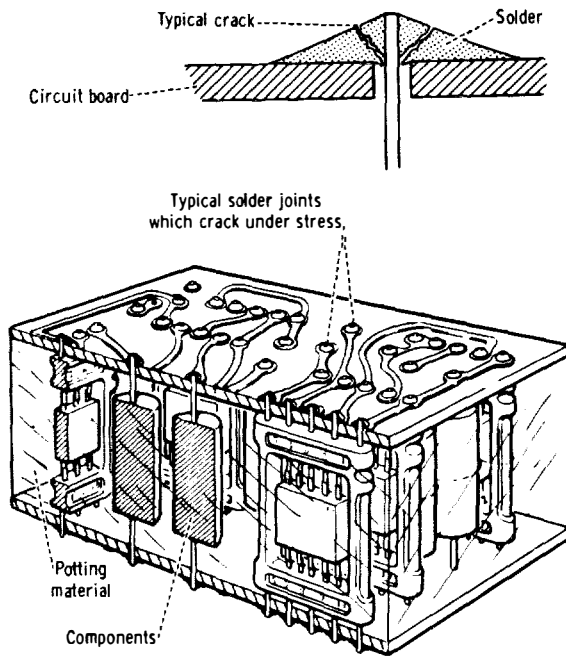
Figure 16-11.- Typical modular construction.

is, electrical components (resistors, capacitors, diodes, etc.) were soldered between two circuit boards, and the void between the boards was filled with potting compound (fig. 16-11). The differential expansion between the potting compound and the component leads caused the solder joints to crack and break electrical contact. Presumably, the 11-hour period the timer was off allowed the timer to cool sufficiently for the cracked joint to make electrical contact, and the timer then operated normally.

Based on the characteristic behavior of the mission timer and the similarity to previous timer failures, the most probable cause of the failure was a cracked solder joint. The reason for the cracked solder joint was the cordwood construction; that

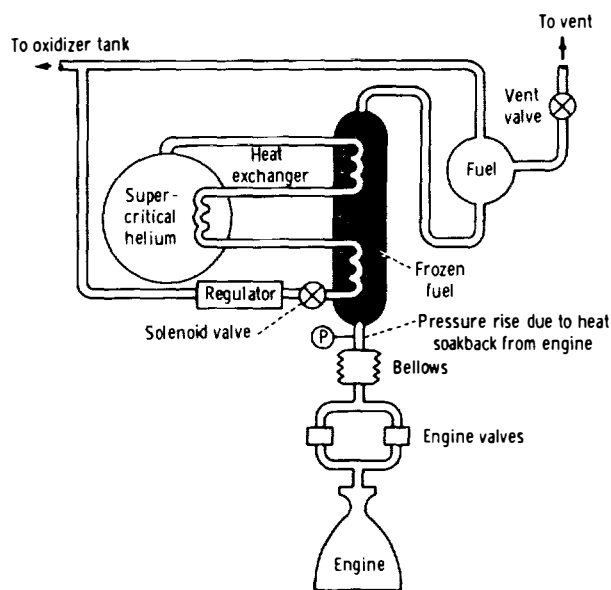
Figure 16-12.- Supercritical helium flow for descent propulsion system.

High fuel interface pressure after landing.- During simultaneous venting of the descent propellant and supercritical helium tanks, fuel in the fuel/helium heat exchanger was frozen by the helium flowing through the heat exchanger. Subsequent heat soakback from the descent engine caused expansion of the fuel trapped in the section of line between the heat exchanger and the engine shutoff valve (fig. 16-12). The result was a pressure rise in this section of line. The highest pressure in the line was probably in the range of 700 to 800 psia. (The interface pressure transducer range is 0 to 300 psia.) The weak point in the system is the bellows links, which yield at pressures greater than 650 psia and fail at approximately 800 to 900 psia. Failure of the links would allow the bellows to expand and relieve the pressure without external leakage. The heat exchanger, which is located in the engine compartment, thawed within approximately 0.5 hour and allowed the line pressure to decay.

On future missions, the solenoid valve (fig. 16-12) will be closed prior to fuel venting and opened some time prior to lift-off. This procedure will prevent freezing of fuel in the heat exchanger and will allow the supercritical helium tank to vent later. The helium pressure rise rate after landing is approximately 3 to 4 psi/hr and constitutes no constraint to presently planned missions. Appropriate changes will be made to operational procedures.

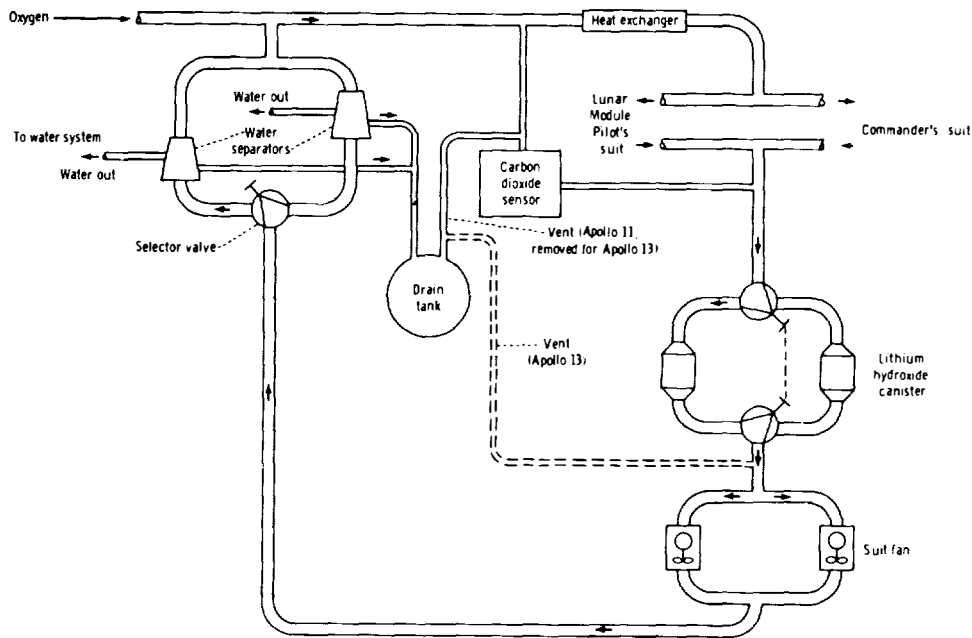
Figure 16-13.- Simplified suit-loop schematic.

into a tank (fig. 16-13). The drain tank contained a honeycomb material designed to retain the condensate. If the amount of condensate exceeded the effective surface of the honeycomb, water could have leaked through the vent line and into the system just up stream of the sensor. (Before the sensor became erratic, the Commander had noted water

in his suit.) Free water in the optical section of the sensor will cause erratic performance. The carbon dioxide content is sensed by measuring the light transmission across a stream of suit-loop gas. Any liquid in the element affects the light transmission and thus gives improper readings. To preclude water being introduced into the sensor from the drain tank, the vent line was relocated to an existing boss upstream of the fans, effective on Apollo 13 (fig. 16-13).

The possible sources of free water in the suit loop are the water separator drain tank, an inoperative water separator, local condensation in the suit loop, and leakage through the water separator selector valve (fig. 16-13). An evaluation of each of these possible sources indicated that leakage through the water separator selector valve was the most probable source of the free water.

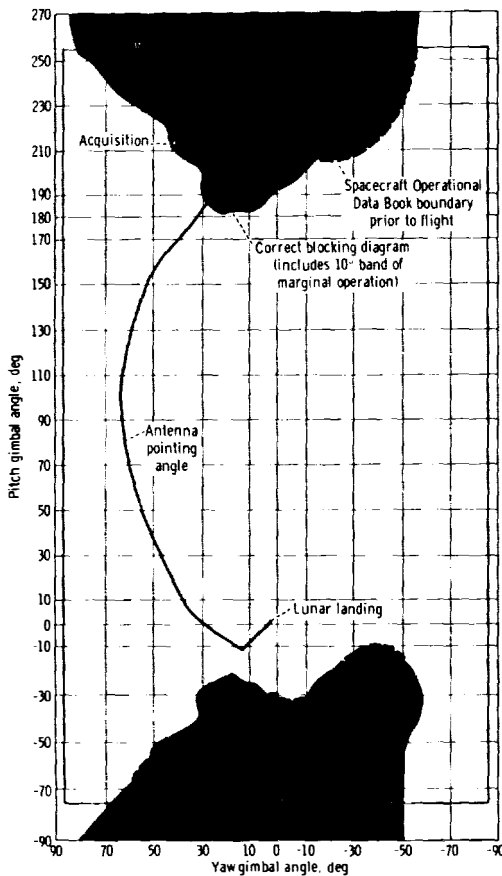
Figure 16-14.- Coverage restrictions for S-band steerable antenna.

For the pointing angles used, errors were discovered in the antenna coverage restriction diagram in the Spacecraft Operational Data Book. In addition, the diagram failed to include the thruster plume deflectors, which were added to the lunar module at the launch site. Figure 16-14 shows the correct blockage diagram and the diagram that was used in the Spacecraft Operational Data Book prior to flight. The pointing angles of the antenna were in an area of blockage or sufficiently close to blockage to affect the coverage pattern. As the antenna boresight approaches the vehicle structure, the on-boresight gain is reduced, the selectivity to incoming signals is reduced, and sidelobe interference is increased. Furthermore, a preflight analysis showed that the multipath signal, or reflected ray (fig. 16-15), from the lunar surface to the vehicle flight trajectory would be sufficient to cause some of the antenna tracking losses. Also, the reduction in antenna selectivity caused by vehicle blockage increases the probability of multipath interferences in the antenna tracking circuits. In conclusion, both the vehicle blockage and the multipath signals probably contributed to the reduced measured signal.

For future missions, the correct vehicle blockage and multipath conditions will be determined for the predicted flight trajectory. Operational measures can be employed to reduce the probability of the recurrence of this problem by selecting vehicle attitudes that orient the antenna away from vehicle blockages and by selecting vehicle attitude hold with the antenna track mode switch in the SLEW or MANUAL position throughout the time periods when this problem may occur.

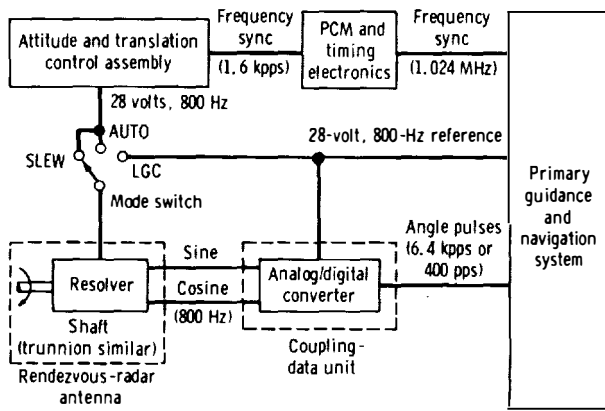
Figure 16-16.- Interfaces from rendezvous-radar antenna to primary guidance system.

The alarms were of the Executive overflow type, which signify that the guidance computer cannot accomplish all of the data processing requested in a computation cycle. The alarms indicated that more than 10 percent of the computation capacity of the computer was preempted by unexpected counter interrupts of the type generated by the coupling data units which interface with the rendezvous-radar shaft and trunnion resolvers (fig. 16-16).

The interrupts during the powered descent resulted from the configuration of the rendezvous-radar/coupling data unit/computer interface. A schematic of the interface is shown in figure 16-16. When the rendezvous-radar mode switch is in the AUTO or SLEW position, the excitation for the radar shaft and trunnion resolvers is supplied by a 28-volt, 800-hertz signal from the attitude and translation control assembly. When the switch is in the LGC position, the positioning of the radar antenna is controlled by the guidance computer, and the resolver excitation is supplied by a 28-volt, 800-hertz source in the primary guidance and navigation control system. The output signals of the shaft and trunnion resolvers interface with the coupling data units, regardless of the excitation source. The attitude and translation control assembly voltage is locked in frequency with the primary guidance and navigation control system voltage through control (by the primary guidance and navigation control system) of the PCM and timing electronics frequency, but it is not locked in phase. When a mode switch is not in LGC, the attitude and translation control assembly voltage is the source for the resolver output signals to the coupling data units, while the primary guidance and navigation control system 800-hertz voltage is used as a reference voltage in the analog-to-digital conversion portion of the coupling data unit. Any difference in phase or amplitude between the two 800-hertz voltages will cause the coupling data unit to recognize a change in shaft or trunnion position, and the coupling data unit will "slew" (digitally). The "slewing"

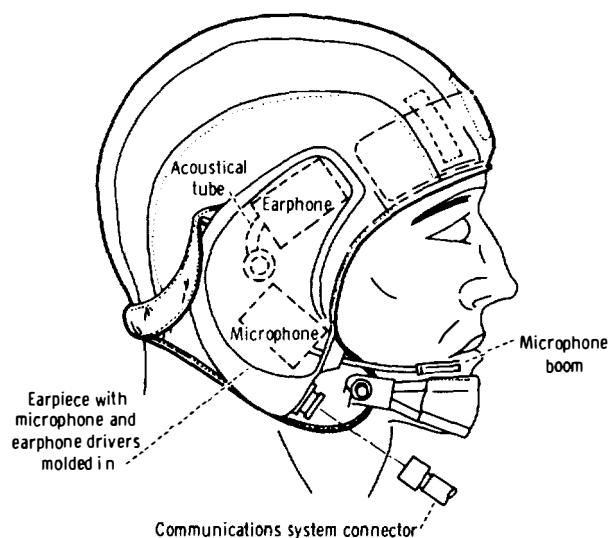
Figure 16-19.- Communications carrier.

Echo during extravehicular activity.- A voice turnaround (echo) was heard during extravehicular activity. At that time, the lunar module was operating in a relay mode. Up-link voice from the S-band was processed and retransmitted to the two extravehicular crewmen by means of the lunar module vhf transmitter. Crew voice and data were received by the lunar module vhf receiver and relayed to the earth by means of the lunar module S-band transmitter (fig. 16-18). The echo, which was duplicated in the laboratory, resulted from mechanical acoustical coupling between the communications carrier earphone

and microphone (fig. 16-19). The crewmen indicated that their volume controls were set at maximum during the extravehicular activity. This setting would provide a level of approximately +16 dBm into each crewman's earphones. Isolation between earphones and microphones, exclusive of airpath coupling, is approximately 48 decibels. Therefore, at the microphone output, the ground voice signal would appear at a level of approximately -32 dBm. If it is assumed that extravehicular communications keying was enabled, this signal would be processed and transmitted by the extravehicular communications system and would provide a level of approximately -12 dBm at the output of the lunar module vhf receiver. If the lunar module relay was enabled, this signal would be amplified and relayed to earth by means of the S-band at a nominal output level.

When the lunar module voice-operated keying circuit is properly adjusted, any signal that keys the extravehicular communications system will also key the lunar module relay. There are indications that the lunar module voice-operated keying sensitivity was set below maximum, as evidenced by the relayed voice breakup experienced by the Lunar Module Pilot. (See "Voice Breakup During Extravehicular Activity" in this section.) Therefore, it would have been possible for the extravehicular communications system to have been keyed by breathing or by suit airflow without this background noise being relayed by the lunar module. However, the up-link turnaround voice could have provided the additional lunar-module-received audio signal level to operate the voice-operated keying circuits, which would have permitted the signal to be returned to earth. The crew indicated that the voice-operated keying circuits in the extravehicular communications system were activated by suit airflow for some positions of the head in the helmet.

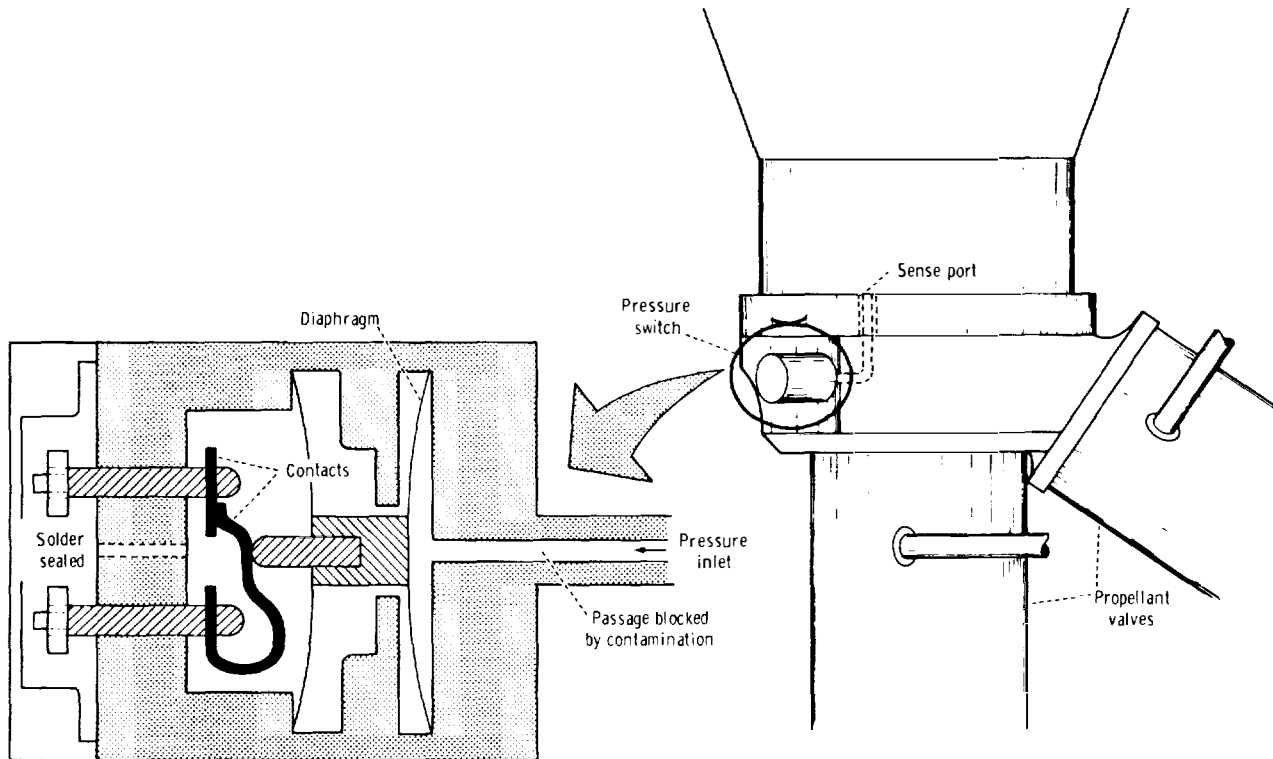
Figure 16-20.- Chamber pressure switch.

Thrust chamber pressure switches.- The switch used to monitor the quad 2 aft-firing engine (A2A) exhibited slow response to jet driver commands during most of the mission. During an 18-minute period just prior to terminal phase initiation, the switch failed to respond to seven consecutive minimum-impulse commands. This failure resulted in a master alarm and a thruster warning flag, both of which were reset by the crew. The engine operated normally, and the switch failure had no effect on the mission. The crew did not attempt any investigative procedures to determine whether the engine had actually failed. A section drawing of the switch is shown in figure 16-20.

This failure was the first of its type to be observed in flight or in ground testing. The switch closing response (time of jet driver ON command to switch closure) appeared to increase from an average of approximately 15 to 20 milliseconds during station keeping to 25 to 30 milliseconds at the time of failure. Normal switch closing response is 10 to 12 milliseconds, based on ground test results. The closing response remained at the 25- to 30-millisecond level following the failure, and the switch continued to fail to respond to some minimum-impulse commands. The switch opening time (time from jet driver OFF command to switch opening) appeared to be normal throughout the mission. In view of these results, the most probable cause of the switch failure was particulate contamination in the inlet passage of the switch. Contamination in this area would reduce the flow rate of chamber gases into the diaphragm cavity, thereby reducing the switch closing response. However, the contamination would not necessarily affect switch opening response because normal chamber pressure tailoff requires approximately 30 to 40 milliseconds in order to decrease from approximately 30 psia to the normal switch opening pressure of approximately 4 psia. The 30- to 40-millisecond time would probably be sufficient to allow the gases in the diaphragm cavity to vent such that the switch would open normally. The crews for future missions will be briefed to recognize and handle similar situations.

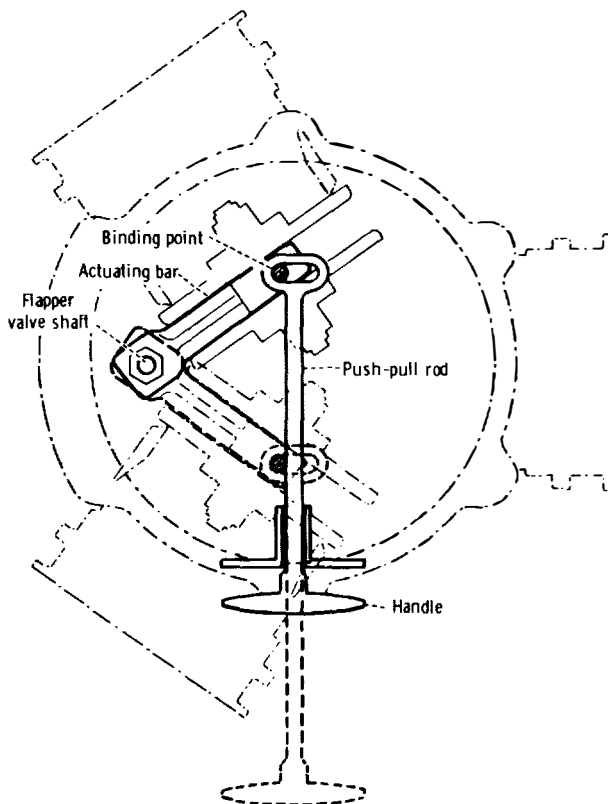
Figure 16-21.- Water separator selector valve.

Water in one suit.- After the lunar module achieved orbit, water (estimated to be 1 tablespoonful) began to enter the Commander's suit in spurts at approximately 1-minute intervals. The Commander immediately selected the secondary water separator, and the spurts stopped after 15 to 20 minutes. The spurts entered the suit through the suit half-vent duct when the crewmen were not wearing their helmets. The pressures in all liquid systems that interface with the suit loop were normal, which indicated no leakage.

The flapper-type valve is located in a Y-duct arrangement and is used to select one of two water separators. Leakage of this valve would allow free water to pass through the idle water separator and subsequently enter the suit hose. This leakage would most probably result from a misalignment and binding in the slot of the selector valve actuation linkage (fig. 16-21).

The allowable actuation force after linkage rigging was 15 pounds. The usual actuation forces have been 7 to 8 pounds, but 12.5 pounds were required on the Apollo 11 mission. The allowable actuation force has been lowered to 10 pounds, and inspections for linkage binding have been incorporated into procedures at the factory and the launch site.

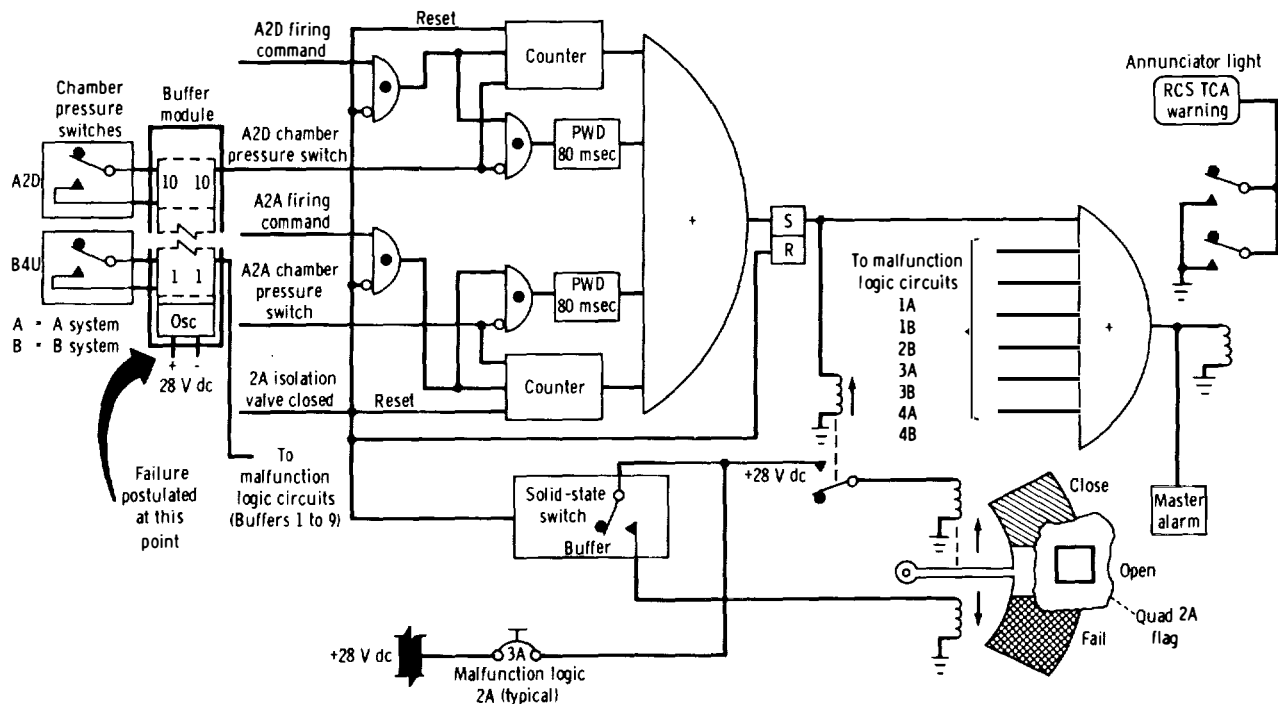
Figure 16-22.- Reaction control system malfunction-detection circuits.

Reaction control system warning flags.- The crew reported thrust chamber assembly warning flags for three engine pairs. Quad 2 and quad 4 warning flags for system A occurred simultaneously during lunar module station keeping prior to descent orbit insertion. The quad 4 flag for system B appeared shortly thereafter and also twice just before powered descent initiation. The crew believed these flags were accompanied by master alarms. The flags were reset by cycling of the caution and warning electronics circuit breaker. Sufficient data are not available to confirm any of the reported conditions.

The first two possible causes are unlikely because simultaneous multiple failures would have to occur and subsequently be corrected. The third possible cause is the most likely to have occurred where a single-point failure existed. Ten of the 16 engine pressure switch outputs are conditioned by the 10 buffers in one module in the signal conditioner electronics assembly (fig. 16-22). This module is supplied with +28 V dc through one wire. In addition, the module contains an oscillator that provides an

ac voltage to each of the 10 buffers. If either the +28 V dc is interrupted or the oscillator fails, none of the 10 buffers will respond to pressure switch closures. If engines monitored by these buffers are then commanded on, the corresponding warning flags will appear, and a master alarm will occur.

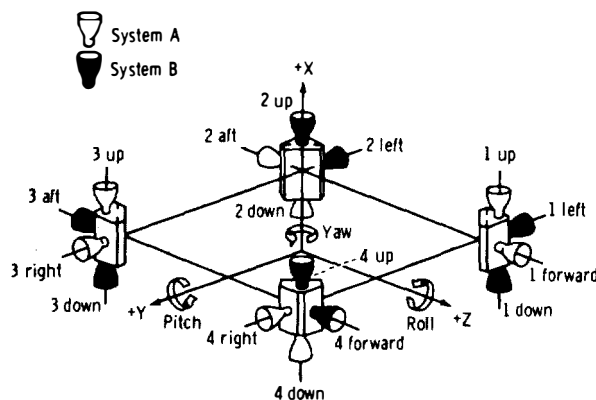
Figure 16-23.- Reaction control system geometry.

If plus X translation were commanded (fig. 16-23), the down-firing engines in quads 2 and 4 of system A could fire, and flags 2A and 4A would appear. A subsequent minus X rotation could fire the forward-firing thruster in quad 4 of system B and the aft-firing thruster in quad 2 of system A, and flag 4B would appear. The aft-firing engine in quad 2 of system A (A2A) is not monitored as having failed. The failure, then, could have cleared itself. The response of the vehicle to thruster firings would have been normal under these conditions. There is no history of similar failures either at package or module level in the signal conditioner electronics assembly. No corrective action was taken.

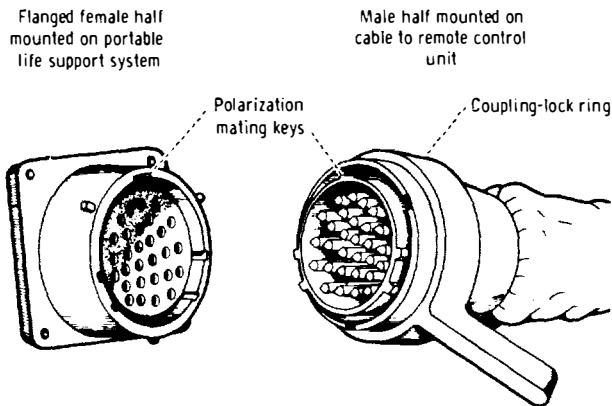
Figure 16-24.- Connector between remote control unit and portable life support system.

Mating of remote control unit to portable life support system.- During preparation for extravehicular activity, the crew experienced considerable difficulty in mating the electrical connectors from the remote control unit to the portable life support system. For rotational polarization alignment, it was necessary to grasp the cable insulation because the coupling lock ring was free for unlimited rotation on the connector shell (fig. 16-24).

For future missions, the male half of the connector has been replaced with one that has a coupling lock ring with a positive rotational position with the connector shell and that can be grasped for firm alignment of the two halves. The ring is then rotated 90° in order to capture and lock the two halves. In addition, easier insertion has been attained with conical-tipped contact pins in place of hemispherical-tipped pins.
