Preliminary Insights from Surveys of Bridges at High Scouring Risk in West Piedmont

# Preliminary Insights from Surveys of Bridges at High Scouring Risk in West Piedmont

Mauro Aimar<sup>a</sup>, Marco Civera<sup>a\*</sup>, Sebastiano Foti<sup>a</sup>, and Bernardino Chiaia<sup>a</sup>

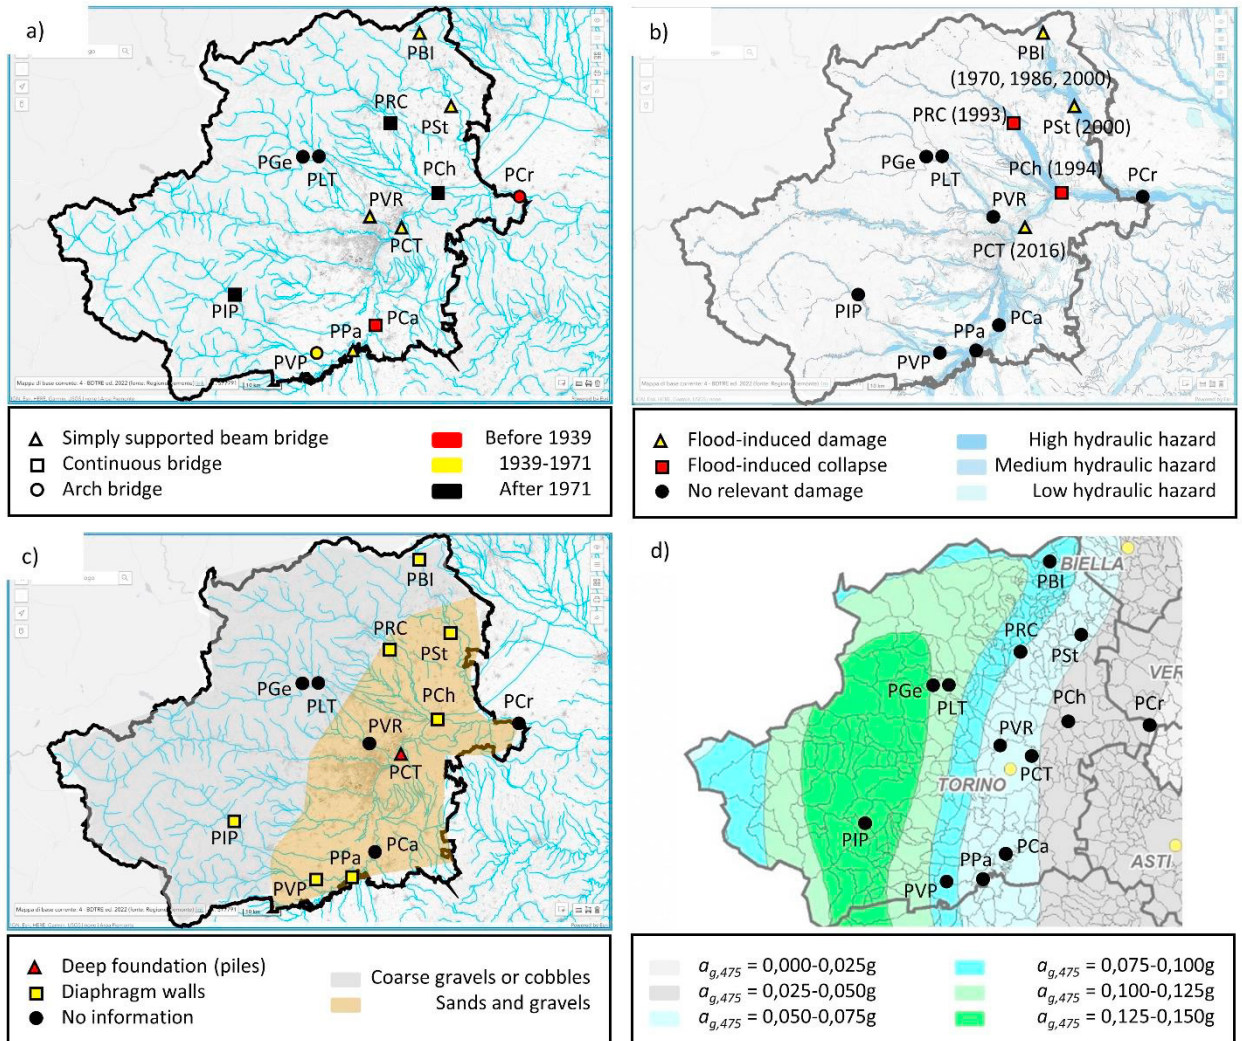
As for the superstructure, Fig. 2a identifies the investigated bridges in terms of both the static scheme of the bridge deck and the year of construction. For simplicity, bridges were clustered according to three periods of construction, that is, before 1939, between 1939 and 1971, and after 1971. Indeed, in these years, the building codes through to the Regio Decreto Legge 2229/1939 and the Legge 1086/1971 were proclaimed. Thus, such clustering is consistent with the main steps in the evolution of the Italian building codes. In general, most of the investigated bridges were built in the 1950s-1960s and they are characterized by a stack of simply supported spans, consistently with the construction trends in those years. On the other hand, many bridges were built recently (i.e., end of the 1990s), although some of them are replacing collapsed bridges after flooding events, as it will be addressed below.

Being river bridges, the understanding of their interaction with the water channel is crucial. Fig. 2b overlaps the location of selected bridges with the hydraulic hazard map<sup>†</sup>, which identifies regions with different degrees of hydraulic hazard, from low to high. Indeed, bridges in alluvial areas can be affected by hydraulic forces and foundation scour on both piers and abutments during flood events, inducing relevant damage or even collapse. To highlight this issue, Fig. 2b also indicates the bridges that needed significant repair intervention or a complete reconstruction after floods.

Fig. 2c reports available information on the geotechnical side. On the one hand, it shows a simplified representation of the surface geology, as it mainly affects the bridge behavior as well as the erosion. Bridges in mountain areas are typically founded on coarse-grained soils (i.e., gravels and cobbles), although most of the considered bridges are built on sands and gravels, being located in the plain. On the other hand, Fig. 2c labels each bridge as a function of the foundation type. To our knowledge, the information about the foundation is not available for 5 bridges. Instead, the remaining bridges are supported by pile foundations (with the exception of the Castiglione Torinese bridge, PCT, which adopts diaphragm walls), which reduce the sensitivity of the bridge behavior to soil erosion. However, the actual benefit on the structure depends on the foundation geometry (i.e., number, diameter and depth of piles), and the related information is currently missing for many of the considered bridges.

Finally, in Fig. 2d, the bridge map is overlapped with the seismic hazard map<sup>‡</sup>, which represents the 475-year return period expected peak ground acceleration,  $a_{g,475}$ . This parameter can be considered as a proxy of the intensity of the expected ground motion. The investigated bridges are affected by different seismicity levels, with  $a_{g,475}$  values ranging from 0.0025g in the plain areas up to 0.15g in the Alps. These amplitude levels are typical of low-seismicity areas, although they do not account for the local geology and the site topography, which can significantly increase the expected shaking level. This aspect can be critical for river bridges, as they are typically built on sedimentary areas and/or alluvial valleys, which are prone to stratigraphic amplification and basin effects.

Figure 2. a) Location of the investigated bridges, labelled according to the structural scheme and the period of construction; b) Location of the investigated bridges in the hydraulic hazard map, classified according to the damage entity observed in past flood events and the event year; c) Location of the investigated bridges in the simplified map of the surface geology, labelled according to foundation type; d) Location of the investigated bridges in the seismic hazard map.
