HYGROTHERMAL DURABILITY OF BOND IN FRP-STRENGTHENED MASONRY

ABSTRACT

This paper presents the results of an experimental program aimed at investigating the hygrothermal durability of bond in FRP-strengthened bricks. Accelerated ageing tests were performed on the FRP-strengthened brick elements and the bond degradation was periodically investigated by visual inspection and by conventional single-lap shear bond tests. The changes in the properties of material constituents have also been monitored. The obtained results are presented and critically discussed.

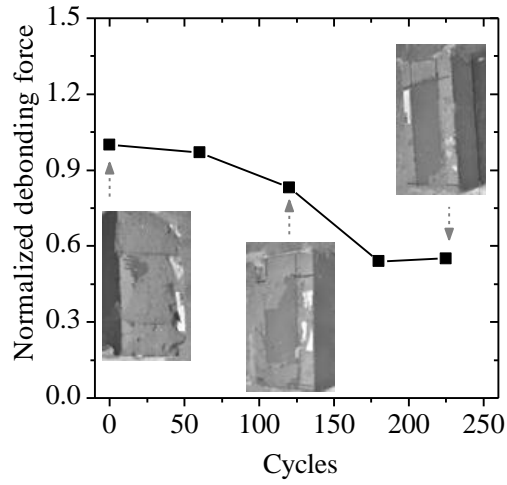
Fig. 13 Observed failure modes in shear bond tests: (a) exposure HT; (b) exposure FT

Regarding the failure mode, three different failures were observed in the specimens: (1) cohesive failure within a thick layer of brick; (2) cohesive failure within a superficial layer of brick, next denoted by interfacial cohesive; (3) adhesive failure at the FRP/brick interface. For both hygrothermal exposures, a progressive change of failure mode from cohesive to adhesive was observed in the specimens with the increase of exposure cycles, Fig. 13. Such a change in the failure mode of the specimens, also reported in (Green et al. 2000), can be attributed to the observed bond degradation during environmental exposures. The contribution of each failure mode in the debonding behavior is presented in Fig. 14. These values are obtained by measuring the area corresponding to each failure mode on the failure surface of the specimens after debonding tests. Then, the
