Soils and Foundations

Precaution and early warning of surface failure of slopes using tilt sensors

A simple monitoring method for the early warning of rainfall-induced landslides is proposed. Tilting angles in the surface layer of the slope are mainly monitored in this method. In the first stage of this study with a scaled model slope, distinct behaviors were observed in the tilt angles monitored on the surface of the slope prior to failure. Hence, a set of equipment has been developed for practical use, which is equipped with a Micro Electro Mechanical Systems (MEMS) tilt sensor and a volumetric water content sensor. An optional arrangement of tilt sensors has also been developed in order to investigate the deformation of the deeper layers. These sets of equipment have been deployed at several slope sites in Japan and China, and their performances have been recorded. Slope failure tests were also conducted on a natural slope by applying artificial heavy rainfall. The developed system detected distinct behaviors in the tilting angles at these sites in the pre-failure stages. Considering the behaviors of tilting monitored on the surfaces of these slopes, it is proposed that a prec

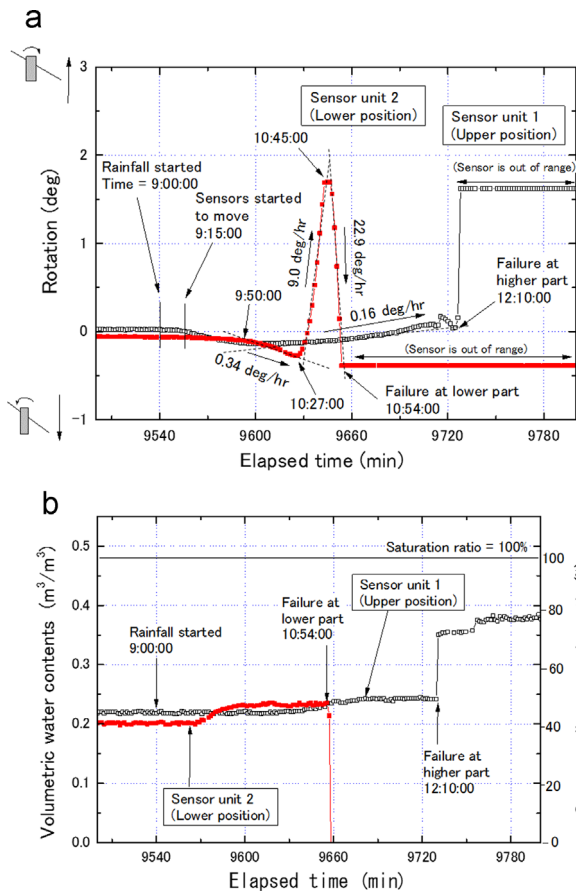
Fig. 4. (a) Behaviors of inclination for the model test 2006 and (b) behaviors of water contents for the model test 2006.

Fig. 4(a) shows the tilting angle obtained by each sensor unit. The slope failure progressed starting from the toe, and the lower part with sensor unit 2 failed around 2 h after the rainfall started. The sensor tilted abnormally 30 min before failure. Such behavior could be considered as a signal of ongoing slope instability.

In contrast to sensor unit 2, the upper part of the slope around sensor unit 1 failed after 3 h of rainfall, but the development of the tilting angle was not as clear as in the lower part. The pre-failure tilting behavior is case-by-case. As mentioned above, the tilt sensor detects the average shear deformation of the slope surface layer. However, the depth of the tilt sensor units in this test was very short, only 200 mm. Therefore, the behavior in the very shallow part of the slope surface was observed, while the major deformation may have occurred in deeper part. This may be one of the possible reasons for these disunity behaviors. In the field monitoring cases, mentioned later in this paper, the tilting angles of the steel rods installed to a depth of 0.5–1 m showed more consistent behaviors.

Although the tilting behaviors varied drastically during the failure process, tilting rates exceeding 0.1°/h were observed for more than 1 h at both tilt sensors. From this, the idea of detecting abnormal conditions in slopes by monitoring the tilting rate on the surface can be suggested.

On the other hand, the records of volumetric water contents are presented in Fig. 4(b). As the void ratio of the slope ground is $e=0.935$, the volumetric water content will be 0.48 at full saturation. The measured water content increased after the rainfall started, but it did not indicate nearly saturated condition before the failure. Thus, it was found difficult to detect a precursor of failure based on the monitored water contents only. One of the reasons for this difficulty is that the water content varies very sensitively with the depth from the slope surface. In addition, it is hard to determine the depth of the failure surface.

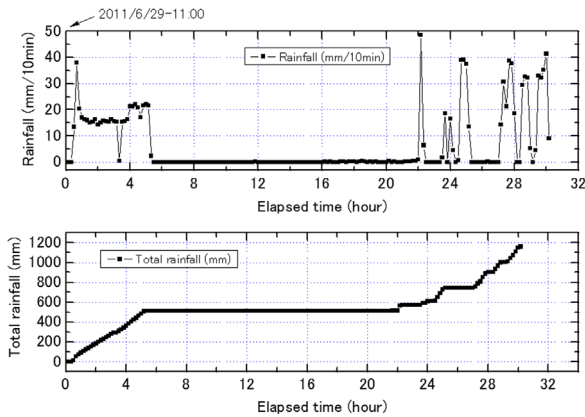
Fig. 6. Record of rain intensity given for artificial rainfall test.

A time history of the artificial heavy rainfall is recorded in Fig. 6. The rainfall intensity fluctuated due to the restricted water supply, but a total of around 500 mm of rain occurred on the first day, and an additional 700 mm fell on the second day. As the slope material is loose and highly permeable, rainfall of this amount was needed to cause failures.

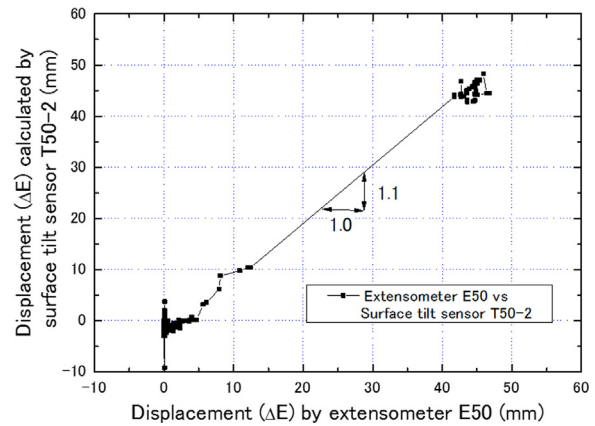
Fig. 10. Comparison between tilting angle and surface displacement in artificial rainfall test.

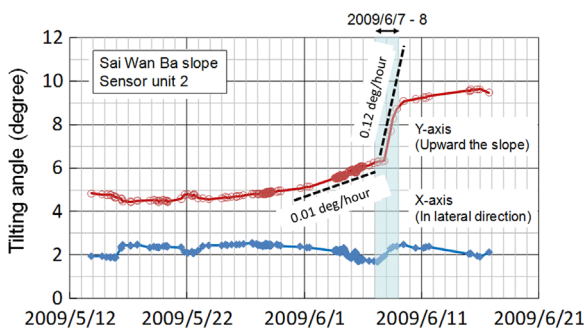
Fig. 15. Time histories of tilting angle obtained by Sensor unit 2.

warning was set at 30 mm per day in this area. The increasing rate of the tilting angle in the *Y*-axis was 0.12°/h during this event. The slope did not fail at the position of this sensor unit, but the slope did finally fail at an adjacent place. Therefore, such quickly obtained behavior is considered as a sign of a high-risk condition in this area. According to the people in this village, the slope failure near sensor unit 2 took place at noon on June 8, while the quick increase in the *Y* direction started late at night on June 7. Therefore, there was a time margin of around 12 h, which is sufficient for issuing an early warning.

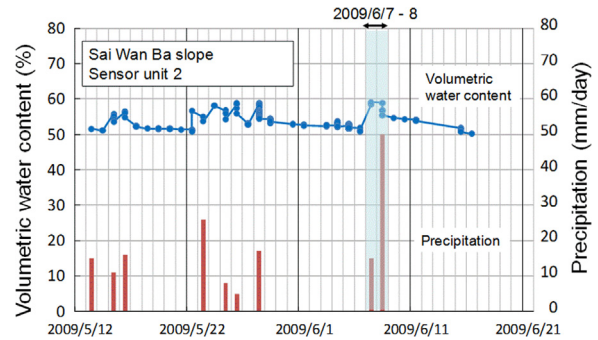
Fig. 16. Time history of volumetric water content transducer at Sensor unit 2, and records of rainfall.

throughout the monitoring period (Fig. 16). It responded to every rainfall event, but no extraordinary response was recorded at the time of the landslide on June 7 and 8. As the volumetric water content sensor was buried in a shallow part of the slope, only 30 cm from the ground surface, the obtained values did not correspond to the conditions at the depth of the slip surfaces. Thus, it is not relevant to define the criteria of early warning based only on the water content.

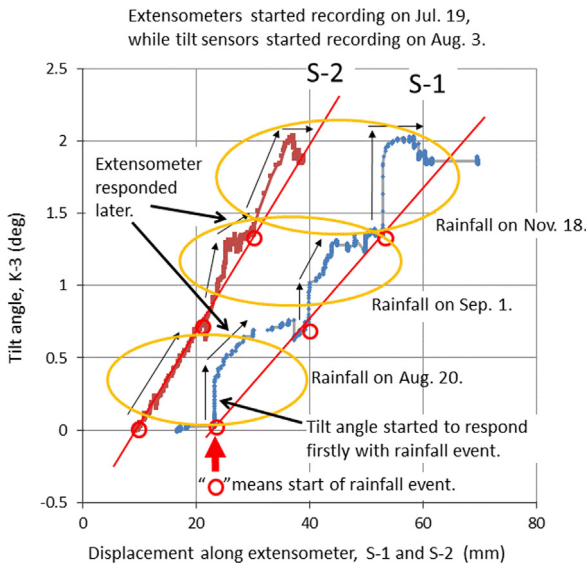
Fig. 19. Comparison between data from extensometer (S-1 and S-2) and surface tilt sensor (K-3).

Fig. 18(e)–(h) also indicates time delays among the responses of the sensors. Moreover, Fig. 19 compares the tilting behaviour at K-3 with the displacement obtained by extensometers S-1 and S-2, respectively. When their responses to each rainfall event are investigated in detail, it can be noted that the sensors at the lower part of slope, tilt sensor K-3 and extensometer S-1, were the first to start to respond. However, the extensometer at the upper part,

S-1, responded later by 10–27 h. This suggests that the movement of this slope starts from the bottom, and then propagates upward. In such a case, it is effective to use the tilt sensor at the lower part of the slope for early warning.

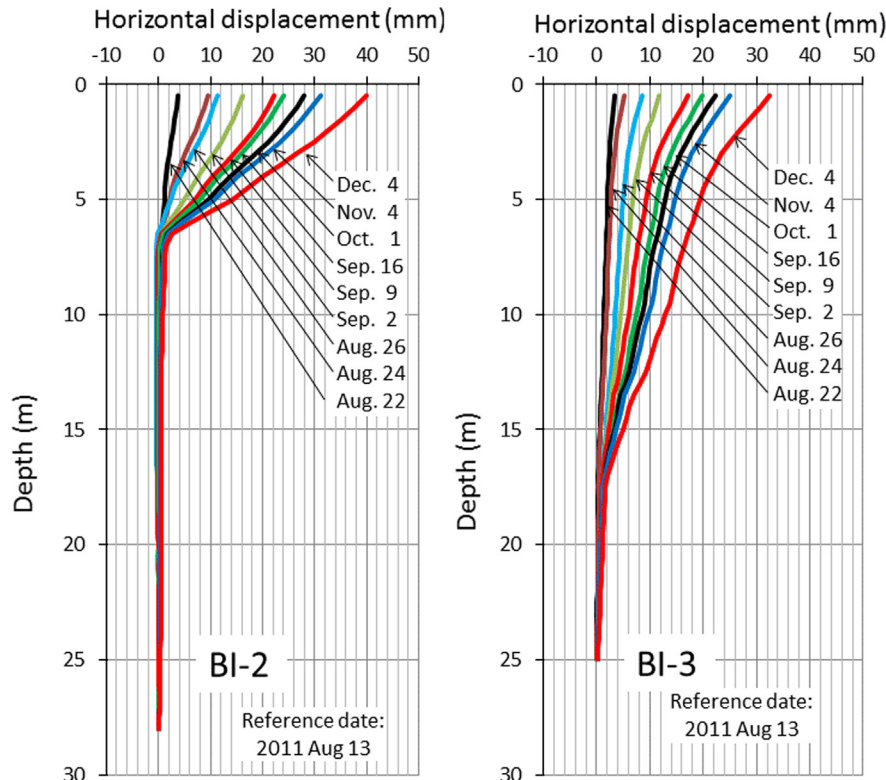
Fig. 20. The results of multiple borehole inclinometers.

Fig. 20 provides a profile of deformation along the multiple borehole inclinometers at BI-2 and BI-3. The upper part, BI-2, showed progressive deformation over the depth of around 7 m, while the lower part, BI-3, deformed at the depth of around 20 m. These data were utilized to estimate the location of the active slip surface in Fig. 17. Fig. 21(a) shows time histories of the lateral displacements on the slope surface obtained by BI-2 and 3. In addition, Fig. 21(b) plots them against the tile angles from the nearest tilt sensors, K-2 and 3, respectively. The obtained tilt angles have clear co-relations with the displacement on the slope surface.

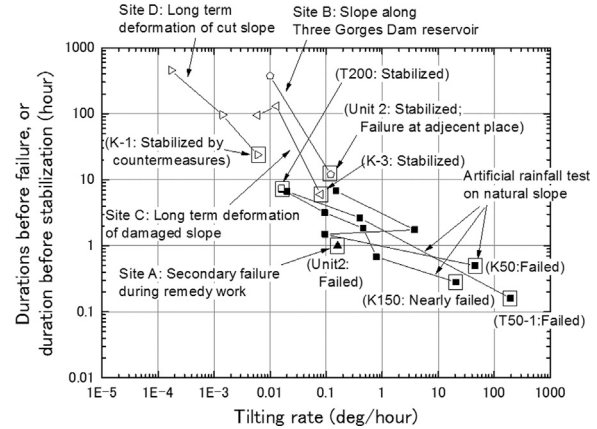
Fig. 25. Summary of the tilting rate and duration observed on slope surface.

Fig. 25 shows the relationships between the tilting rates and the duration before failure or stabilization. The observed tilting rate was more than $0.01^\circ/\text{h}$ for all the cases in which the slope finally failed or nearly failed, while it was less than $0.1^\circ/\text{h}$ for all other cases. At Site B, the tilting rate exceeded $0.1^\circ/\text{h}$, while the slope did not failed at the position of the sensor. However, another failure occurred at a very adjacent place. Therefore, the authors propose the issuance of a warning at a tilting rate exceeding $0.1^\circ/\text{h}$ and a precaution at a tilting rate of $0.01^\circ/\text{h}$ for the sake of safety.

Fig. 25 also suggests that the tilting rate tends to increase toward failure, and that a shorter duration remains before failure when a higher tilting rate is observed. Durations of 1–10 h remained before failure when a tilting rate of $0.1^\circ/\text{h}$ was observed.
