XVII International Colloquium on Mechanical Fatigue of Metals (ICMFM17)

Surface characterization of spline coupling teeth subjected to fretting wear

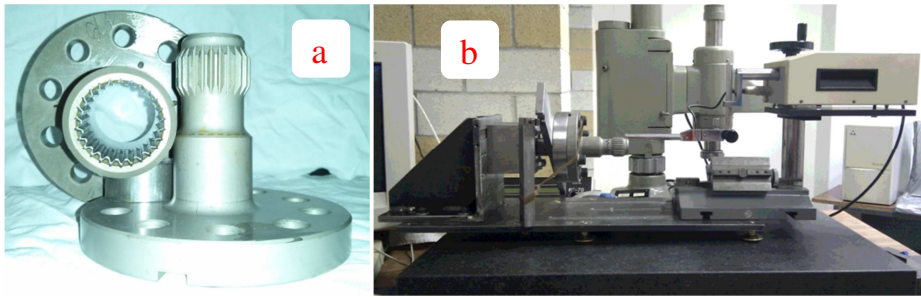
Fig. 1. spline coupling specimen (a), positioning of the specimen before a roughness acquisitions (b).

Aim of this work is to use some surface roughness parameters to identify the fretting wear damage in a real engineering application like spline coupling teeth [6]. Splined couplings are mechanical components used to connect two rotating shafts; these components find applications in many industrial sector and in particularly in the aerospace field. One of the main cause splined couplings failure is the fretting wear caused by the relative motion between engaging teeth; as a matter of fact, these components are subjected to fretting phenomena above all when they work in misaligned conditions [7] and so the teeth surface morphology may change according to the corresponding working parameters (misalignment amplitude, presence of lubrication, etc). Experimental tests have been performed by means of a dedicated test rig [10,11]; specimens are steel made splined couplings (see Figure 1a).

The test bench used in this work has a mechanical power recirculation scheme [8], since the external power to be applied offsets only the power dissipated in friction [8]. Splined couplings specimens are steel made (42CrMo4) nitrogen-hardened; they have crowned tooth profile and the main characteristics are: 26 teeth, 1.27mm modulus, 30° pressure angle, 200 mm crowing radius and 12 mm face width. The surface of all teeth of each specimen has been analyzed before and after the wear tests with a Alpha SM RT-70 profilometer; the roughness trend of the teeth surface has then been obtained. To guarantee the correspondence of the same profile measurement before and after each tests, a dedicated device has been realized (see Figure 1b); in this way a perfect parallelism of the specimen axis has been obtained respect to the support plane of the profilometer touch probe.

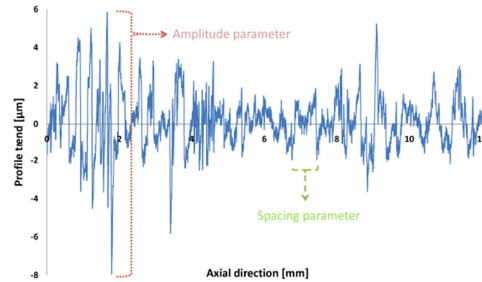
Fig. 2. profile trend of a crowned tooth.

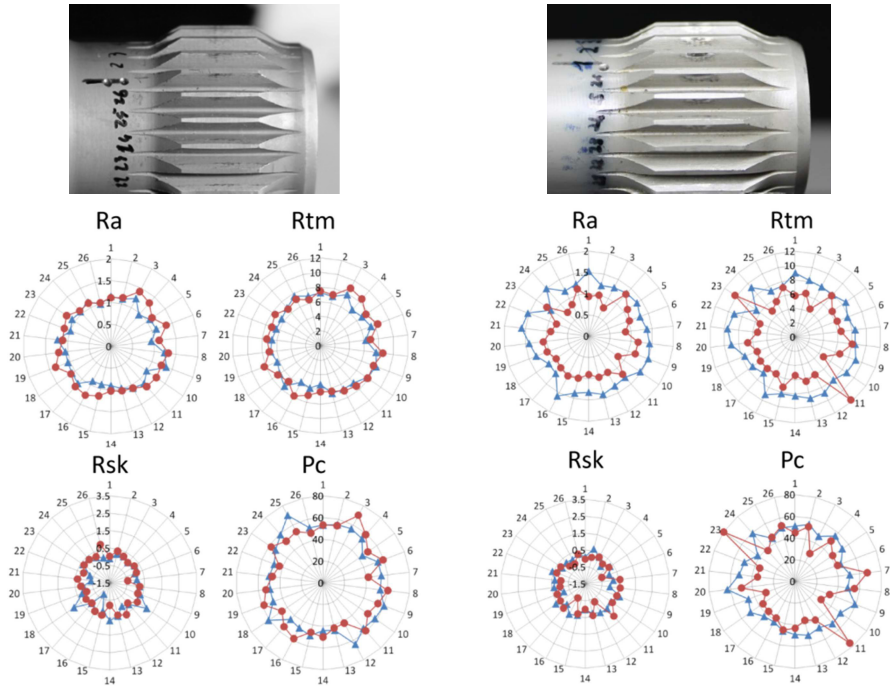
Fig. 4. roughness parameters (R_a , R_{tm} , R_{sk} , P_c) for test MB1 (left) and MB2 (right).

To compare the roughness values before and after each test, all roughness parameters have been represented by a polar graph. The quadrant of the graph has been divided into 26 parts corresponding to each tooth of the specimen; the roughness parameter values before (pre test) and after (post test) wear tests may be seen on the corresponding radius. In the following, for sake of brevity, only the most representative parameter between the above considered parameter are considered. In particular R_a , R_{tm} , R_{sk} , and P_c have been chosen to represent the wear damage because they shown the most significant variation before and after the tests.

Figures 4-7 show R_a , R_{tm} , R_{sk} and P_c in polar graphs together with the corresponding specimen image respectively for tests MB1 and MB2 (Figure 4), MB3 and MB5 (Figure 5), MB6 and MB7 (Figure 6), MB8 and MB9 (Figure 7).

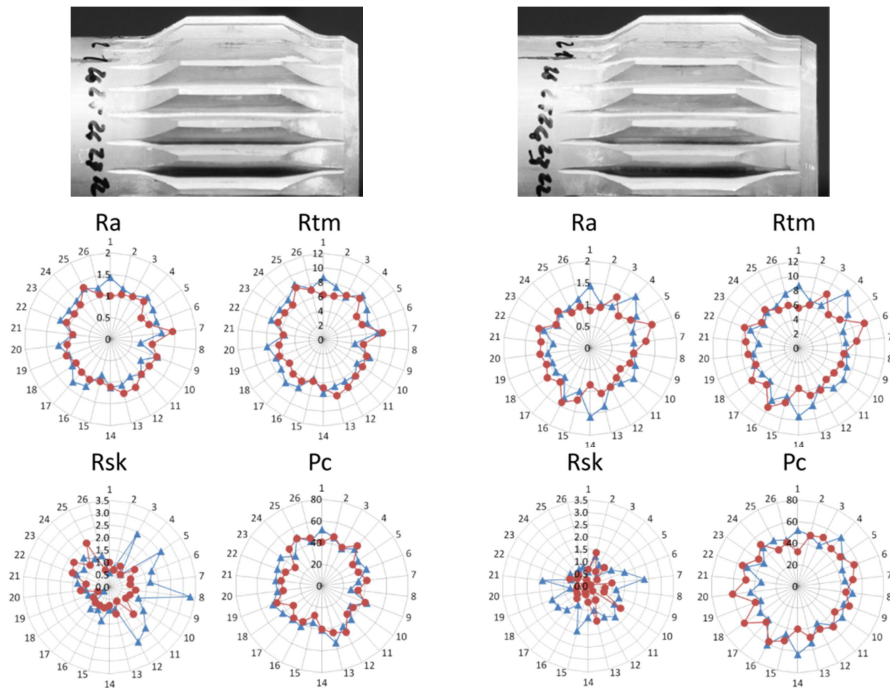
Fig. 5. roughness parameters (R_a , R_{tm} , R_{sk} , P_c) for test MB3 (left) and MB5 (right).

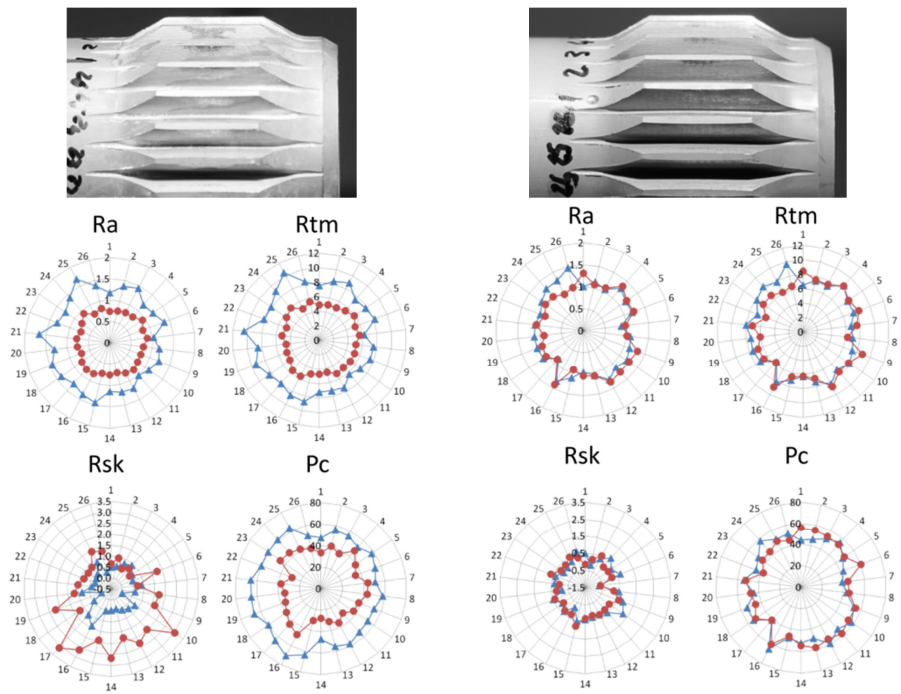
Fig. 6. roughness parameters (R_a , R_{tm} , R_{sk} , P_c) for test MB6 (left) and MB7 (right).

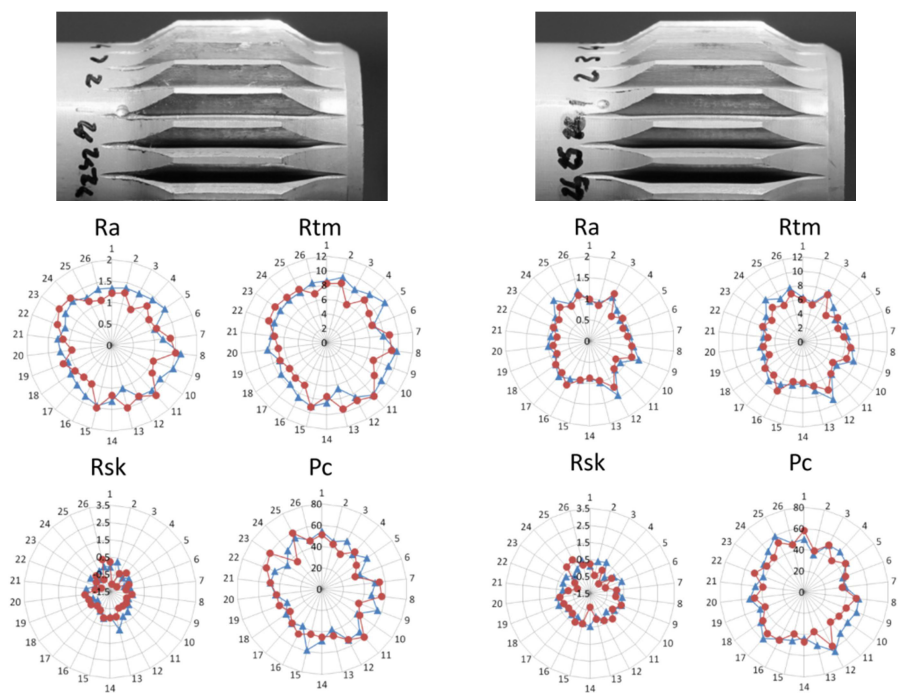
Fig. 7. roughness parameters (R_a , R_{tm} , R_{sk} , P_c) for test MB8 (left) and MB9 (right).

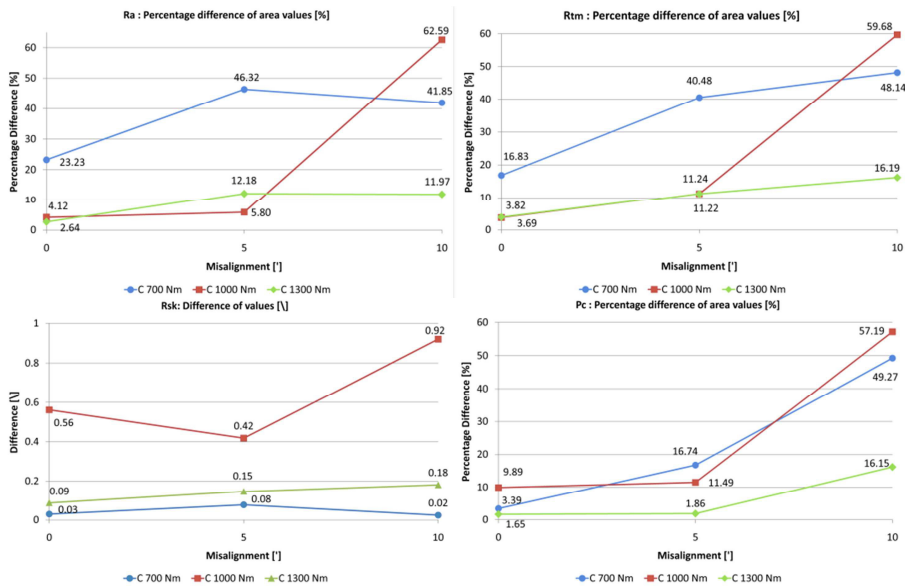
Figure 8 represents the trend of the roughness parameters for varying both misalignment angle and applied torque.

Fig. 8. effect of the applied torque on mean roughness area variation ($\alpha = 0', 5' \text{ and } 10'$).

In particular, diagrams of Figure 8 show that all the chosen roughness parameters are able to emphasize the fretting damage phenomenon, above all on the basis of the different testing conditions, although to a different amount.

Particularly, the most relevant surface damage is shown in the tests where the maximum misalignment angle (corresponding to the maximum surfaces sliding) and 1000Nm torque have been applied.

This unexpected phenomenon related to the tests done with 1300Nm is due to the fact that, for this torque value, the splined couplings material exceeds its upper yield point; in this condition the number of peaks decreases due to the high stresses of the teeth in contact.
