*Ministry of Transport
Republic of Tajikistan*

PAVEMENT INSPECTION GUIDELINE

Japan International Cooperation Agency

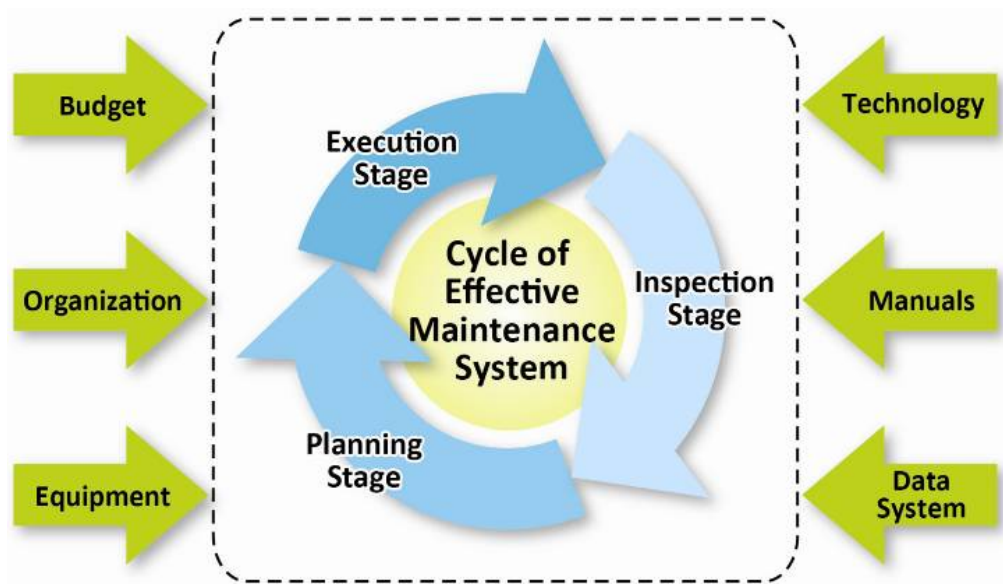
Figure 1 Road Maintenance Cycle

The systematic maintenance with regular inspection preventive repair is effective to enhance the life period of the pavement (Figure 1). This cycle contributes to minimize the maintenance work load as well as maintenance cost.

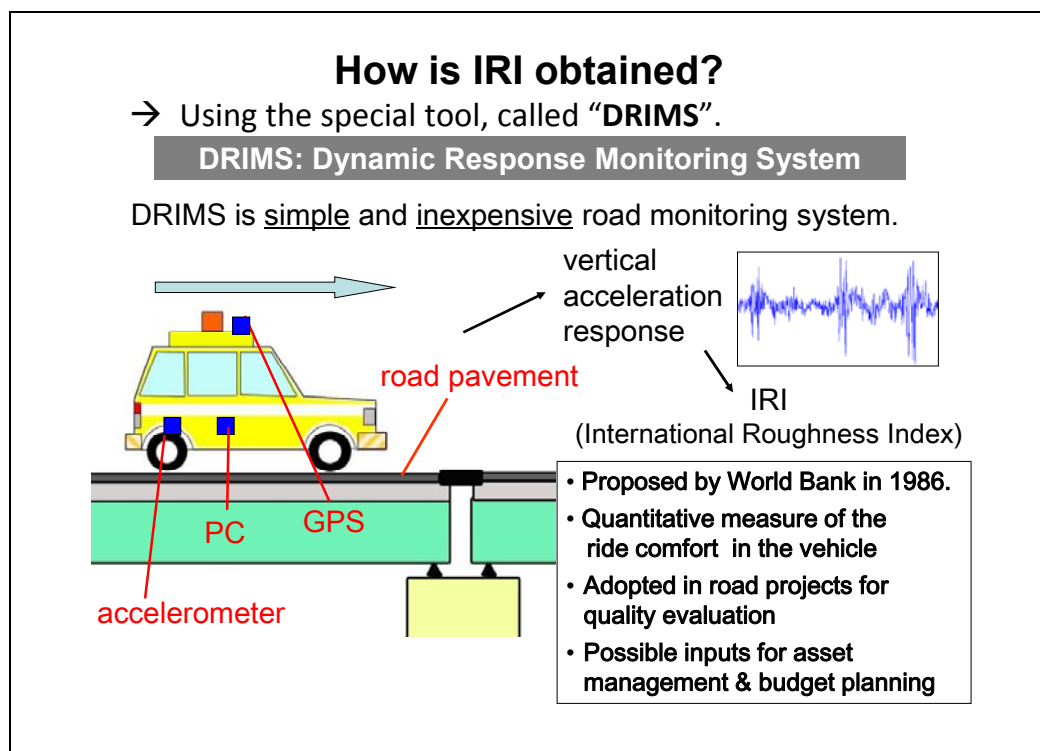
Figure 5 General Outline on IRI Measurement

IRI can be measured by using specific tools called DRIMS (Dynamic Response Intelligent System) as described in Figure 5. For detailed information to operate DRIMS, refer to ***Attachment-1 DRIMS Operation Guideline***.

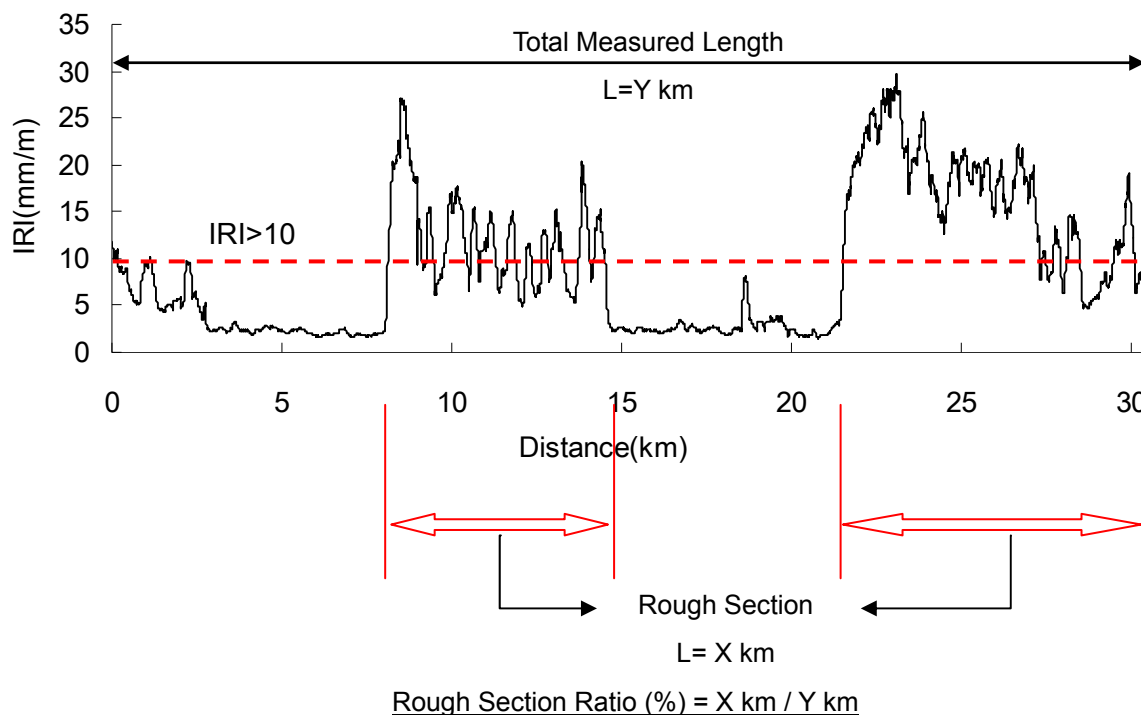
Figure 6 Rough Section

Once IRI is obtained, smoothness of the pavement can be evaluated by average IRI and an index called Rough Section. Rough Section is defined as below.

Average IRI	Average of IRI to total length
Rough Section Ratio (%)	The percentage of Rough Section Length to measured road. *Rough Section is defined as the length of which IRI is 10 or more.

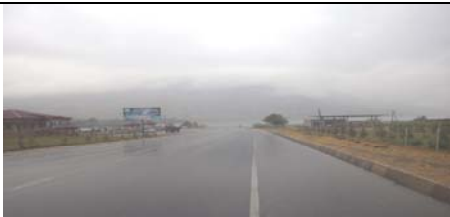
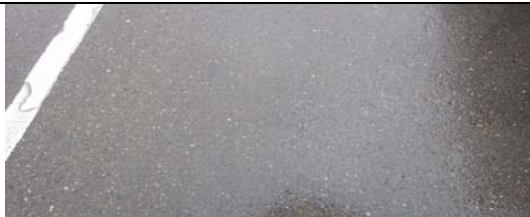
IRI	Typical Photograph	
	General	Detail
0~3

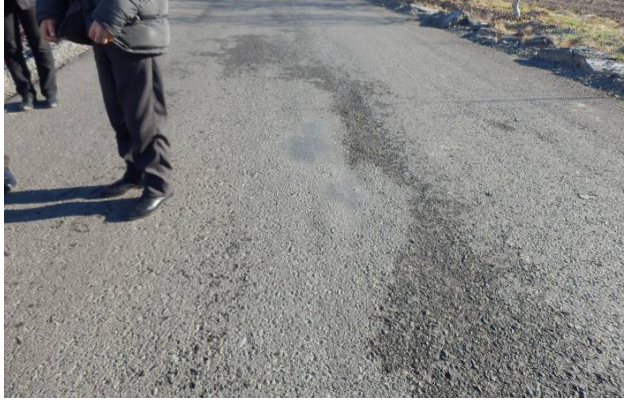
Crack Rate	Condition	Photo
0%	<p>New Pavement</p>

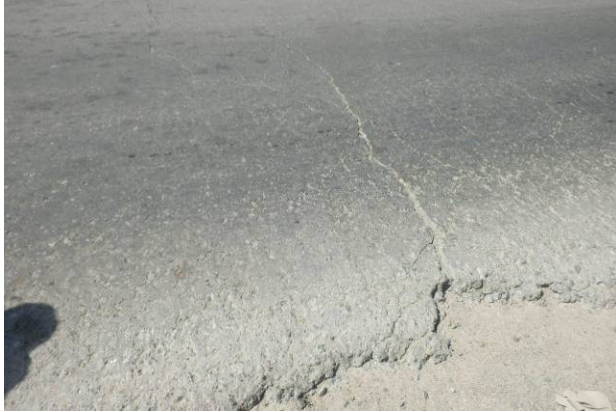
1% to 50%	<p>Partial Crack</p> <ul style="list-style-type: none"> ◆ Longitudinal Cracks ◆ Traverse Cracks

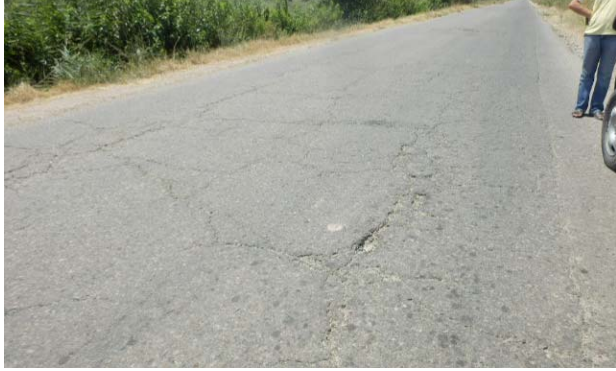
50% to 70%	<p>Jointed partial Crack</p> <ul style="list-style-type: none"> ◆ Longitudinal crack and traverse crack joint and covers all surface

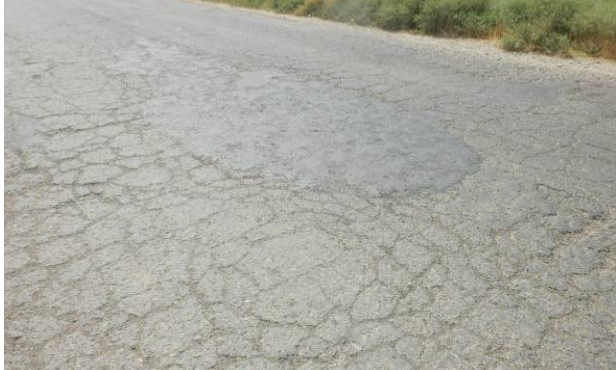
70% to 100%	<p>Dense Agitator Cracks</p> <ul style="list-style-type: none"> ◆ Agitator crack smaller than 0.5x0.5m covers whole surface

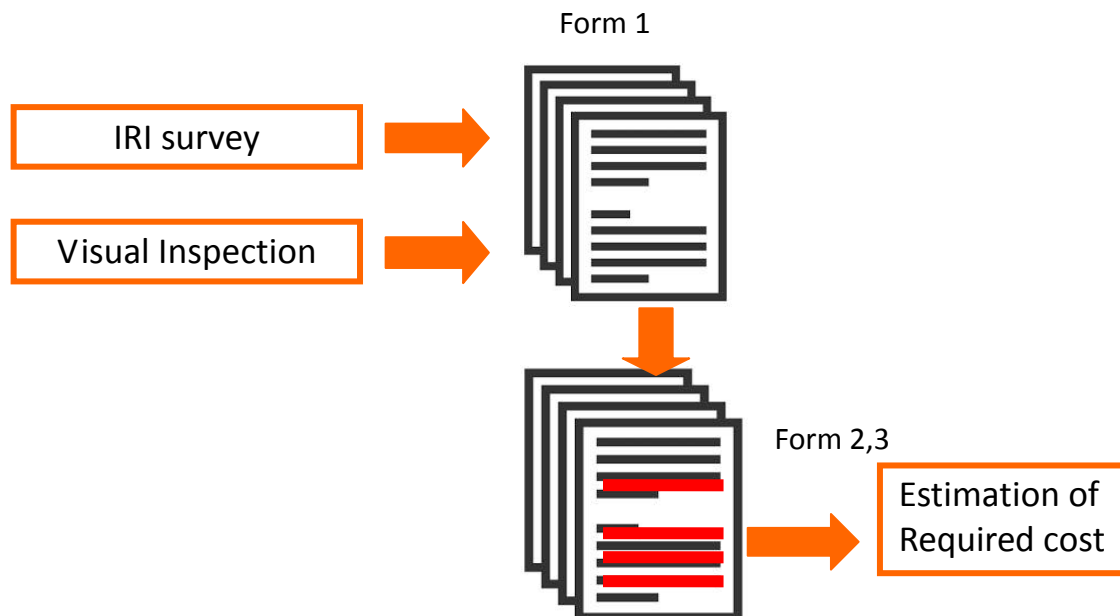
Figure 10 Update of Form 1

Form 1 is the basic information of present pavement condition. Form 1 shall annually be prepared by conducting of IRI survey and visual inspection in spring (April to May). However, the Form 1 should be updated regularly when the road maintenance engineer finds out any changes on the pavement such as newly-occurred defects or maintained sections. Keeping such record is the 1st duty of the maintenance engineer.

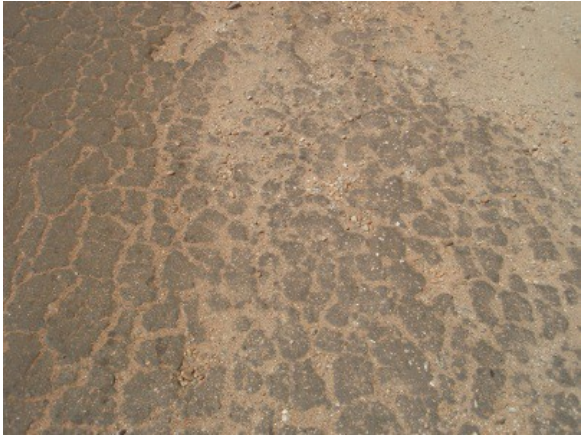
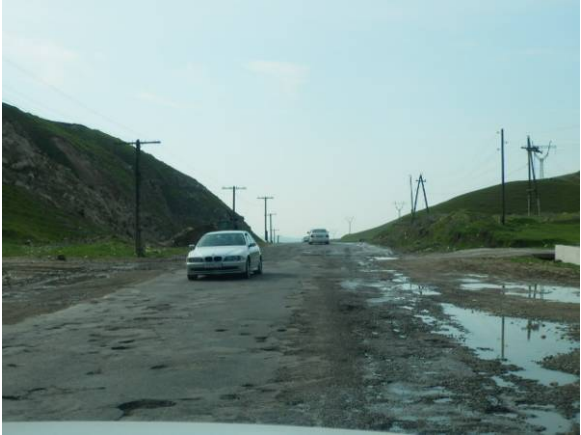
DEFINITION OF DEFECT		Urgency: Very High	
Item: Paved Roads (Bitumen)	Sub-Item: Surface	Defect: Alligator Cracking	
<p><u>Alligator Cracking</u> Alligator cracking is a series of interconnecting cracks creating interconnected patterns. The cracks start at the bottom of asphalt surface and propagate to the surface, initially as one or more longitudinal parallel cracks. After repeated traffic loading, the cracks interconnect, forming many - sided, sharp angled pieces that resemble chicken wire or the skin of an alligator. Alligator Cracking occurs normally only in areas subjected to repeated traffic loading, such as wheel paths.</p>			
<div style="display: flex; justify-content: space-around;">

</div>			
<p>Possible Causes: <u>Alligator Cracking</u></p> <ul style="list-style-type: none"> ● Inadequate pavement thickness. ● Low modulus base. ● Brittle base or wearing course (e.g. cemented aged). ● Fatigue failure of asphalt pavement due to repeated traffic loading.

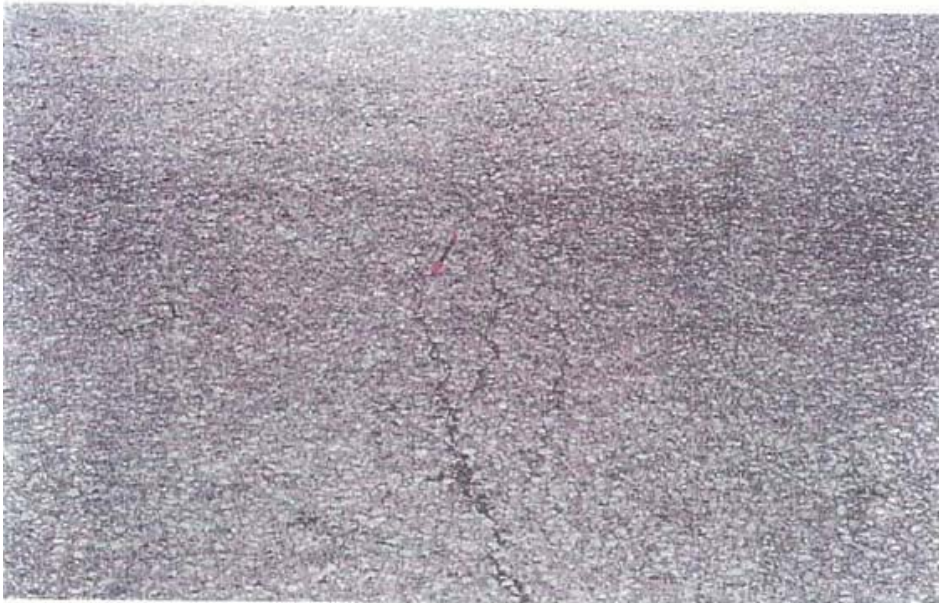
DEFINITION OF DEFECT		Urgency: Small
Item: Paved Roads (Bitumen)	Sub-Item: Surface	Defect: Transverse Cracking
<p><u>Transverse Cracking</u> Transverse cracks run perpendicular to the direction of traffic flow. Transverse cracks can start at the curb or shoulder, be contained in only one lane, or extend completely across the roadway. These cracks can also start in the middle of a lane or at the centerline.</p>

<p>Possible Causes:</p> <ul style="list-style-type: none"> • Reflection of shrinkage crack or joint in underlying base(common with Portland cement concrete or cemented materials). • Construction joint or shrinkage crack (due to low temperatures or bitumen hardening) in asphalt surfacing. • Structural failure of Portland cement concrete base. 		
<p><u>Effect (if neglected):</u></p> <ul style="list-style-type: none"> • Allows water to enter the pavement causing softening and weakening of the pavement and layers. • This may cause early failure of the pavement. • If severe, cause uneven ride for the motorist and may reduce traffic speed.

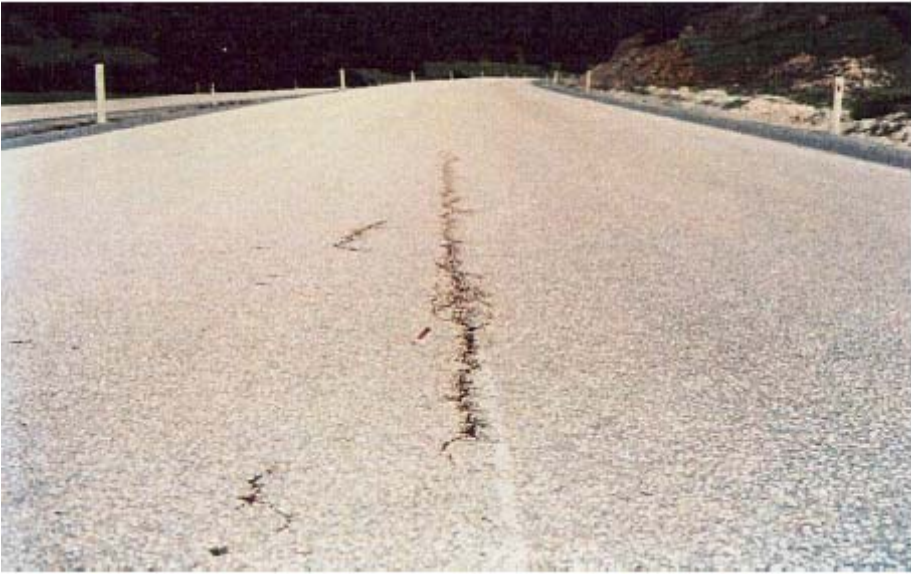
DEFINITION OF DEFECT		Urgency : Small
Item: Paved Roads (Bitumen)	Sub-Item: Surface	Defect: Longitudinal Cracking
<p><u>Longitudinal Cracking</u> Longitudinal cracks occur parallel to the direction of traffic flow. Longitudinal cracks can occur along the centerline, in mid - lane, in the wheel tracks and along the edge. Cracks can be relatively short in length or run the entire length of a pavement section.</p>

<p><u>Longitudinal Cracking</u></p> <p>Reflection of shrinkage crack or joint in underlying base (common with Portland cement)</p> <ul style="list-style-type: none"> ● Concrete, cemented base of asphalt surfacing. ● Poorly constructed paving lane joint in asphalt surfacing. ● Daily temperatures cycle or asphalt hardening. 		
<p><u>Effect (if neglected):</u></p> <ul style="list-style-type: none"> ● Allows water to enter the pavement causing softening and weakening of the pavement and layers. ● This may cause early failure of the pavement. ● If severe, cause uneven ride for the motorist and may reduce traffic speed.

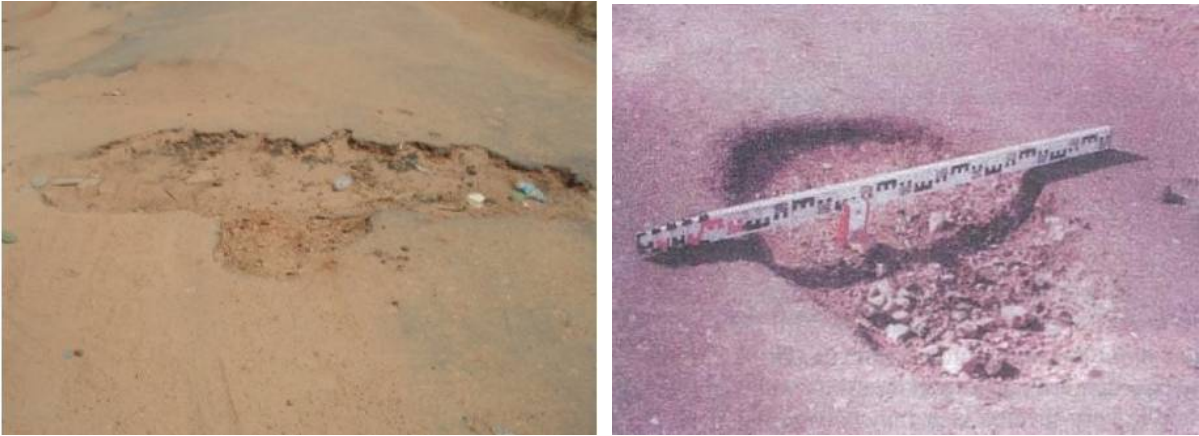
DEFINITION OF DEFECT		Urgency: High
Item: Paved Roads (Bitumen)	Sub-Item: Surface	Defect: Pothole
<p><u>Pothole</u> A defect on the surface of the paved (bitumen) roads. Potholes are small bowl –shaped depressions on the pavement surface/base course, usually less than one meter in diameter. They generally have sharp edges and vertical sides near the top of the hole. Their growth is accelerated by free water collecting inside the hole. Potholes are reproduced when traffic abrades small pieces of pavement surface. The pavement then continues to disintegrate because of poor surface quality, weak spots in the base or sub grade, or because of severe alligator cracking. Most potholes are due to structurally related distress, and should not be confused with raveling and weathering. When holes are created by high-severity alligator cracking, they should be identified as potholes.</p>

<p><u>Possible Causes: Pothole</u></p> <ul style="list-style-type: none"> • Asphalt content too low, • Excessive heating of asphalt, • Poor quality mixtures, • Lack of compaction allowing ingress of water. • Excessive axle loads, • Mechanical damage to the road due to poor reinstatement of roads after services installations, • Injury to pavement, • Spills or leakages.

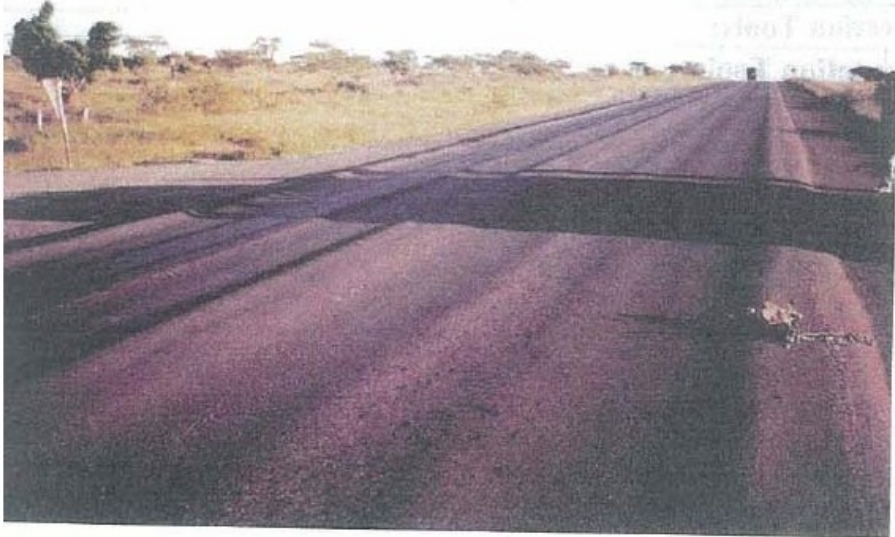
DEFINITION OF DEFECT		Urgency: High
Item: Paved Roads (Bitumen)	Sub-Item: Surface	Defect: Rutting/Deformation
<p><u>Rutting/Deformation</u> Rutting is characterized by longitudinal depressions in the pavement surface that occur in the wheel paths of a roadway.</p>

<p>Possible Causes:</p> <ul style="list-style-type: none"> • Inadequate pavement thickness, • Inadequate compaction in surfacing or base, • Inadequate strength (stability) in surfacing or base, • Excessive bitumen in mix, • Excessive axle loads. 		
<p><u>Effect (if neglected):</u></p> <ul style="list-style-type: none"> • If water is able to penetrate into the body of the pavement, there will be a rapid increase in the degree of rutting, which often leads to cracking and the breaking up of the pavement, if excessive, can reduce serviceability and reduce vehicle travel speeds and in very severe cases, may be an accident risk.

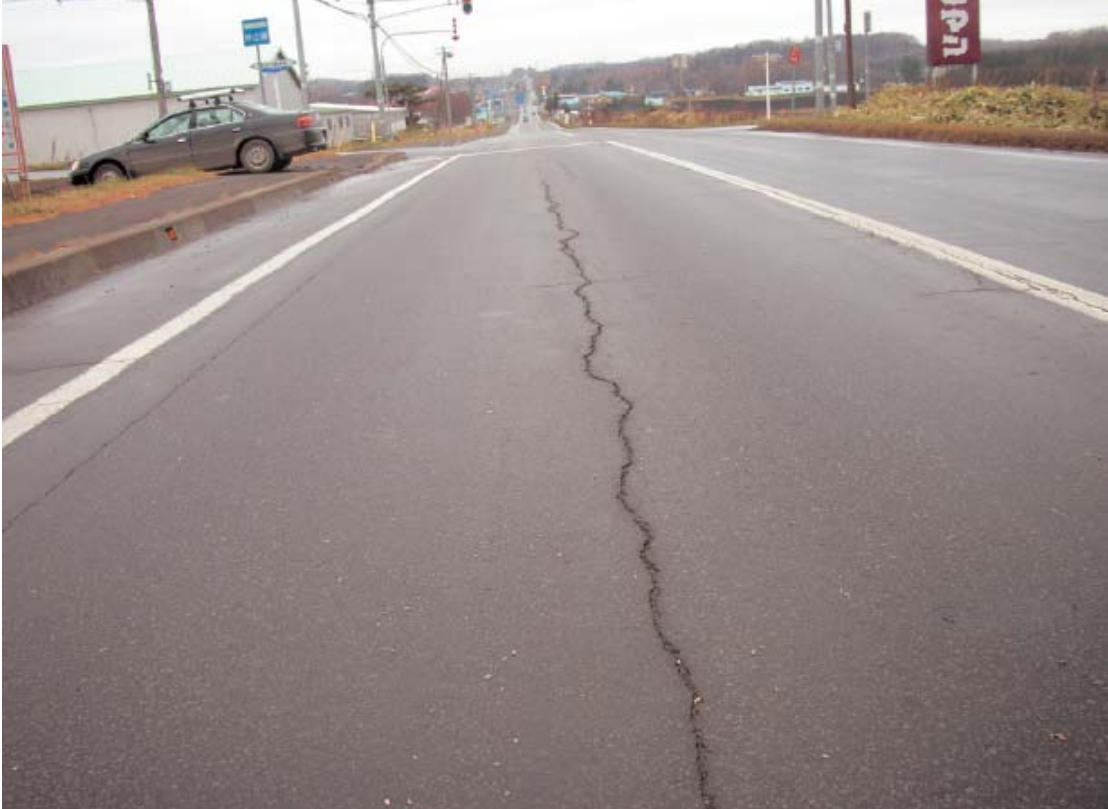
DEFINITION OF DEFECT		Urgency : High
Item: Paved Roads (Bitumen)	Sub-Item: Surface	Defect: Frost Heaving
<p><u>Frost Heaving</u></p> <ul style="list-style-type: none"> ◆ Frost heaving is characterized by longitudinal depressions in the pavement surface. ◆ Asphalt surface is more strongly cooled than other natural surface especially when snow is removed from the surface. ◆ The deflection is caused by the ice lens in the soil.

<p>Possible Causes:</p> <ul style="list-style-type: none"> ● High ground water level ● Water contents in the base course or road bed frozen and push pavement surface which caused surface deflection. ● Loss of the bearing force by melting ice in the pavement ● High water contents in the base course 		
<p><u>Effect (if neglected):</u></p> <ul style="list-style-type: none"> ● Surface deflection ● Loss of bearing force of the pavement ● Destruction of the pavement

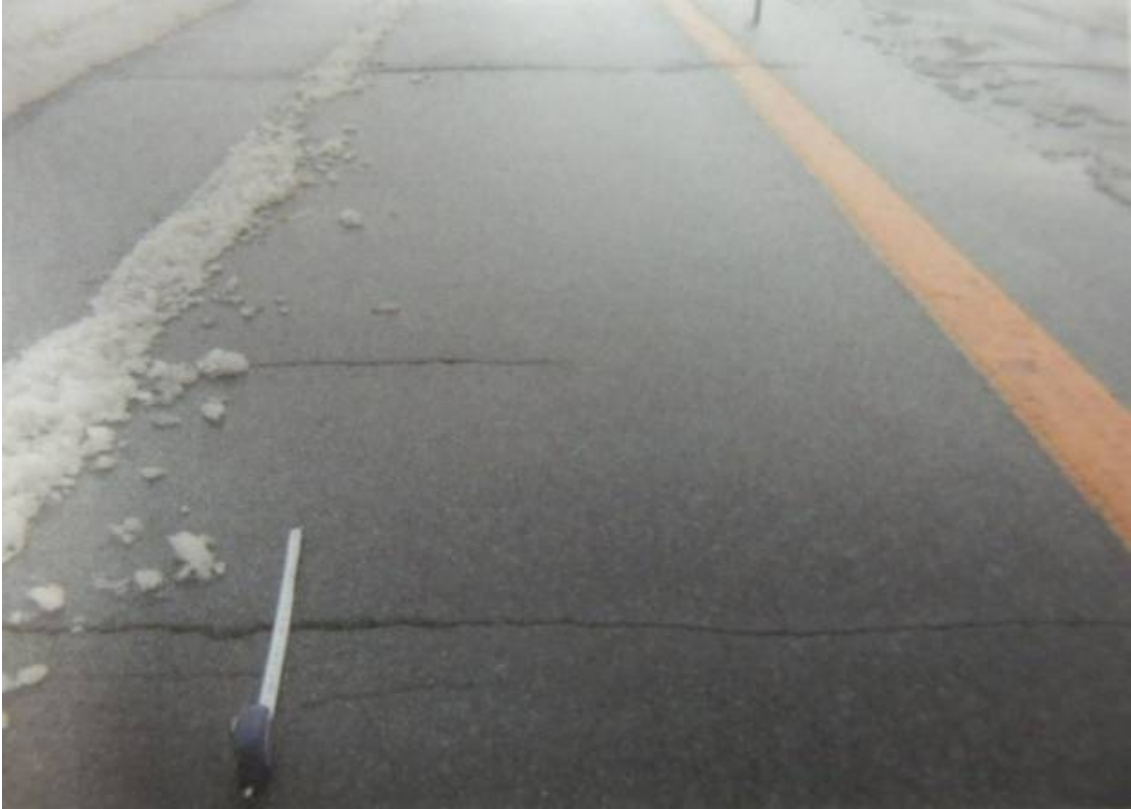
DEFINITION OF DEFECT		Urgency : Low
Item: Paved Roads (Bitumen)	Sub-Item: Surface	Defect: Thermal Crack/ Low Temperature Crack
<p><u>Thermal Crack/ Low Temperature Crack</u></p> <ul style="list-style-type: none"> ◆ Cracks caused by shrinkage of the asphalt mixture by low temperature. It is observed in the cold weather area. ◆ Traverse crack at the equal interval of 10m to 20m is observed.

<p>Possible Causes:</p> <ul style="list-style-type: none"> ● Shrinkage of the asphalt mixture by low Temperature ● Insufficient pavement thickness 		
<p><u>Effect (if neglected):</u></p> <ul style="list-style-type: none"> ● This crack is normally limited only surface course but required treatment such as sealing of the crack to avoid penetration of water. ● Monitoring regular inspection is recommended. 		
<p><u>Inspection Method:</u></p> <ul style="list-style-type: none"> ● Visual Inspection 		
<p><u>Inspection Tools:</u></p> <ul style="list-style-type: none"> ● Visual Inspection ● Camera.

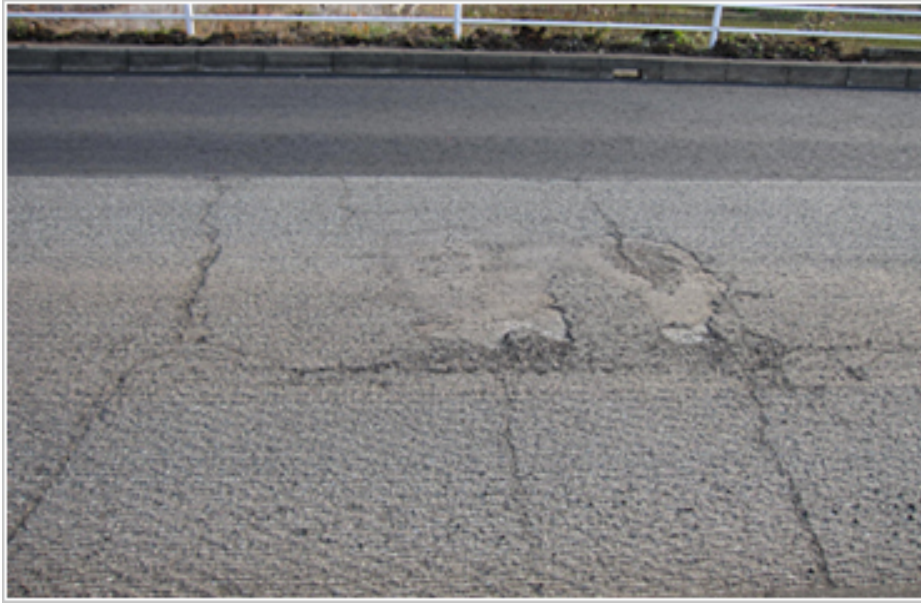
DEFINITION OF DEFECT		Urgency: Middle
Item: Paved Roads (Bitumen)	Sub-Item: Surface	Defect: Reflection Crack
<p><u>Reflection Crack</u></p> <ul style="list-style-type: none"> ◆ Crack due to existing crack of the under layer structure of the pavement such as joint of base course, crack of the cement stabilized course etc., ◆ Crack of the asphalt pavement which is paved over the old concrete pavement. Cracks of under layed concrete pavement cause the cracks ◆ Cracks found on the overlay pavement which is constructed on the surface without sufficient remedy of the defects such as potholes.

<p>Possible Causes:</p> <ul style="list-style-type: none"> ● Crack of underneath layer ● Possible by underground structures (pipe culvert etc.,) 		
<p><u>Effect (if neglected):</u></p> <ul style="list-style-type: none"> ● Crack expand to larger defects such as pothole 		
<p><u>Inspection Method:</u></p> <ul style="list-style-type: none"> ● Visual Inspection

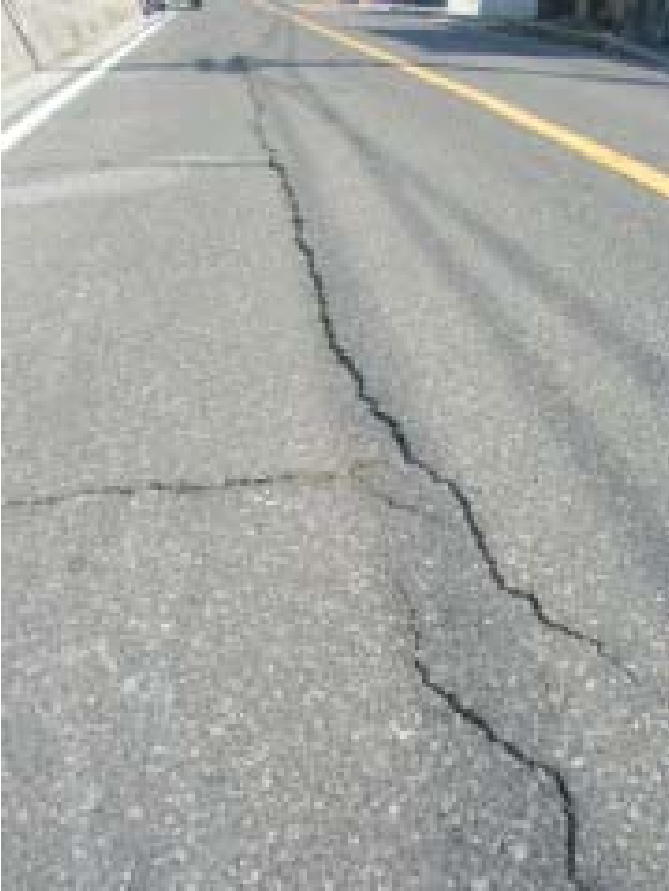
DEFINITION OF DEFECT		Urgency : High
Item: Paved Roads (Bitumen)	Sub-Item: Surface	Defect: Uneven settlement
<p><u>Uneven Settlement</u></p> <ul style="list-style-type: none"> ◆ Normally longitudinal crack along the road at the border of embankment and cut cause of settlement of embankment. ◆ Also observed at the concret structure due to unsifficient compaction.

<p>Possible Causes:</p> <ul style="list-style-type: none"> • Difference of bearing force between cut and embankment • Insufficient compaction at small area • Loss of bearing force by penetrating of rain water into base course • Consolidation 		
<p><u>Effect (if neglected):</u></p> <ul style="list-style-type: none"> • Possible to cause large scale slope failure 		
<p><u>Inspection Method:</u></p> <ul style="list-style-type: none"> ● Visual Inspection 		
<p><u>Inspection Tools:</u></p> <ul style="list-style-type: none"> ● Visual Inspection ● Camera.

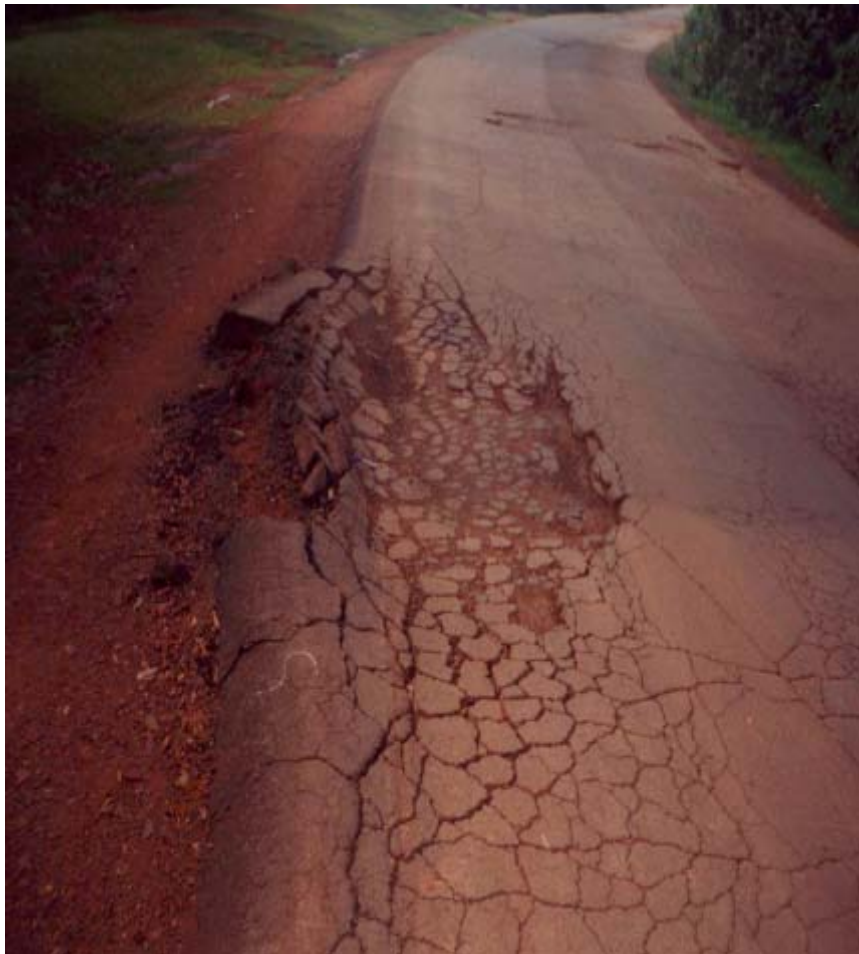
DEFINITION OF DEFECT		Urgency: Very High
Item: Paved Roads (Bitumen)	Sub-Item: Surface	Defect: Heaving/ Shoving
<p><u>Heaving/ Shoving</u> Usually heaving/shoving occurs on either side of the wheel tracks. The irregularities are associated with deformation and subsidence.</p>

<p><u>Possible Cause</u></p> <ul style="list-style-type: none"> • Ingress of water: reduced bearing capacity of the pavement. • Materials: of poor quality. • Workmanship: insufficient compaction. • Traffic: passage of vehicles which are too heavy for the pavement structure 		
<p><u>Effect (if neglected):</u></p> <ul style="list-style-type: none"> • Forcing up of weak materials as deformation occurs. • Progressive disintegration of the pavement. 		
<p><u>Inspection Method:</u></p> <ul style="list-style-type: none"> ● Scaling of length. 		
<p><u>Inspection Tools:</u></p> <ul style="list-style-type: none"> ● Tape, ● Camera

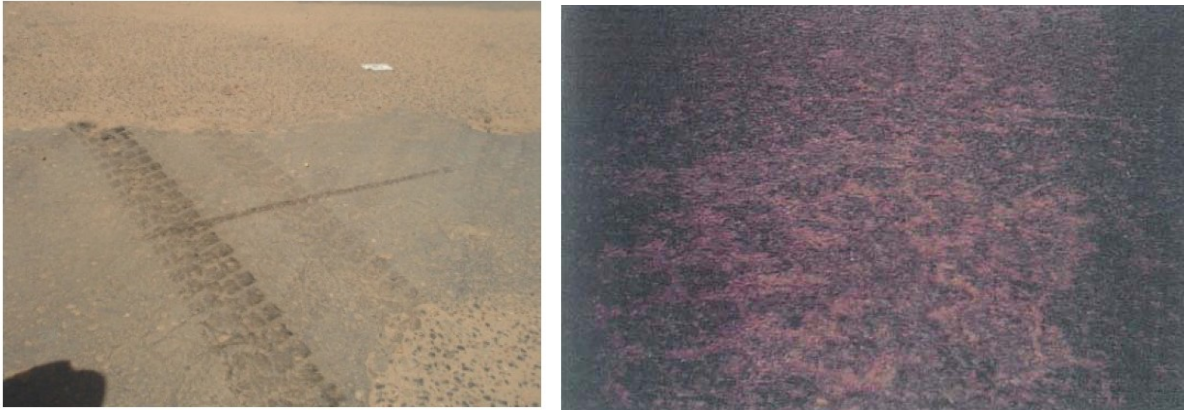
DEFINITION OF DEFECT		Urgency : Low
Item: Paved Roads (Bitumen)	Sub-Item: Surface	Defect: Stripping/fretting
<p><u>Stripping/fretting</u> Stripping/fretting is the wearing away of the pavement surface caused by the dislodging of aggregate particle and loss of asphalt binder. This generally indicates that the asphalt binder has hardened significantly. Loss of coarse aggregate of a sprayed seal that leaves the binder exposed to tire contact can happen bit by bit, or over a localized area.</p>

<p><u>Possible Cause</u></p> <ul style="list-style-type: none"> ● Low binder content, ● Poor binder to stone adhesion (dirty aggregate, ineffective pre - coating with adhesion agent or wet stone, ● Ageing or absorption of binder, ● Stone deterioration, ● Inadequate rolling before opening of seal to traffic, ● I incorrect bleeding of binder, ● Poor workmanship. 		
<p><u>Effect (if neglected):</u></p> <ul style="list-style-type: none"> ● Progressive breaking away of chippings resulting in surfacing becoming more slippery and more permeable.

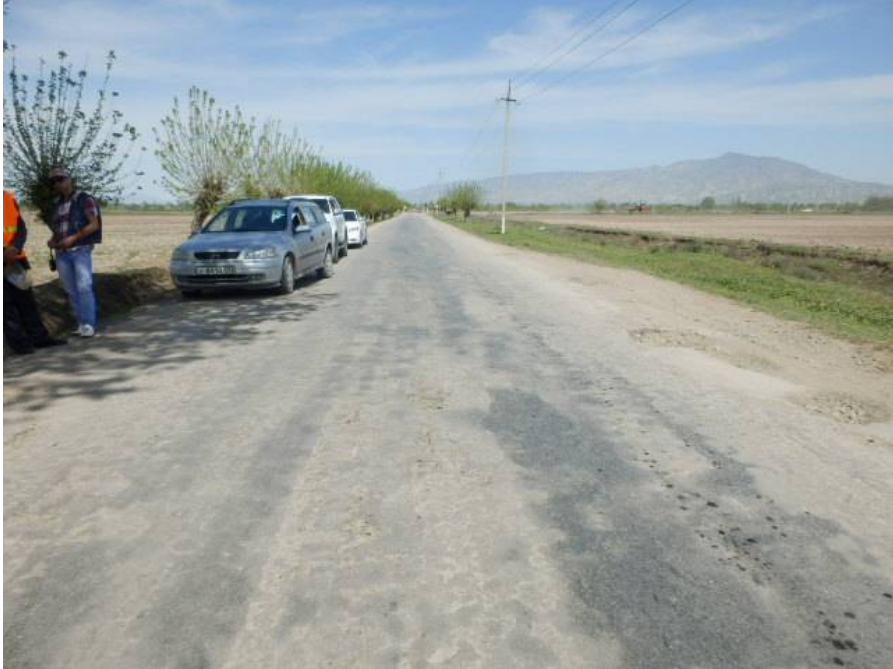
DEFINITION OF DEFECT		Urgency : Low
Item: Paved Roads (Bitumen)	Sub-Item: Surface	Defect: Bleeding
<p><u>Bleeding</u> Bleeding is a film of bituminous material that covers the pavement surface and which creates a shiny, glass like appearance. It occurs when asphalt fills the void of the mix during hot weather and then migrates to the pavement surface.</p>

<p><u>Possible Cause</u></p> <ul style="list-style-type: none"> • Excessive application of binder with respect to stone size. • Excessive prime coat incorporated into the seal • Excessive binder in underlying surface (patches or flushed area) • Prime seal covered before volatiles in primer binder evaporated. 		
<p><u>Effect (if neglected):</u></p> <ul style="list-style-type: none"> • Road surface becomes slippery and hazardous to traffic, • Separation and breaking away of surface layer due to traffic. 		
<p><u>Inspection Method:</u></p> <ul style="list-style-type: none"> ● Quantification of length.

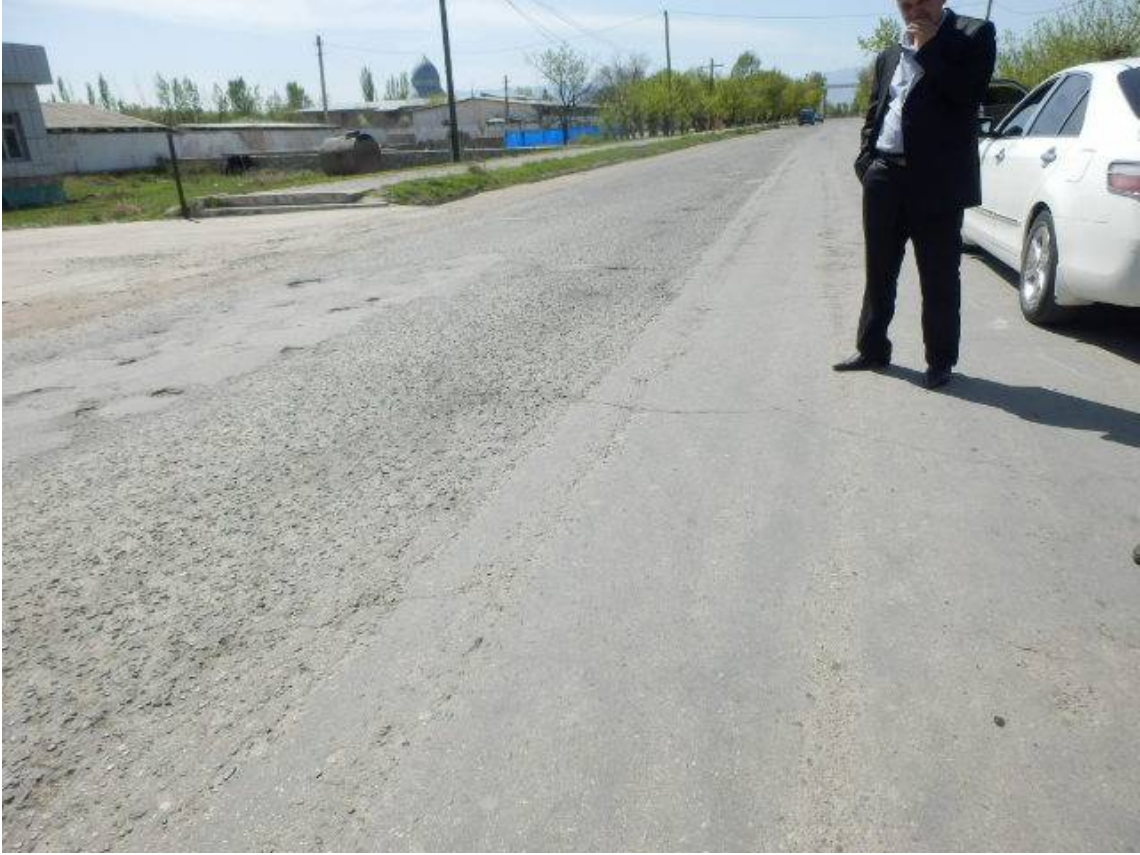
DEFINITION OF DEFECT		Urgency : Low
Item: Paved Roads (Bitumen)	Sub-Item: Surface	Defect: Polishing
<p><u>Polishing</u></p> <ul style="list-style-type: none"> ◆ The condition of the surface with loss of slip resistance due to coarse aggregate and mortal is polished by vehicle

<p>Possible Causes:</p> <ul style="list-style-type: none"> • Use of aggregate with insufficient flakiness • Excessive friction to the road surface by large vehicles (especially at curves) 		
<p><u>Effect (if neglected):</u></p> <ul style="list-style-type: none"> • Loss of slip resistance • Extend to pothole 		
<p><u>Inspection Method:</u></p> <ul style="list-style-type: none"> ● Visual Inspection 		
<p><u>Inspection Tools:</u></p> <ul style="list-style-type: none"> ● Visual Inspection ● Camera.

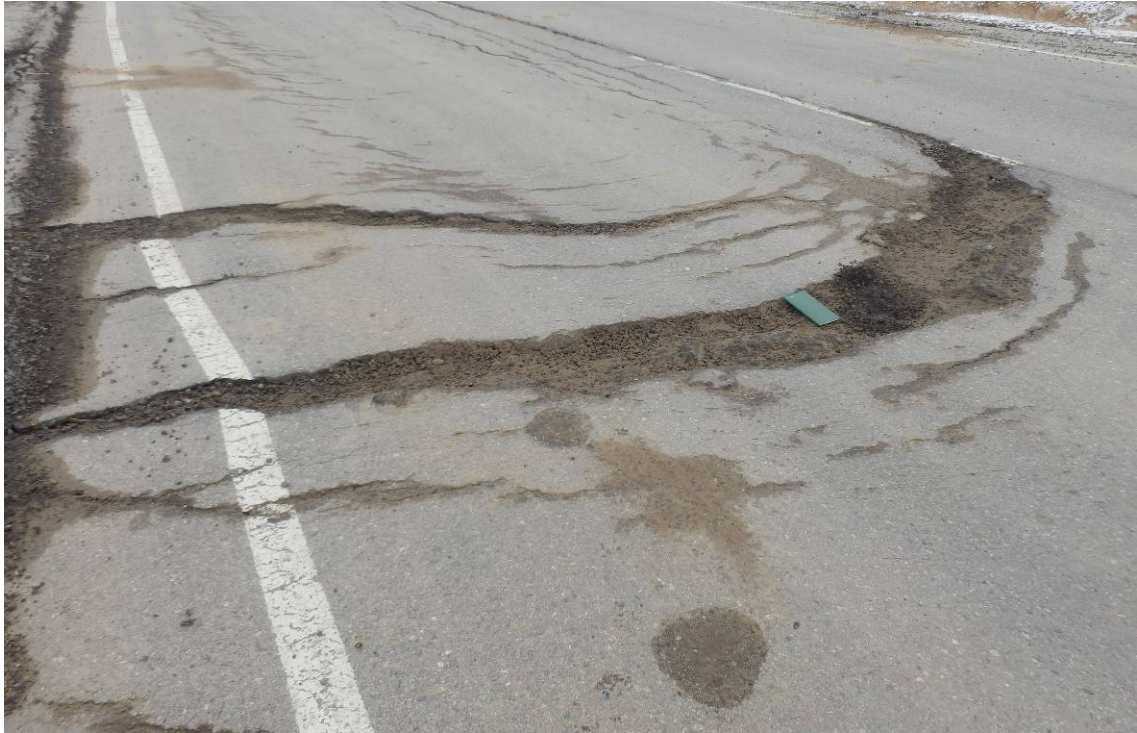
DEFINITION OF DEFECT		Urgency: High
Item: Paved Roads (Bitumen)	Sub-Item: Surface	Defect: Delaminate of binder, Slipping
<p><u>Delaminate of binder, Slipping</u></p> <p>◆ Surface course is delaminated due to the sharing stress between layers.</p>

<p>Possible Causes:</p> <ul style="list-style-type: none"> ● Insufficient joint between pavement layers. ● Water penetration into the pavement layers. ● Excessive tack coat or insufficient tack coat ● Excessive difference of the elasticity between layers. 		
<p><u>Effect (if neglected):</u></p> <ul style="list-style-type: none"> ◆ May grow rapidly to the large defect ◆ Large deflection of the surface 		
<p><u>Inspection Method:</u></p> <ul style="list-style-type: none"> ● Visual Inspection 		
<p><u>Inspection Tools:</u></p> <ul style="list-style-type: none"> ● Visual Inspection ● Camera.

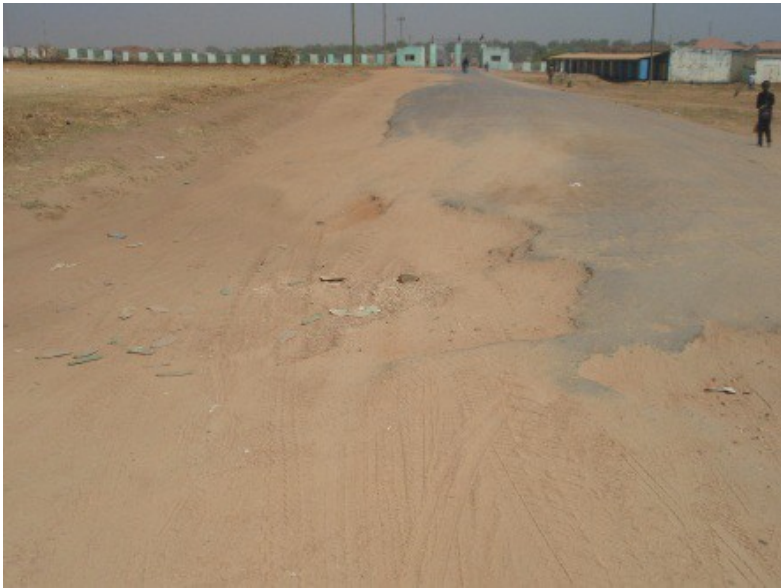
DEFINITION OF DEFECT		Urgency : Middle
Item: Paved Roads (Bitumen)	Sub-Item: Surface	Defect: Edge Damage
<p><u>Edge Damage</u> Edge damage is a difference in elevation between the pavement edge and the shoulder and occurs along the edge of the pavement.</p>

<p><u>Possible Cause</u></p> <ul style="list-style-type: none"> • Shoulder wears (formation of step), • Erosion by water, • Insufficient compaction at edges of bituminous pavement. • Road too narrow, • Excessive axle loads. 		
<p><u>Effect (if neglected):</u></p> <ul style="list-style-type: none"> • Rapid deterioration during rainy season, • Traffic will worsen defect. 		
<p><u>Inspection Method:</u></p> <ul style="list-style-type: none"> • Quantification of % of length and average depth. <p><u>Inspection Tools:</u></p> <ul style="list-style-type: none"> • Tape

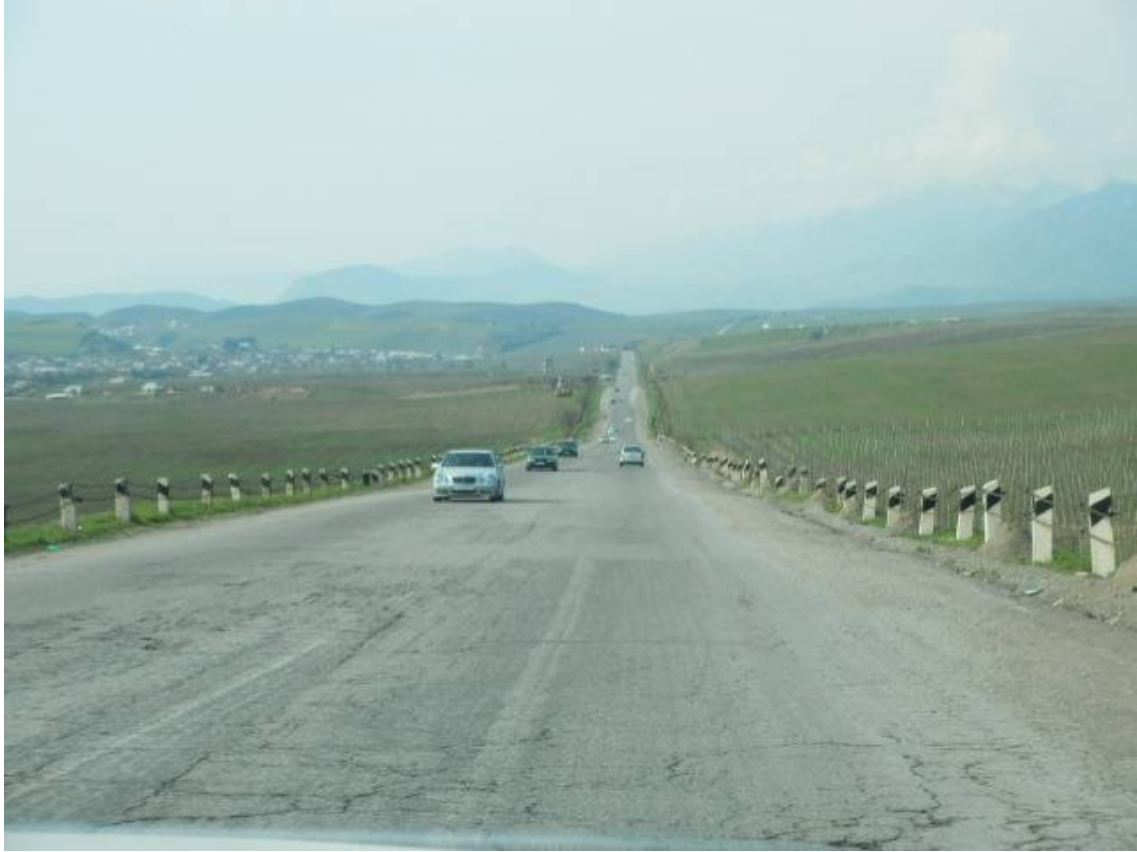
DEFINITION OF DEFECT		Urgency : Low
Item: Paved Roads (Bitumen)	Sub-Item: Surface	Defect: Waving
<p><u>Waving</u> Undulations in road surface of a wavelength longer than corrugations.</p>

<p><u>Possible Cause</u></p> <ul style="list-style-type: none"> • Poor quality material, • Variation in compaction and bearing capacity of lower layers, • Poor quality or lack of prime coat or tack coat, • Material not suited to temperature range. 		
<p><u>Effect (if neglected):</u></p> <ul style="list-style-type: none"> • In hot weather, surface stripping can occur, • Poor ride quality for motorists. 		
<p><u>Inspection Method:</u></p> <ul style="list-style-type: none"> • Defect ranking 		
<p><u>Inspection Tools:</u></p> <ul style="list-style-type: none"> • Nil

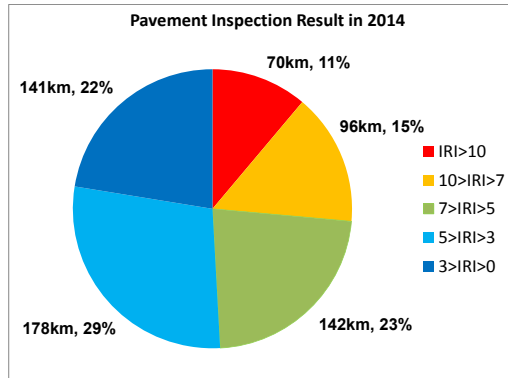
IRI MEASUREMENT RESULT 2014 IN GISSAR SETM

IRI Value	Road Condition	
3.0<	█	Excellent
3.0 to 4.99	█	Good
5.0 to 6.99	█	Fair
7.0 to 10.0	█	Poor
>10.0	█	Bad
NaN or white No.	█	Out of Speed Range

IRI>10	70km	11%
10>IRI>7	96km	15%
7>IRI>5	142km	23%
5>IRI>3	178km	28%
3>IRI>0	141km	22%
Total	627km	100%

Average IRI=6.1
