On the Radiation Damage of BTeV EMCAL Detector Unit¹

Hamamatsu photomultiplier tubes (PMT) and various PMT window materials were exposed to gamma irradiation. Tests were performed with absorbed doses of 1 krad and 120 krad. Initial recommendations on PMT types to use in the BTeV electromagnetic calorimeter are stated.

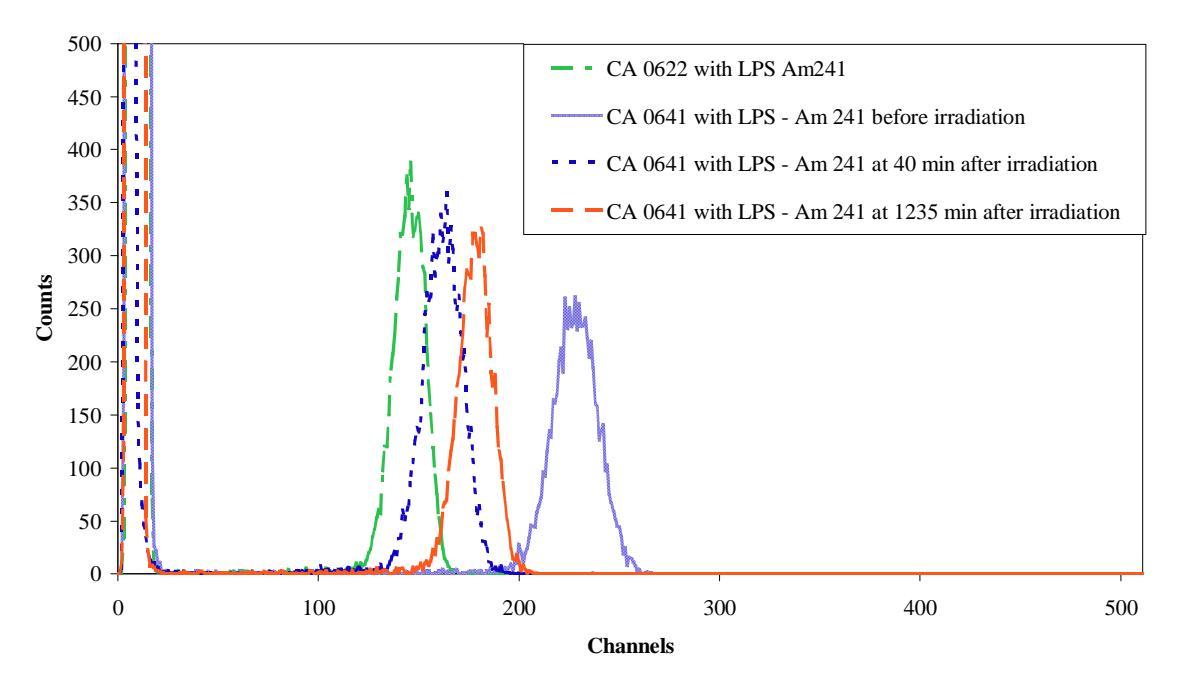
Fig. 1. Pulse height spectra measured with LPS. Since the pulse height spectra for CA 0622 (control sample) didn't change throughout the study we show only one distribution for clarity.

Examples of pulse-height spectra measured using LPS with both PMTs at the same high voltage before and after irradiation are shown in Fig. 1.

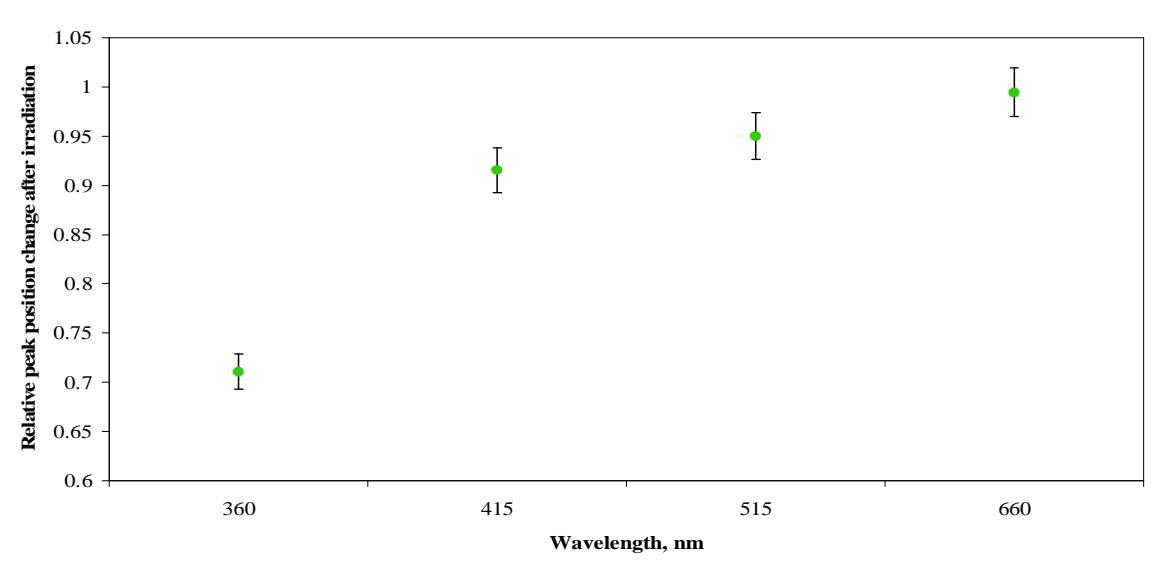
Fig. 2. Change of relative peak positions after R5800 PMT irradiation.

In Fig. 2 we have summarized relative changes of amplitudes of the signals produced by various light sources after irradiation. One can see here that R5800 PMT has the largest deterioration in ultraviolet range.

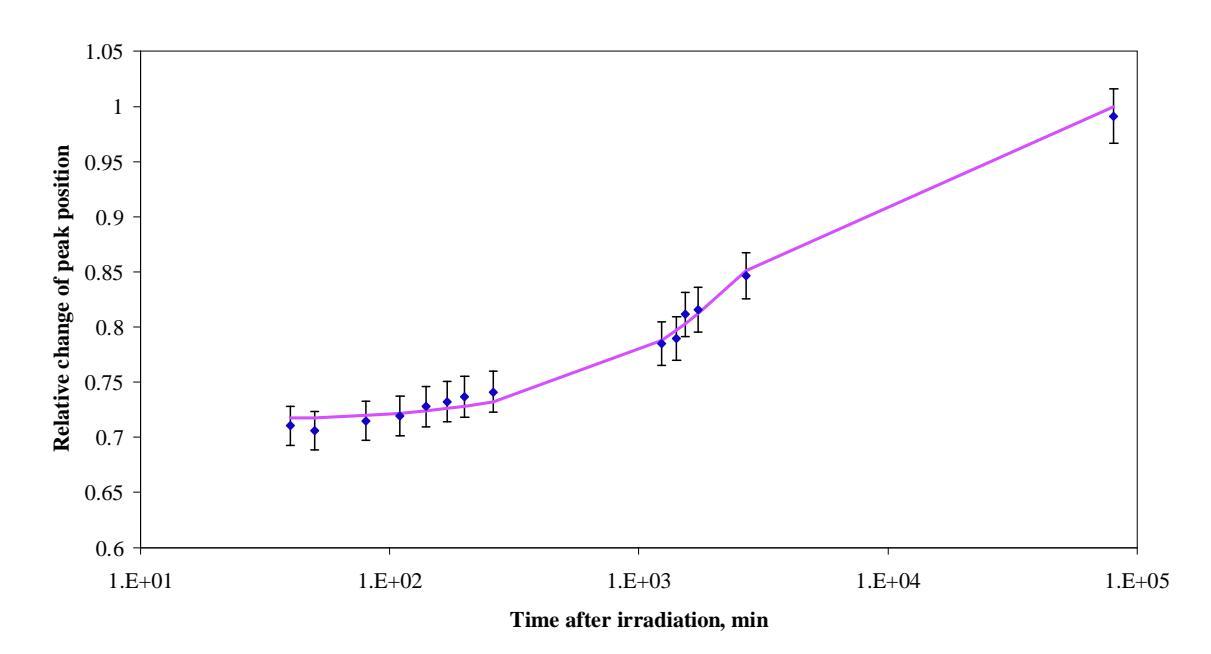
Fig. 3. Recovery of R5800 PMT at 360 nm measured by the change of the LPS peak position.

The PMT recovery at 360 nm is shown in Fig. 3. We estimate that the recovery time constant is not less than 250 hours. As R5800 PMT have reached full (>95%) recovery, we should conclude that applied doses do not produce irreversible damages with ⁶⁰Co irradiation of 120 krad.

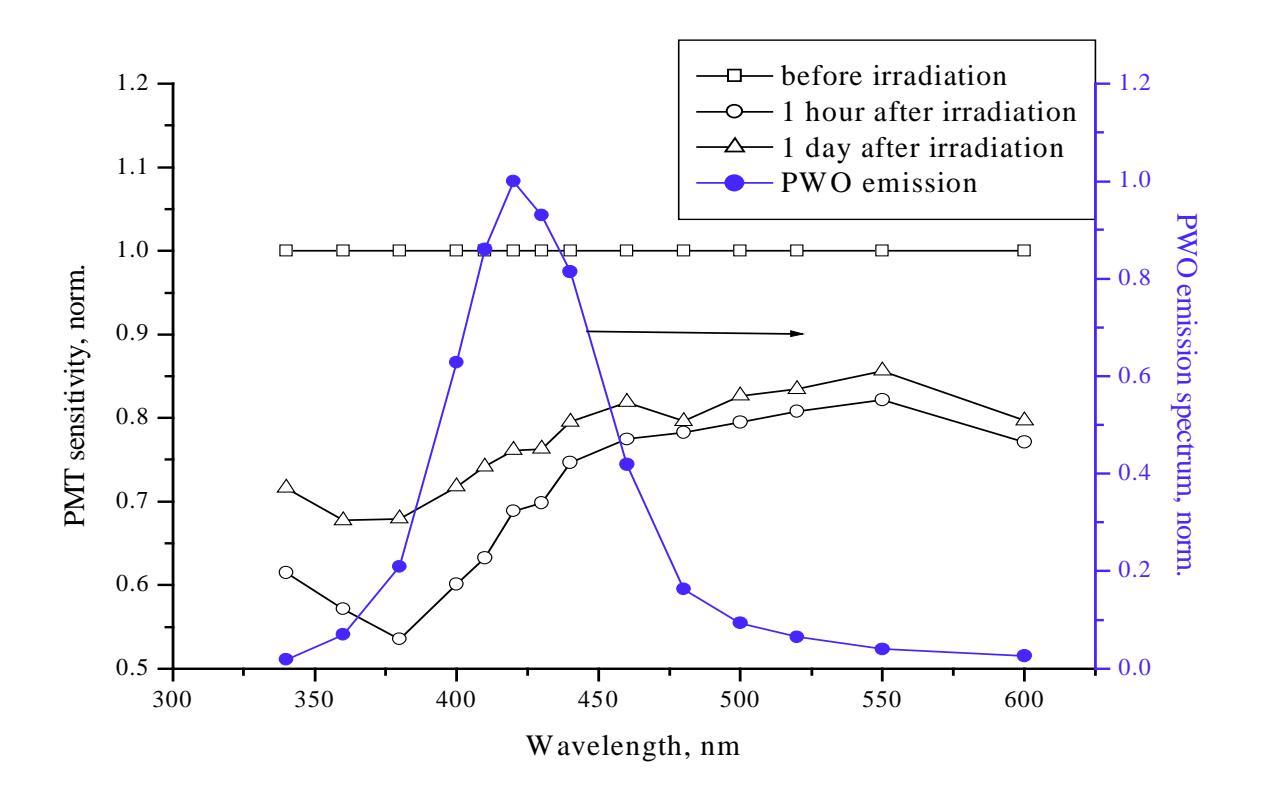
Fig. 4. PMT sensitivity spectra measured one hour after irradiation (open circles)/one day after irradiation (open triangles), and normalized by the spectrum measured before irradiation. Filled circles show the PWO emission spectrum.

emission spectrum is also shown. We can clearly see that PMT radiation-induced damage wavelength range overlaps to a great extent with the PWO emission band.

In order to estimate the net effect of the PMT deterioration on the PWO scintillation light detection, PMT sensitivity spectra were multiplied by PWO emission spectrum and then integrals over the wavelength were calculated. The values of these integrals are presented in Table 2. Since a loss of 30% in the light signal is not acceptable for BTeV, R5800 PMT or, generally, a PMT equipped with a borosilicate glass window cannot be used in the BTeV EMCAL.

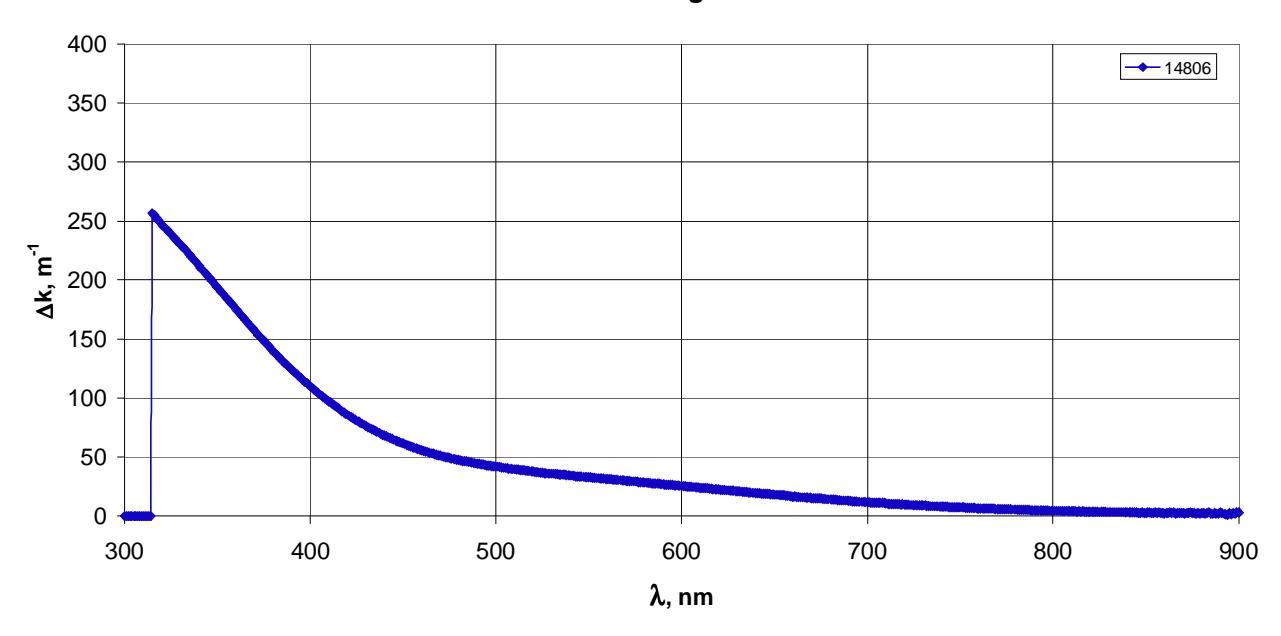
Fig. 5a Radiation-induced absorption of the Borosilicate glass sample after 120-krad irradiation

120 krad tests were performed when one sample of each pair was irradiated for 15 minutes by gamma-rays from a ⁶⁰Co source with non-adjustable exposure dose rate of about 100 R/s. Resulting induced absorption spectra are presented in Fig. 5a-d. For comparison, typical radiation-induced absorption spectrum of CMS-type PWO crystal at the same irradiation conditions is shown in Fig. 6.

• The Borosilicate glass windows have significant damages (induced absorption of ~90 m⁻¹ at 420 nm) after 120 krad (~10³ Gy) gamma-irradiation;

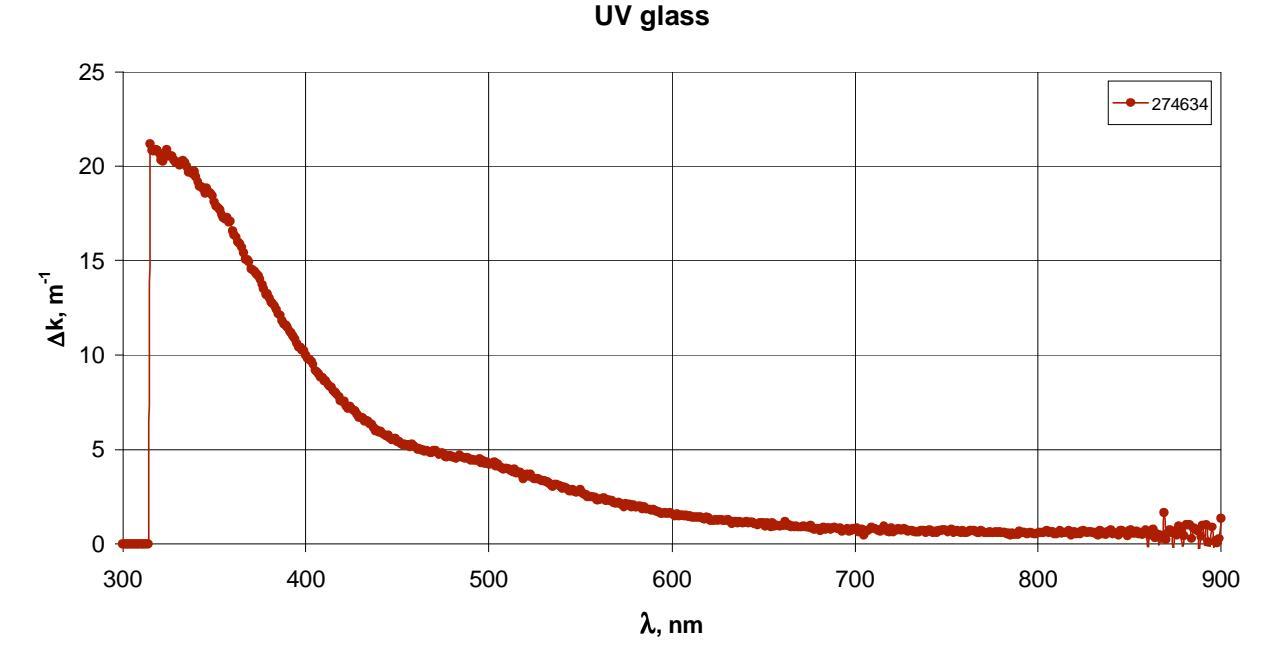
Fig. 5b Radiation-induced absorption of the UV glass sample after 120-krad irradiation

- The UV glass windows' damages are about 10 times lower than that of the Borosilicate glass under the same irradiation conditions, but remain still significantly larger (~8 m⁻¹ at 420 nm) than typical PWO radiation damage (~0.2 m⁻¹ at 420 nm);
- Sapphire sample damage have the same order of magnitude as that of the UV glass;
- No observable damages of the quartz sample were detected;
- The glass samples have slow (days) recovery after irradiation.

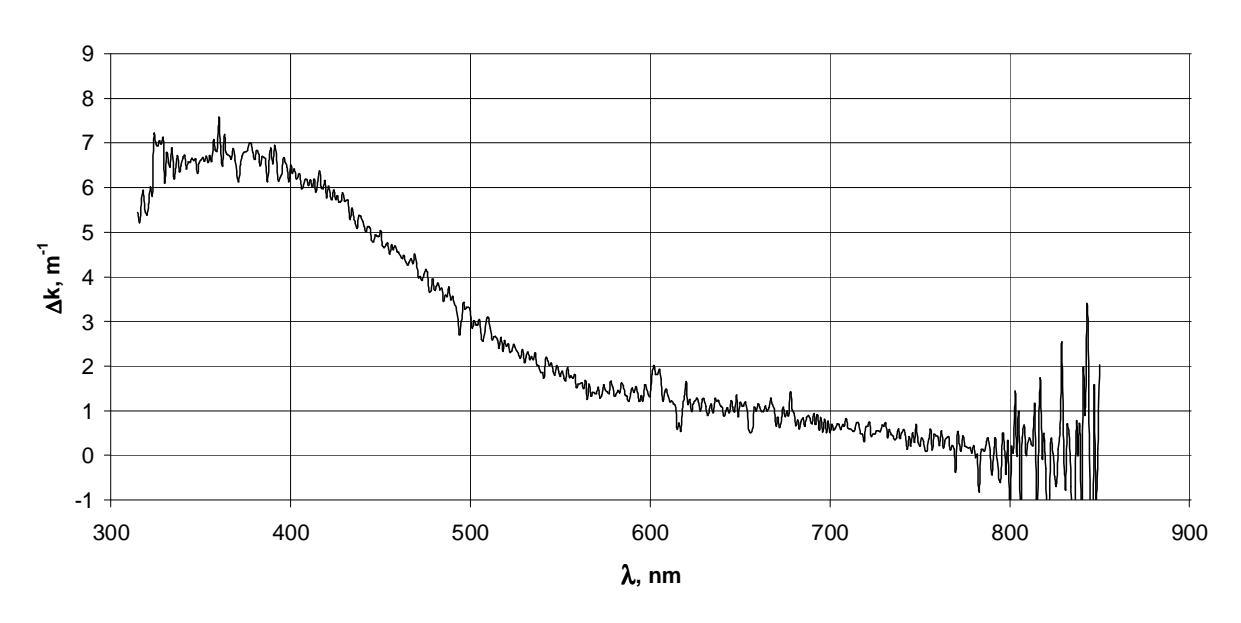
AI_2O_3

Fig. 5c Radiation-induced absorption of the sapphire sample after 120-krad irradiation

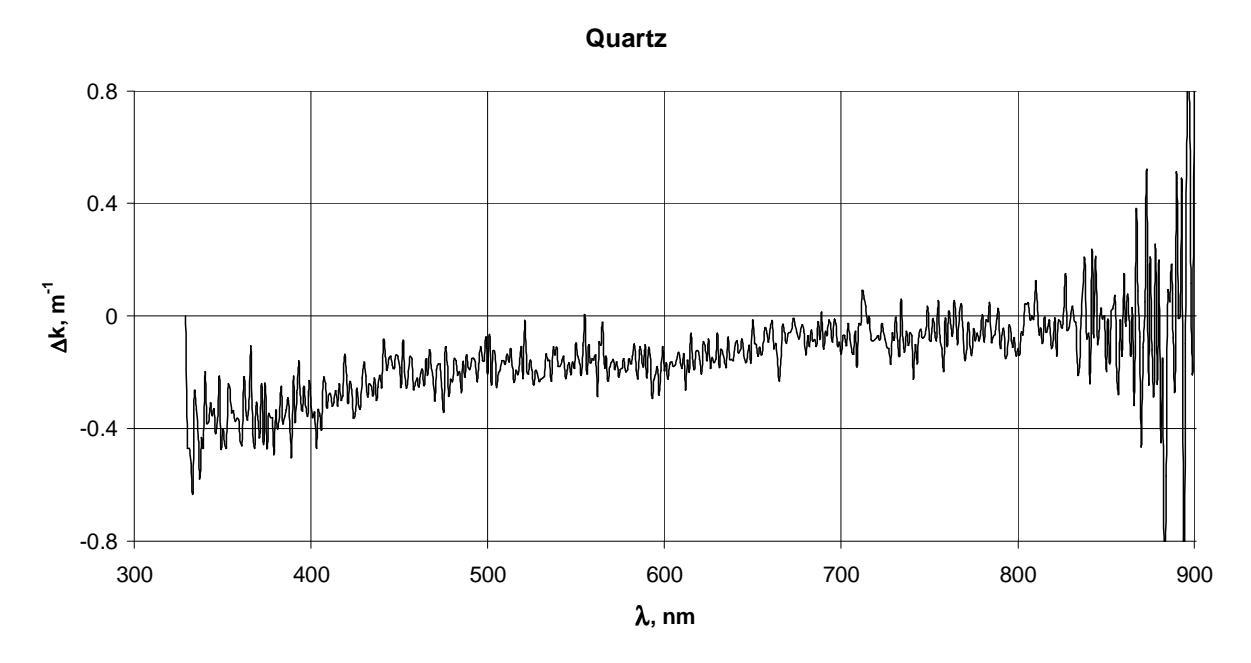
Fig. 5d Radiation-induced absorption of quartz sample after 120-krad irradiation

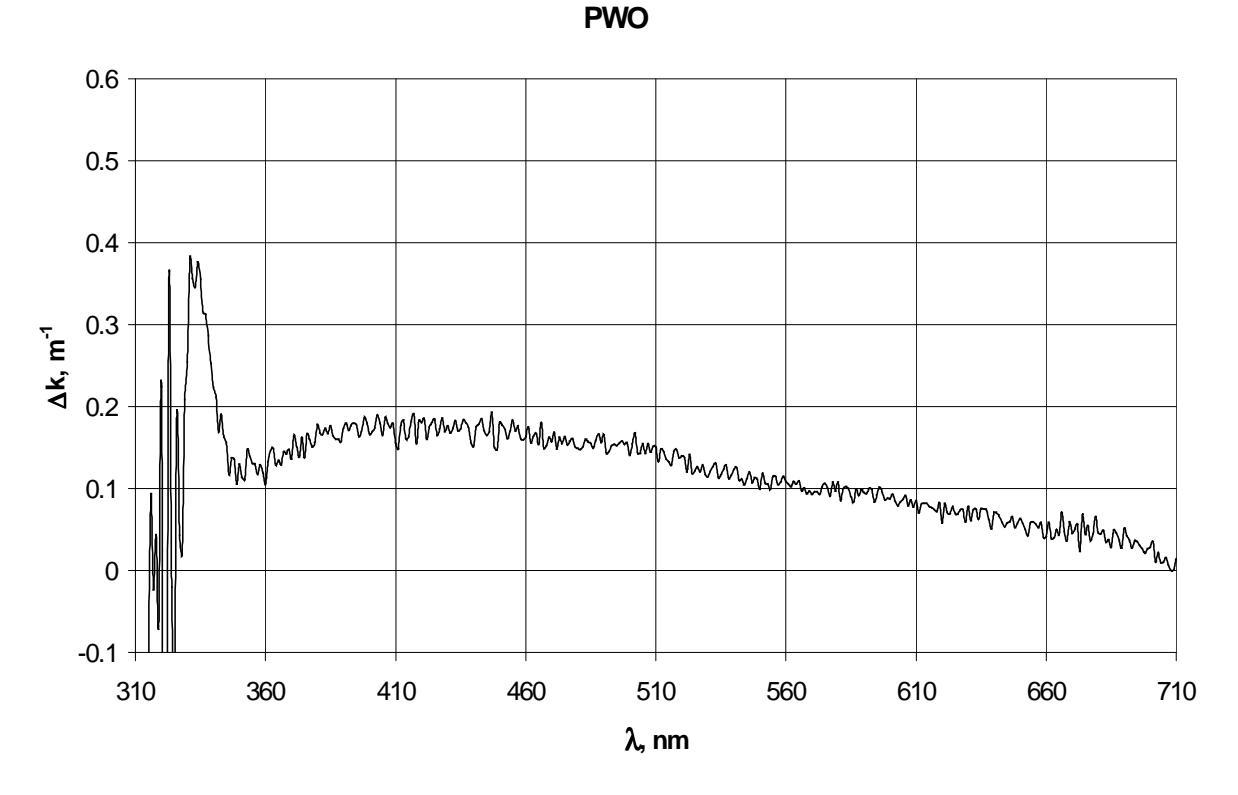
Fig. 6 Radiation-induced absorption of the typical PWO crystal after 120-krad irradiation

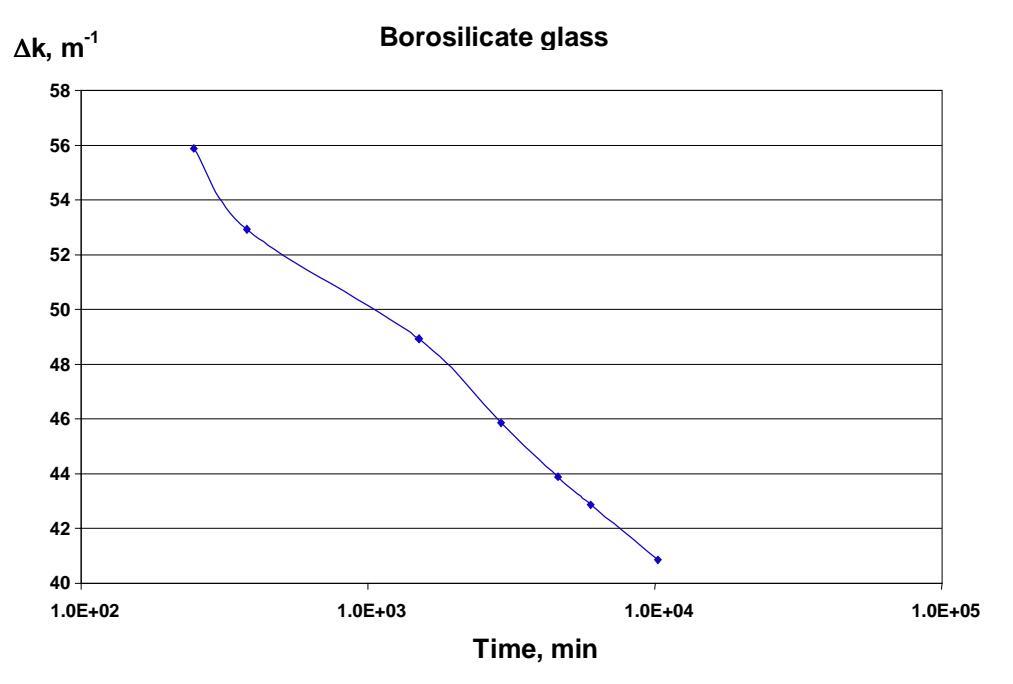
Fig. 7a Recovery of Borosilicate glass induced absorption at 460 nm

Recovery of radiation-induced absorption was measured for Borosilicate and UV glasses. Results drawn for 460 nm (that is the wavelength of the LED-based reference light source recently designed as a prototype for the BTeV EMCAL monitoring system) are presented in Fig. 7a and b.

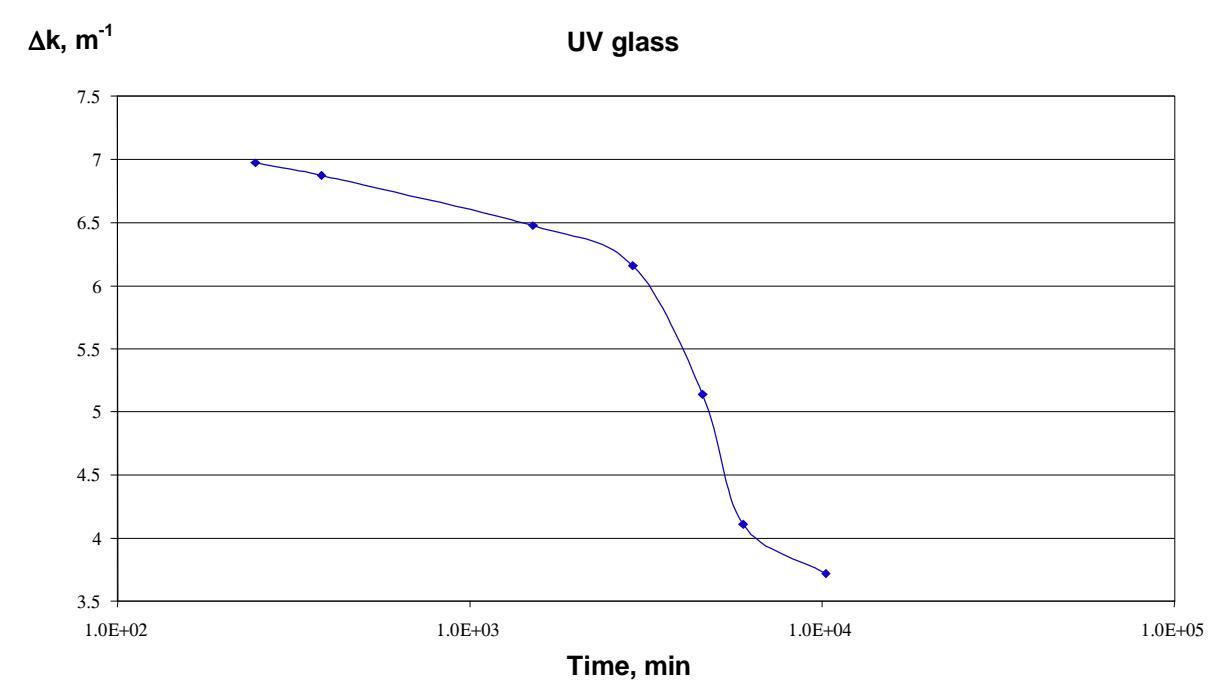
Fig. 7b Recovery of UV glass induced absorption at 460 nm

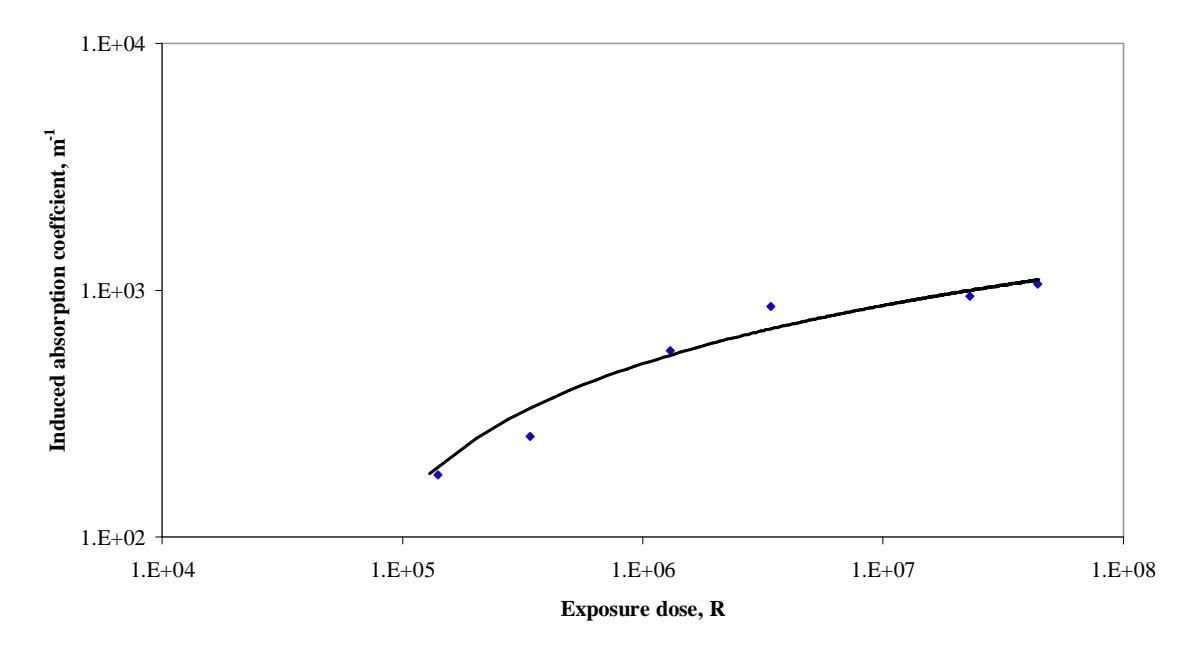
Fig. 8. Induced absorption at 400 nm for borosilicate glass (data extracted from [8]).

Finally, to compare with our results, data from the Hamamatsu Handbook [8] have been used to calculate the induced absorption *vs.* exposure dose. These results are displayed in Fig. 8. Extrapolating this curve to small exposure doses, we estimate that the radiation-induced absorption in this material is about 50 m⁻¹ at 10^4 R exposure dose which is consistent with what we observe with our Borosilicate glass window sample from Hamamatsu.

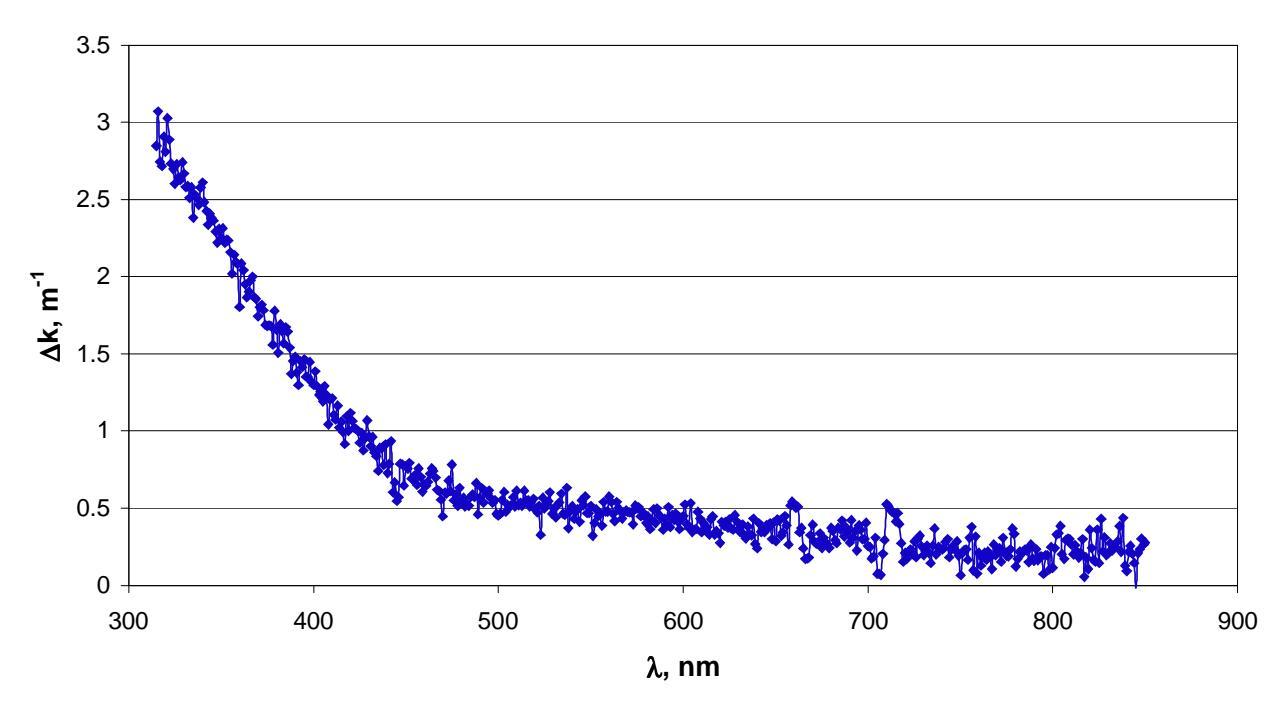
Fig. 9a Radiation-induced absorption of the Borosilicate glass sample after 1 krad irradiation

Only two kinds of window materials were chosen for these low dose tests, namely Borosilicate and UV glasses, since the quartz window did not show any deterioration in the high dose tests. The results are presented in Fig. 9a,b and displayed in Table 3 together with previous results.

As one can see, the rate of damage generation in the Borosilicate glass is much higher than that of the UV glass.

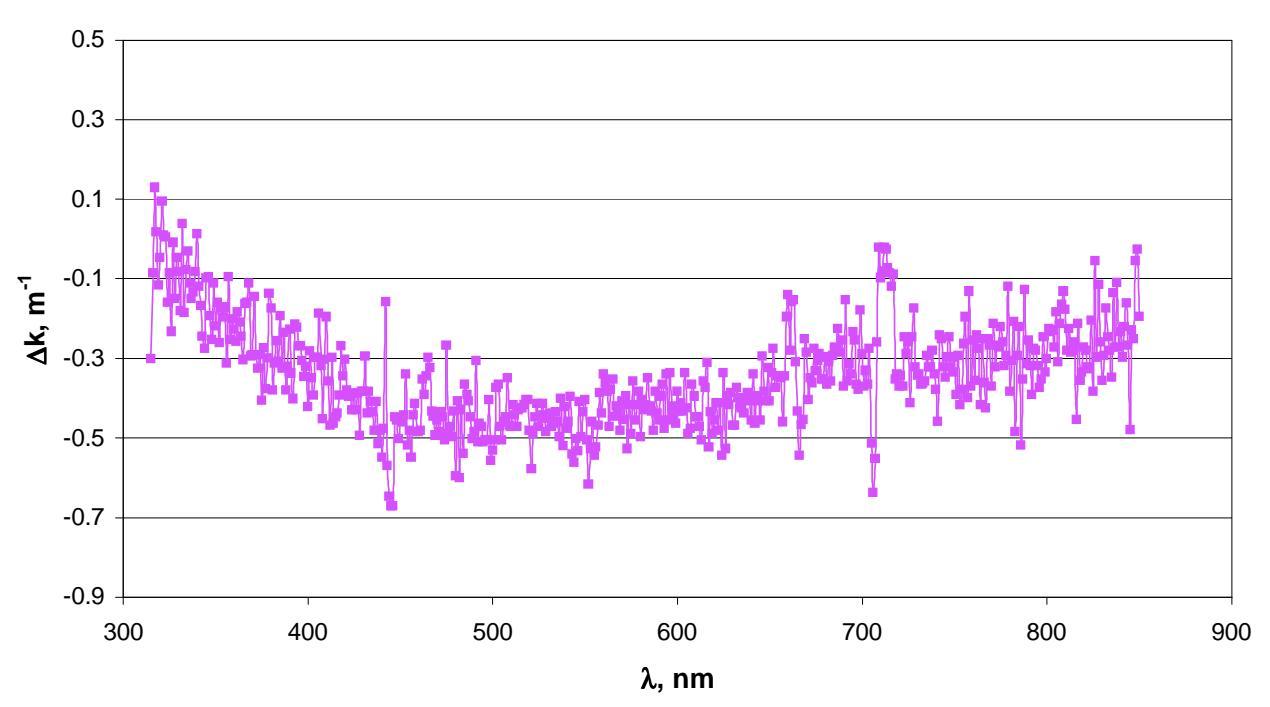
Fig. 9b Radiation-induced absorption of the UV glass sample after 1 krad irradiation
