Sustainable**Solutions**  
CORPORATION

**APRIL 2017**

## **LIFE CYCLE ASSESSMENT OF PVC WATER AND SEWER PIPE AND COMPARATIVE SUSTAINABILITY ANALYSIS OF PIPE MATERIALS**

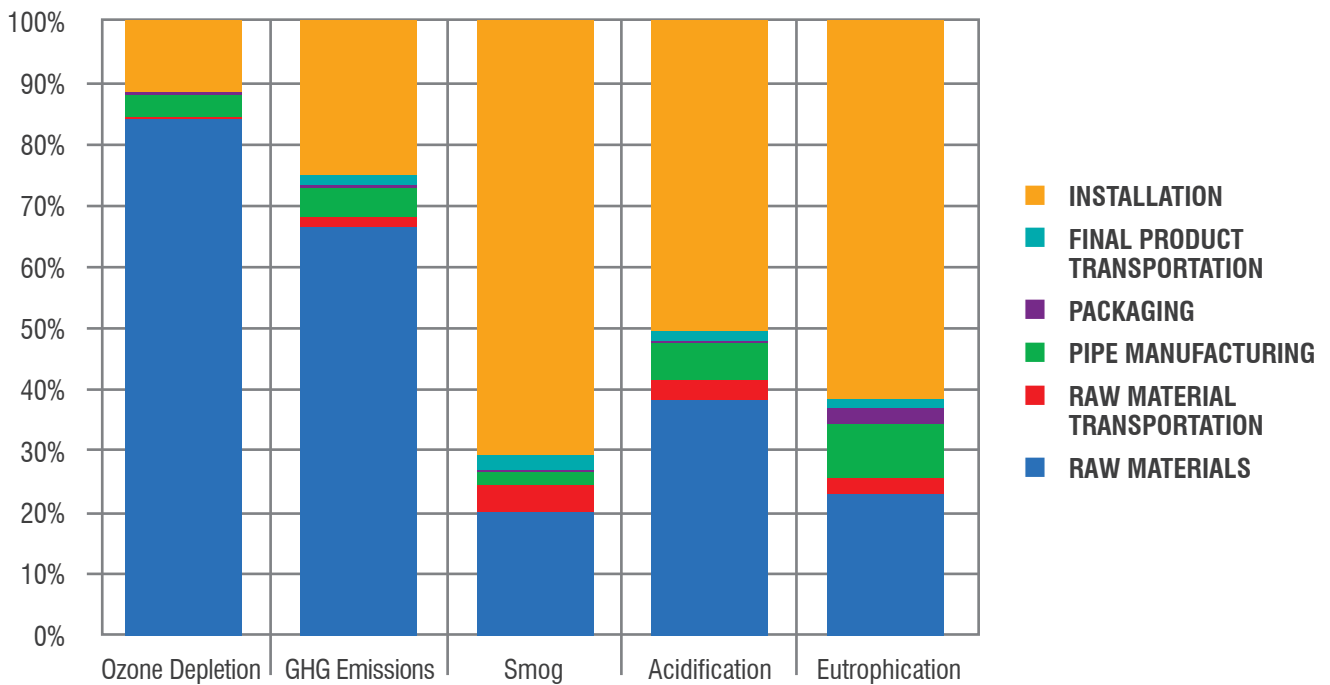
**FIGURE 4.3 : ENVIRONMENTAL IMPACTS OF 8" PVC DR25 PC165 C900 PRESSURE PIPE (TRACI IMPACT ASSESSMENT METHODOLOGY)**

- INSTALLATION
- FINAL PRODUCT TRANSPORTATION
- PACKAGING
- PIPE MANUFACTURING
- RAW MATERIAL TRANSPORTATION
- RAW MATERIALS

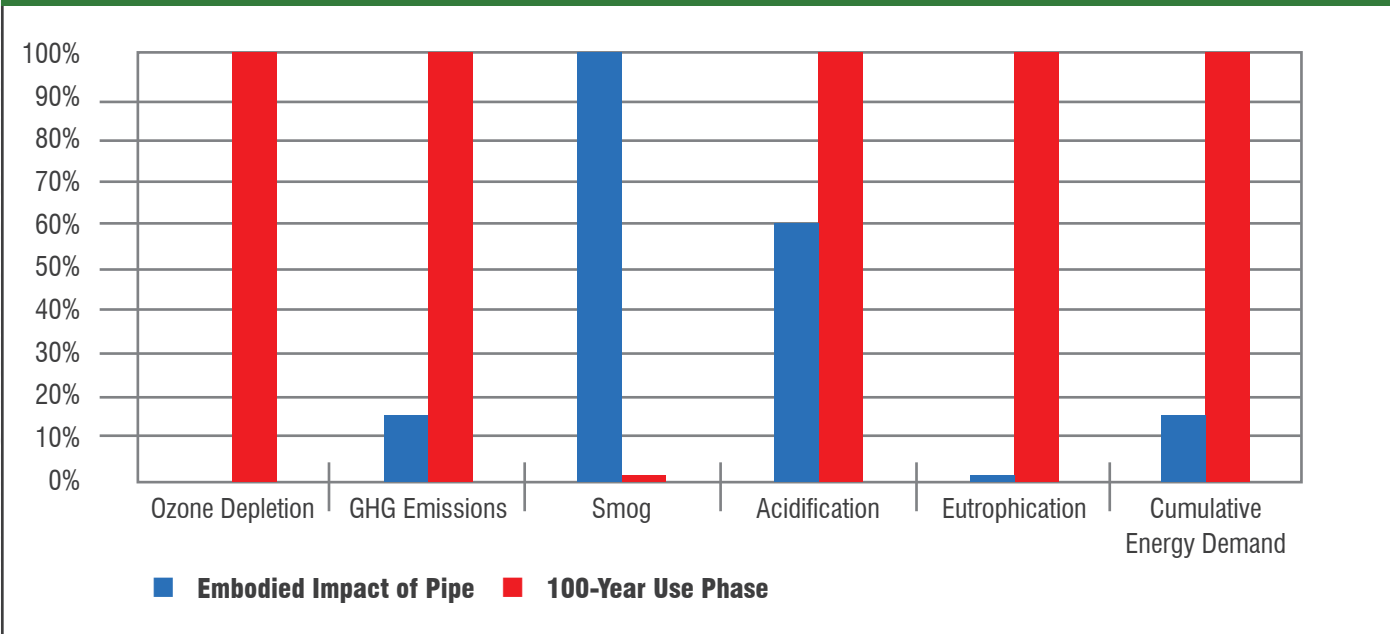
**FIGURE 7.1 : ENVIRONMENTAL IMPACTS OF THE USE PHASE OF 8” PVC DR25 PC165 C900 PIPE VS. EMBODIED IMPACTS OF THE PIPE**

The use phase of the pipe life cycle dominates as the primary cause of environmental impacts of PVC pipe with the exception of smog which is primarily caused by production of electricity and burning of fuel in the pipe installation equipment and from raw materials extraction and production.

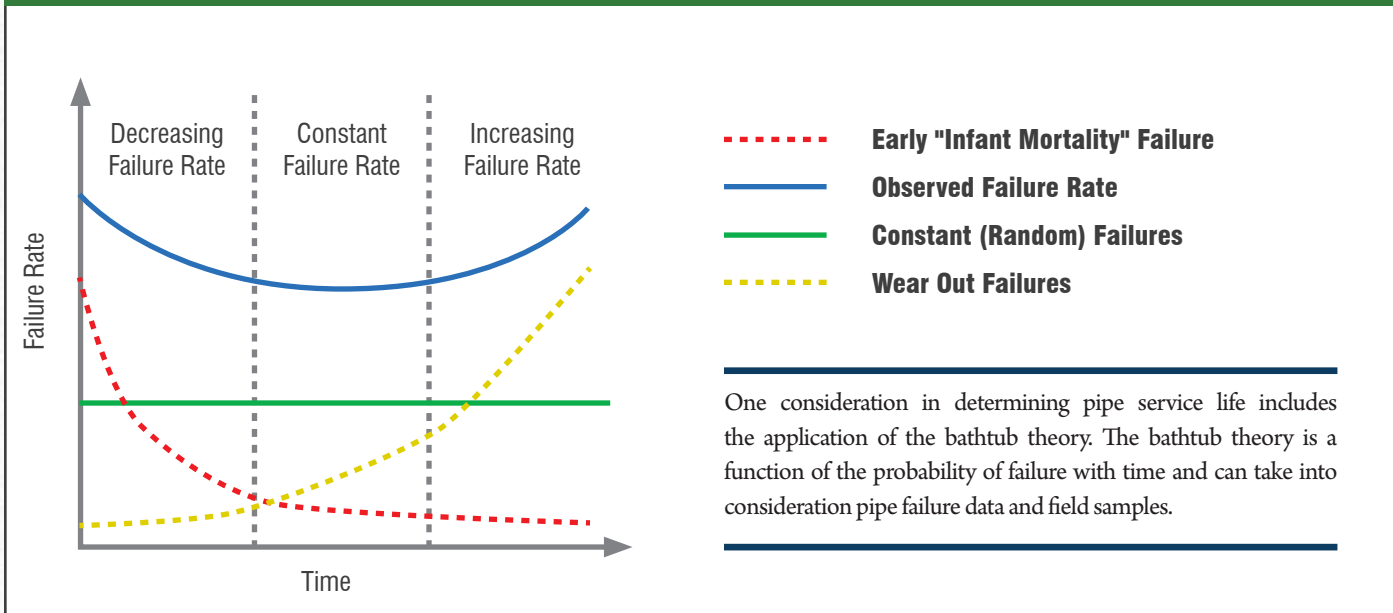
**FIGURE 8.1 : APPLYING THE “BATHTUB” THEORY TO DETERMINING PIPE SERVICE LIFE**

Another component of determining a service life is to assign a value to the various pipe materials for comparison purposes, which includes going beyond manufacturers’ marketing claims and reviewing additional sources to better understand the expected service level of a pipe. The combination of performance and service delivery are critical in order to assign a value.<sup>61</sup> This takes into consideration when water main breaks begin to occur, water quality issues arise, or pipe degradation (internal and/or external) is a concern and needing attention. In these circumstances the pipe has effectively met its service life as a low cost managed asset and now its total life cycle cost or total cost of ownership will begin to drastically increase.

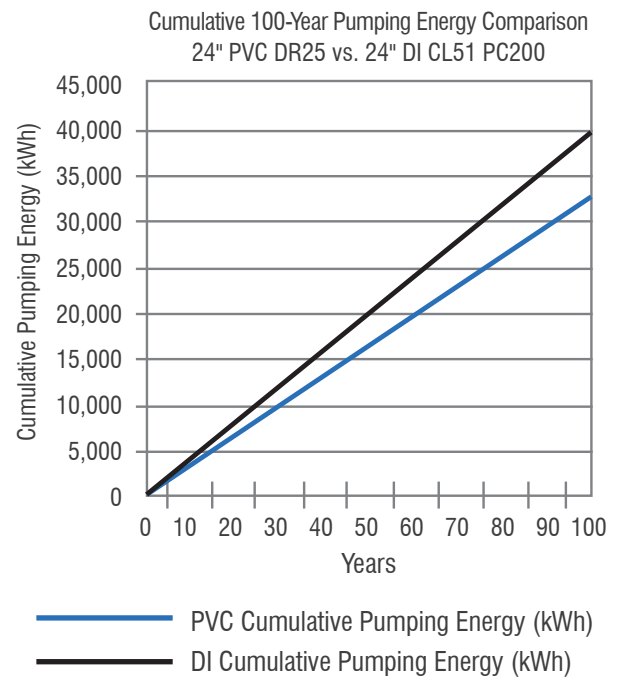
**FIGURE 9.2 : COMPARISON OF CUMULATIVE 100-YEAR PUMPING ENERGY FOR 24" PVC AND DI PIPE**

Note: Graph assumes replacement of DI pipe at 50 years.

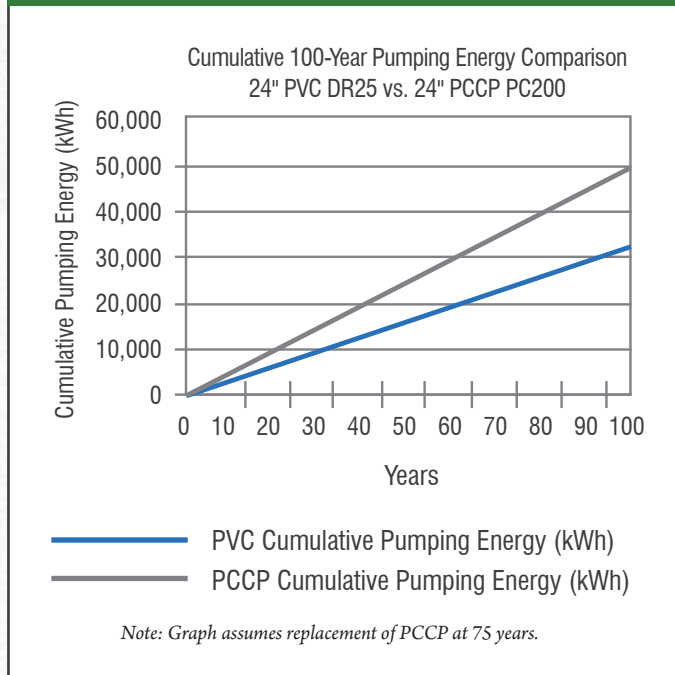
**FIGURE 9.5 : COMPARISON OF CUMULATIVE 100-YEAR PUMPING ENERGY FOR 24" PVC AND PCCP**

Note: Graph assumes replacement of PCCP at 75 years.

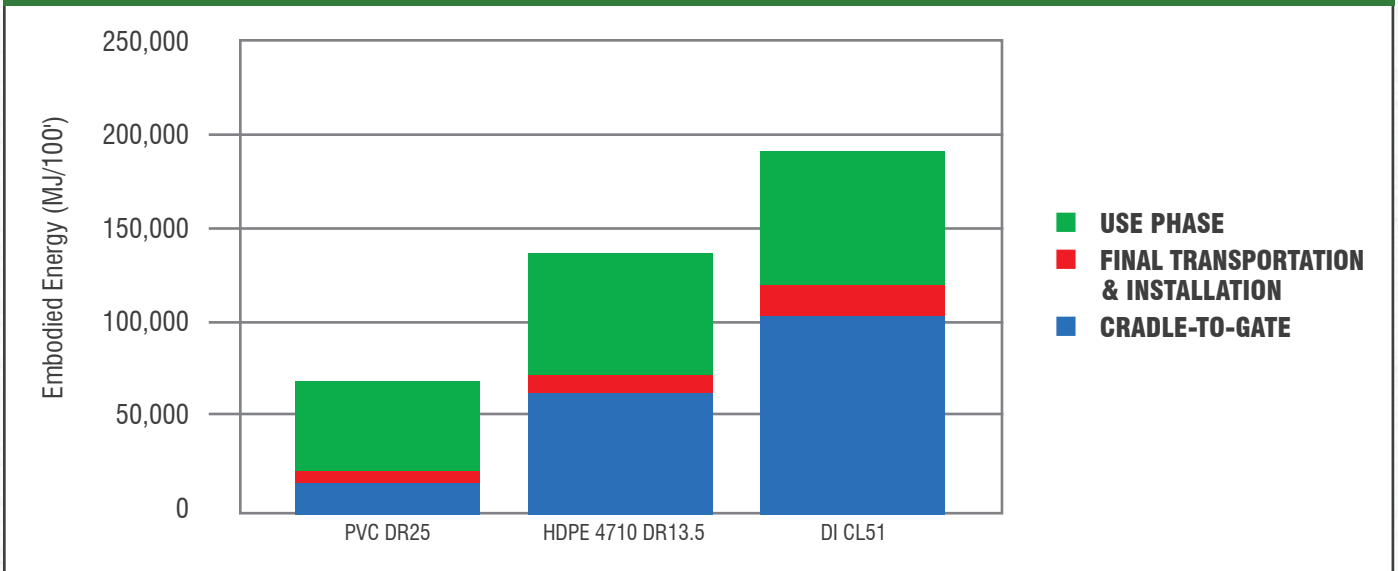
**FIGURE 12.2 : TOTAL 100-YEAR EMBODIED ENERGY FOR 8" PVC DR25 EQUIVALENT PRESSURE PIPES**

Figure 12.2 compares 8-inch PVC, HDPE and DI pipes with a pressure class at or equivalent to PVC DR25 PC165. As demonstrated, the total 100-year embodied energy for PVC pipe is 52 percent less than HDPE and 56 percent less than DI pipes.

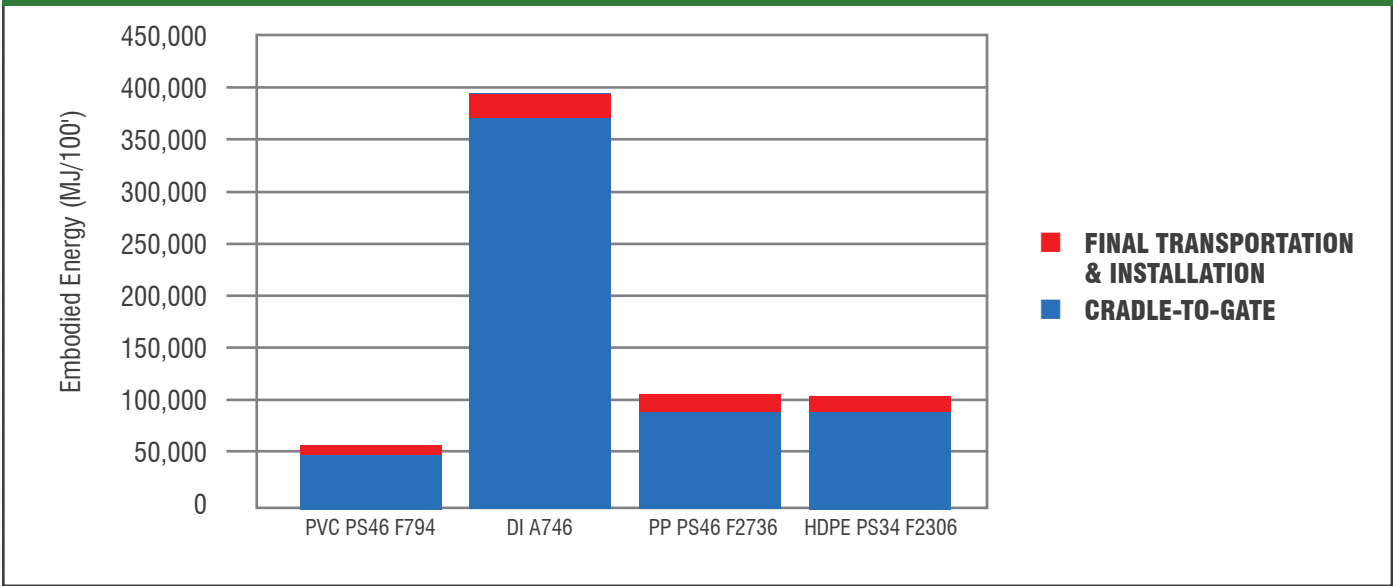
**FIGURE 12.7 : TOTAL 100-YEAR EMBODIED ENERGY FOR 24” PVC PS46 F794 PROFILE-WALL EQUIVALENT GRAVITY PIPES**

Figure 12.7 compares 24-inch PVC profile-wall, DI, PP and HDPE pipes equivalent to PVC PS46 F794 profile-wall pipe. The total 100-year embodied energy of PVC sewer pipe is 85 percent less than equivalent DI sewer pipe; 44 percent less than PP and 43 percent less than HDPE sewer pipes. It should be noted that the equivalent HDPE sewer pipe has a pipe stiffness that is 26 percent less than the pipe stiffness of PVC pipe.

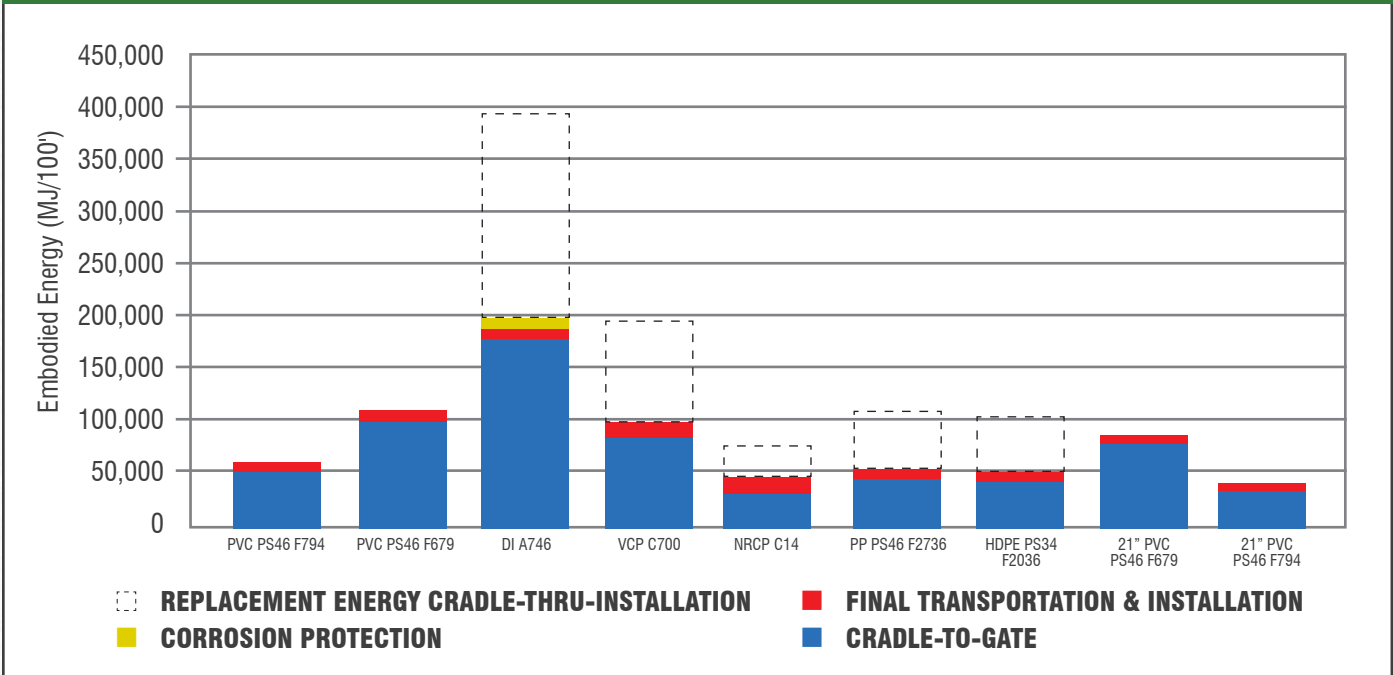
**FIGURE 12.10 : TOTAL 100-YEAR EMBODIED ENERGY FOR 24" PVC PS46 SOLID-WALL & PROFILE-WALL EQUIVALENT GRAVITY PIPES**

In order to be transparent, Figure 12.10 highlights the differences in embodied energy among the 24-inch gravity pipes without the needed replacements during the 100-year design life. Examination of Figure 12.10 reveals that 24-inch DI, VCP, PP and HDPE pipes have higher or equivalent 100-year embodied energies than PVC pipes even when replacement embodied energies are not considered.
