# A study of silicon sensor for ILD ECAL

Talk presented at the International Workshop on Future Linear Colliders (LCWS13), Tokyo, Japan, 11-15 November 2013.

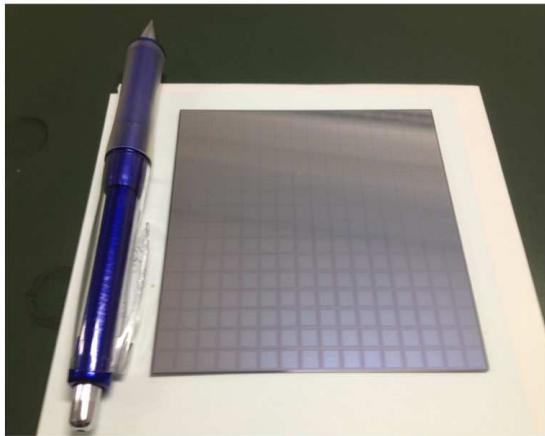
Figure 1: Silicon sensor: each chip has 256 channels.

The silicon sensor chips are produced by Hamamatsu (HPK). The sensors are a kind of silicon PIN diode, and they have 256  $5.5 \times 5.5 \text{mm}^2$  pixels in an area of  $9 \times 9 \text{cm}^2$  (Figure 1). The thickness of sensors is  $320 \mu\text{m}$ . The guard ring can collect surface current of the chips, but it also limit sensitive region of chips. Furthermore, from a former test beam result, 1 guard ring structure makes fake signals along it when particles come into near guard ring. In this way, guard ring has advantage and disadvantage, thus we have to decide which design should be used for ILD ECAL.

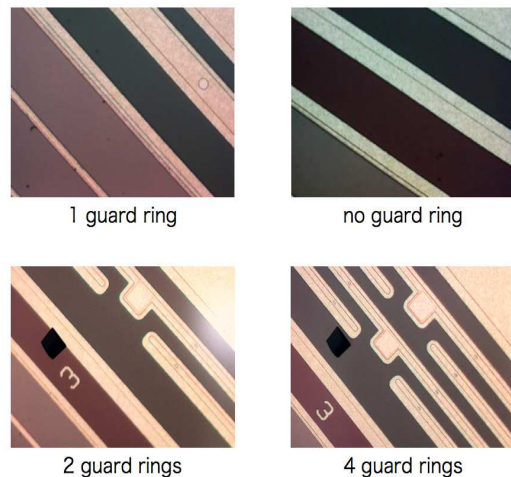
Figure 2: Guard ring structures: the guard ring width is  $80 \mu\text{m}$  (1 guard ring), or  $20 \mu\text{m}$  (2, 4 guard rings).

There are four types of guard ring structure. Currently, we have only 1 guard ring structure in this size. The other structures are provided by smaller chips  $3 \times 3$  pixels (4 guard rings), or  $4 \times 4$  pixels (no guard ring, 2 guard rings). We measured only 1 guard ring type chip, but in the near future we will measure the other chip and compare the properties of each structure.

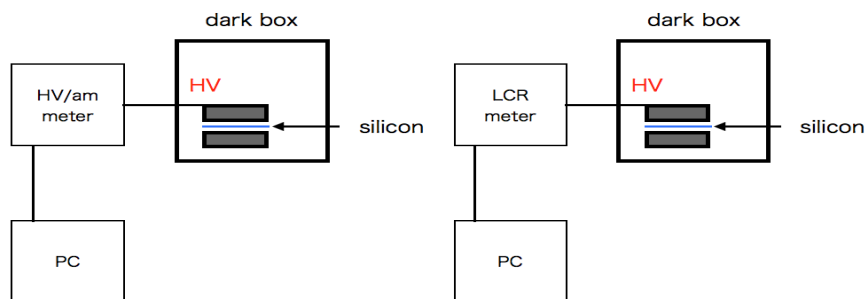
Figure 3: Setup: the left one is for leakage current, the other one is for capacitance.

We made two setups for the measurements of basic properties. One of the them is for the measurement of leakage current, the other is for capacitance measurement (Figure 3).

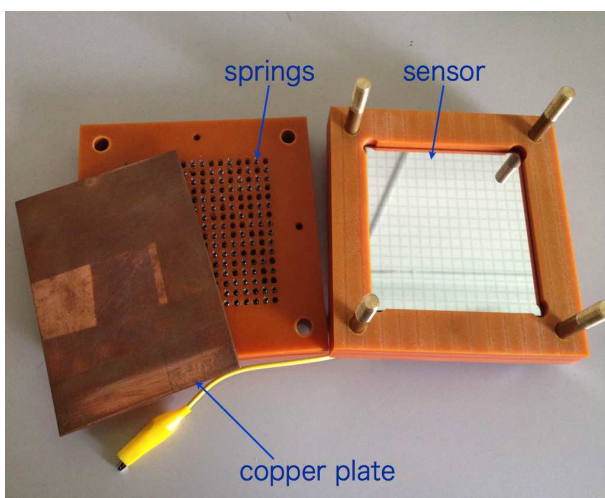
Figure 4: Setup box: copper plate combine 256 channels to 1 channel.

We can control temperature and humidity of dark box, thus we are able to assume these two dependence are negligible in both measurements. In our measurements, we set temperature at 27.5 °C (or 20.0 °C for capacitance measurement) and humidity at 50%. During both measurements, we used copper plate to combine signals from all sensor cells channel at one readout channel (see Figure 4). Between sensor and read out circuit are connected by using springs. The operation and data taking were controlled from a PC (see Figure 5).

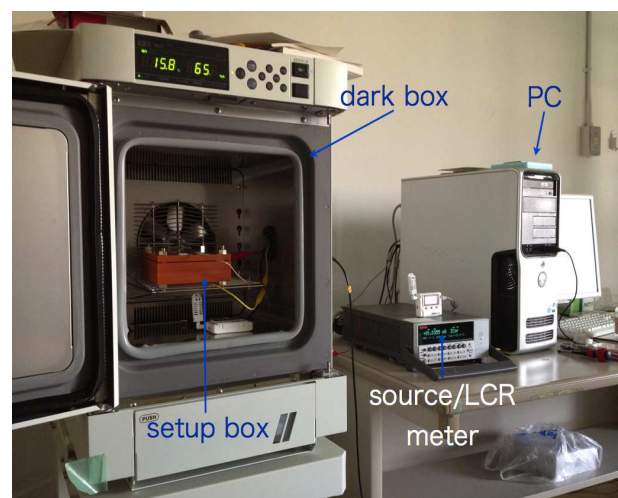
Figure 5: Setup for the measurements: source/LCR meter is controlled from a PC.

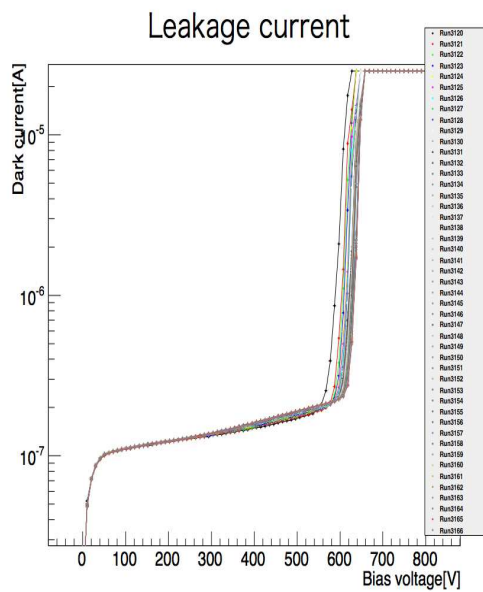
Figure 6: Leakage current of the chip (0-800 V) under the situation of 27.5 °C. Horizontal axis shows applied voltage, and vertical axis shows the total leakage current of silicon sensor. 47 scans of the same chip are overlaid.

For leakage current measurement, we took data from 0 V to 800 V in 10 V step. Each step has 1 second, and if the chip reaches to breakdown voltage we stop the measurement to prevent the chip from getting damaged. As shown in Figure 6, the leakage current is about 100 nA with applied bias voltage of 100-150 V, and its voltage dependence is very small in this region. We repeated this procedure 10-20 times on each chip, and found that the breakdown voltage becomes higher than the previous scan at first 3-4 scans. This phenomenon needs to be understood. However, we can conclude the leakage current is quite small and stable at the operation voltage of 100-150 V. If a chip has bad channel of high leakage current, we expect that the chip reaches breakdown on much smaller voltage. Therefore, this measurement is also important to test the chips before assembly, especially in mass production phase.

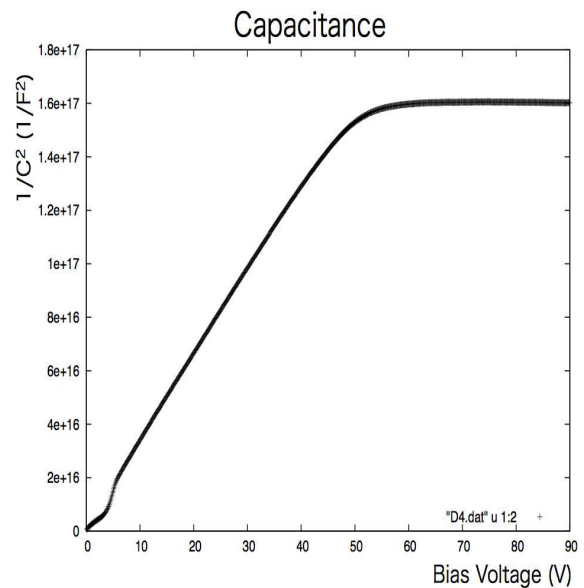
Figure 7: Capacitance curve: the horizontal axis shows applied voltage, and vertical axis shows  $1/\text{capacitance}^2$ . This measurement did in the situation of 20 °C and 50 % of humidity.

For capacitance measurement, we applied bias voltage from 0.1 V to 130 V by step of 0.1 V. Figure 7 shows good linearity in 5 V to 45 V region. From 0 V to 5 V, the capacitance curve is slightly winding because of its Metal-Oxide Semiconductor structure [4]. Shown in Figure 7, the capacitance saturates at around 60 V, which is consistent of the full depletion voltage of 65 V in the specification. We also estimated that the chip thickness is  $318\mu\text{m}$ . This value is also consistent with the specification.

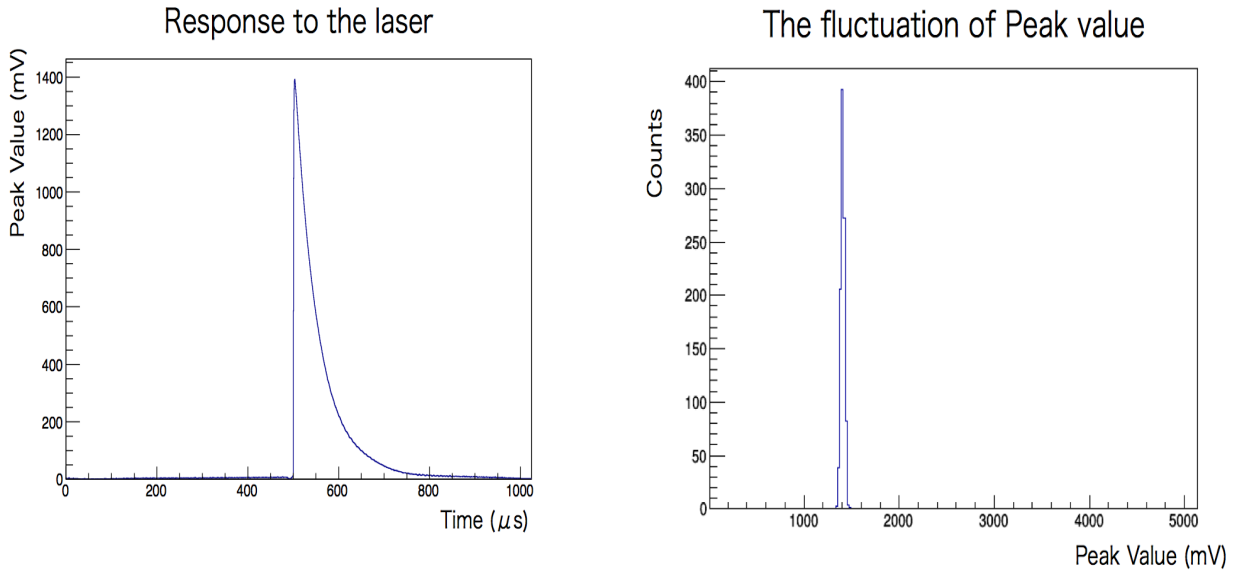
Figure 8: Wave form: the horizontal axis shows time ( $\mu\text{s}$ ), vertical axis shows output value (mV) time constant of pre-amplifier is about  $150\mu\text{s}$ . This measurement ran under applied voltage of 100 V. Figure 9: Peak fluctuation: the horizontal axis shows peak value of response, and vertical axis shows the number of counts. The measurement did in 100 V applied voltage.

At first, we measured the response from a specific pixel to check our system. We used an oscilloscope to see waveform, and we also check the fluctuation of peak value by using the waveform. The waveform taken at 100 V bias voltage is shown in Figure 8. The decay tail was caused by the time constant of the pre-amplifier. We obtained the peak fluctuation value of 3%, shown in Figure 9, which corresponds to the stability of our measurement.

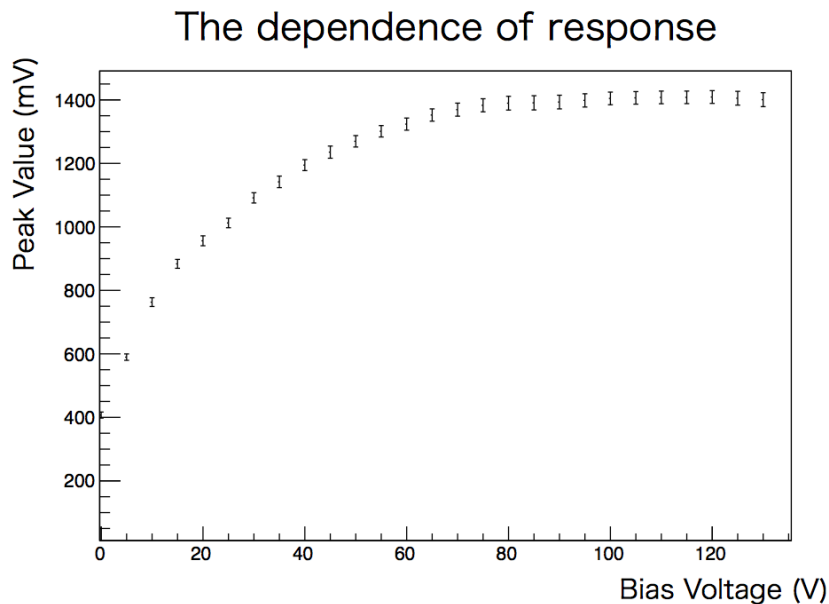
Figure 10: The voltage dependence of peak value: The horizontal axis shows applied voltage, and vertical axis shows peak value. The error bar comes from the fluctuation of peak value (shown in Figure 9).

We also investigated the response for various bias voltages. The result is shown in Figure 10. In this figure, the response saturates at 80 V, which indicates that the chip reached full depletion. Since this saturation is not consistent to the full depletion voltage of 65 V (obtained from previous measurements), we are now investigating the reason of the difference.
