# Nanoscale perspective on the stress-corrosion cracking behavior of a peak-aged 7XXX-Al alloy

## Abstract

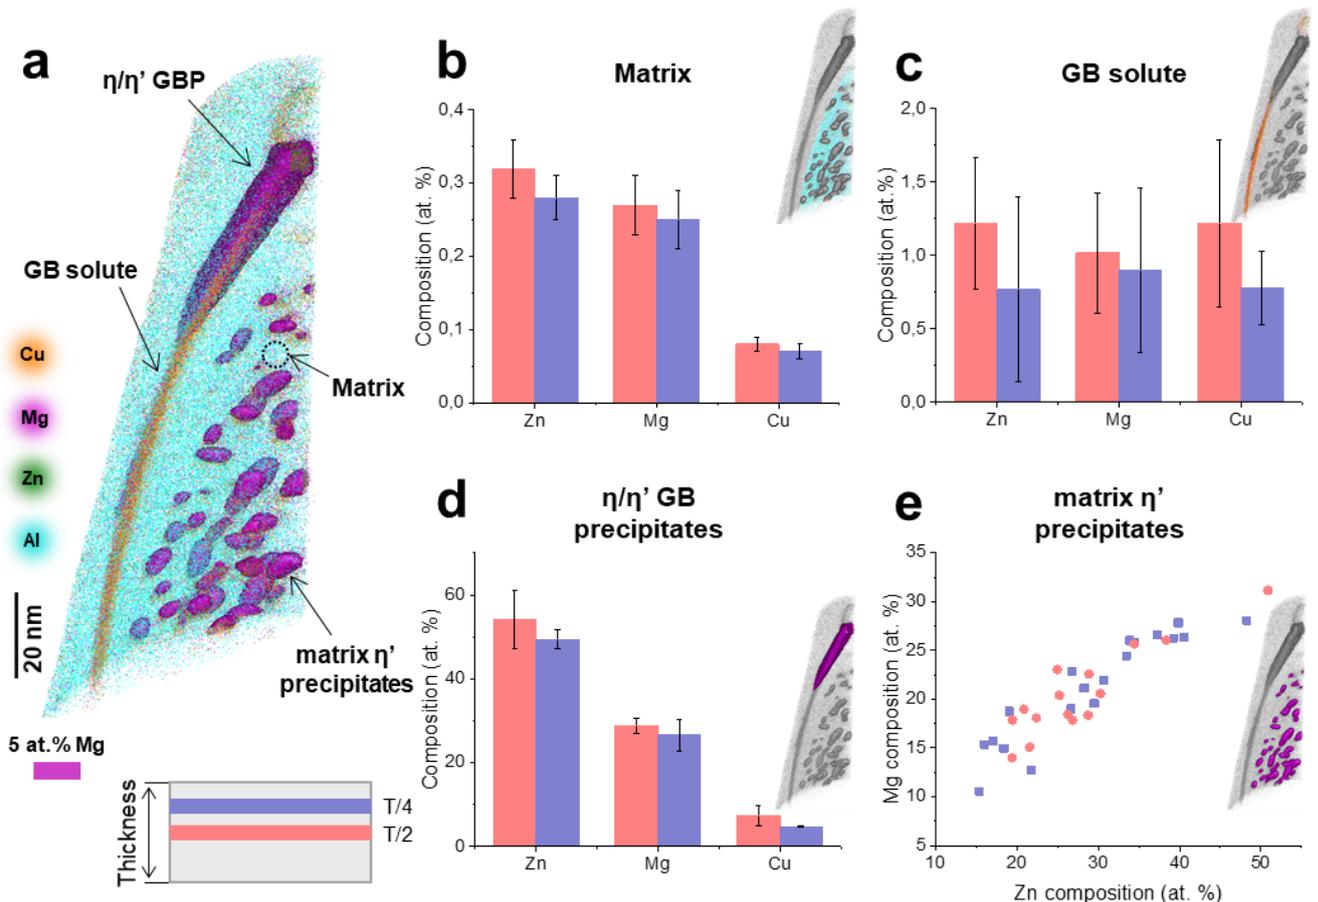
Figure 1. APT characterization of the microstructure at the two plate positions. a) APT reconstruction of a GB containing reference dataset from the T/2 position showing the microstructural features that are characterized. b) Matrix composition at the two plate positions. The values shown are the average of 3 different datasets from different grains. The error values correspond to the standard deviation between the measurements. c) GB solute levels measured at both plate positions. The values shown are the average of 3 different datasets, taken at different high-angle GBs. The error values correspond to the standard deviation of the measurements. d) Composition of GB precipitates at both plate positions. The measurements shown are from one precipitate per plate position. The error bars correspond to the standard deviation within the precipitate. e) Compositions of the matrix  $\eta$ -phase precipitates within the grain interior at both plate positions. 2 datasets for each plate position are shown and each data point corresponds to an individual matrix  $\eta$ -phase precipitate.

In the grain interiors imaged in the datasets used to extract the data reported in Figure 1, we determined the number density using precipitates identified through Mg iso-surfaces. This approach may seem simplistic, but attempts at determining number density and volume fraction of precipitates in the grain interior by means of cluster analysis algorithms were deemed too dependent on the input parameters to reliably compare both plate positions. Multiple attempts have demonstrated the complexity of the process, without managing to

define a heuristic that can be applied across datasets and materials systems [29,30]. The calculated matrix  $\eta$ -phase precipitate number density sits at  $2.82 \cdot 10^{-4} \text{ nm}^{-3}$  for T/2 and  $3.38 \cdot 10^{-4} \text{ nm}^{-3}$  for T/4, in line with measurements from the literature performed on a similar alloy [28]. We can then assume a higher precipitate volume fraction at T/4 due to its higher bulk solute content in the grain interior (Table 2), lower matrix solute content (Figure 1b) and a number density slightly higher than that at T/2.

The composition of the  $\eta$ -phase precipitates contained in the matrix ahead of the crack, is modified. The composition measurements are equivalent to that shown in Figure 1e. At 2 $\mu$ m, some matrix  $\eta$ -phase precipitates are lower in Zn, Mg (Figure 6b) and higher in Cu (Supplementary Figure 6) with respect to reference measurements. The distribution of composition values is shifted towards leaner Zn and Mg levels, which are reduced to as low as 4.7 at. % and 10.6 at. % respectively, whereas Cu increases to as much as 18.9 at. %. However, at 4, 6 and 8 $\mu$ m ahead of the crack composition levels fall within the reference measurements.

The matrix composition is also altered near the GB, as shown in Figure 6c. Matrix solute levels are slightly elevated 2 $\mu$ m ahead of the crack tip, but close to the reference values reported in Figure 1b. The matrix composition 4 $\mu$ m ahead of the crack represents a twofold increase in Zn and Mg, reaching 0.83 at. % and 0.58 at. % respectively. It should be noted that matrix  $\eta$ -phase precipitates showed unaltered composition values at this very position. Further ahead, at 6 $\mu$ m, the Zn and Mg content in the matrix decreases again but is still moderately elevated, and it drops back to the reference values at 8 $\mu$ m. Cu levels are elevated in the matrix ahead of the crack, regardless of the distance with respect to the crack tip, although fluctuation is also observed. These compositional modifications can be related to the presence of the progressing crack, as they are outside the standard deviation obtained for the reference measurements, indicated by shaded areas surrounding a horizontal dotted line in Figure 6c.

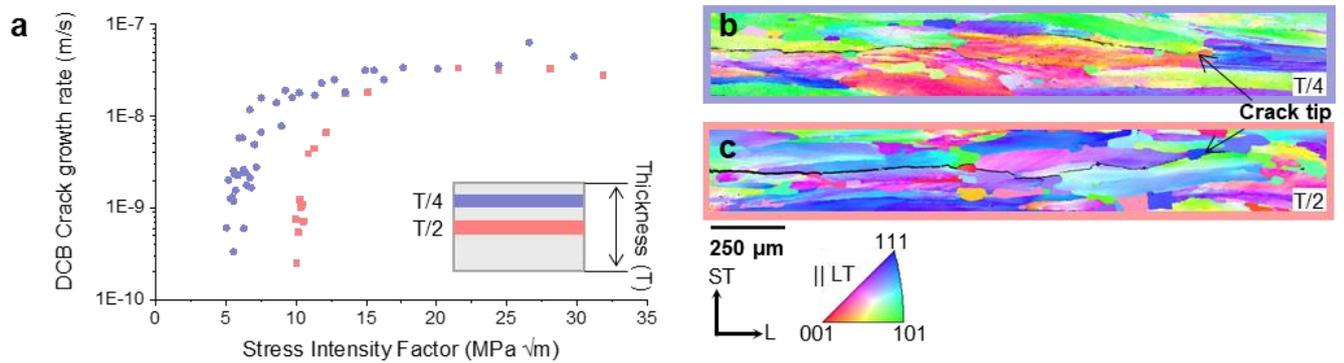
Figure 2. Crack growth behaviour. a) Crack growth rate double cantilever beam tests for the two plate positions. The results of 2 tests are plotted for T/4 and 1 test for T/2. EBSD map of the final crack tip in the ST-L plate orientation for the b) T/4 position. c) T/2 position

The results of the DCB crack growth rate test performed at  $70^\circ\text{C}$  and 85% RH on samples from the AA7140-T6 from T/2 and T/4 are shown in Figure 2a. Both plate positions display identical stage II plateau crack growth rates at  $\sim 3 \cdot 10^{-8} \text{ m/s}$ , similar to values reported in the literature [31]. However, they show a dissimilar behavior in region I. The  $K_{\text{ISCC}}$  for the DCB sample from T/4 is  $6 \text{ MPa}\sqrt{\text{m}}$  whereas the specimen at T/2 does not show crack growth until  $10 \text{ MPa}\sqrt{\text{m}}$ . The plot shows data from 2 tests for the T/4 position and 1 test for T/2. Figure 2b-c shows EBSD scans of the crack tip region in the ST-L plane, showing similar crack paths. The stress-corrosion crack followed primarily high-angle GBs in both samples, with the

average misorientation of the cracked boundaries in region I loading conditions being  $31^\circ$  for T/2 and  $43^\circ$  for T/4.

Conversely, at the higher stress intensities characteristic of region II, the crack growth rate is nearly identical at both plate positions (Figure 2), suggesting that there is another process rather than oxidation rates or mechanical effects that is limiting the advancement of the crack. It has been previously proposed [48], that the plateau observed in region II is caused by a balance of the driving forces for crack propagation with the metal ligaments and the interactions due to the multiplicity of cracks. But we report on nearly identical crack growth rates for the two plate positions, which, at the same time, exhibit grain structures with different propensities to crack branching and therefore, to the creation of ligaments. This can be due to differences in microbranching present at low stress intensities [56] or to mechanisms that remain unidentified. Holroyd and Scamans [4] previously suggested that another, strain-related process could also be rate-controlling.

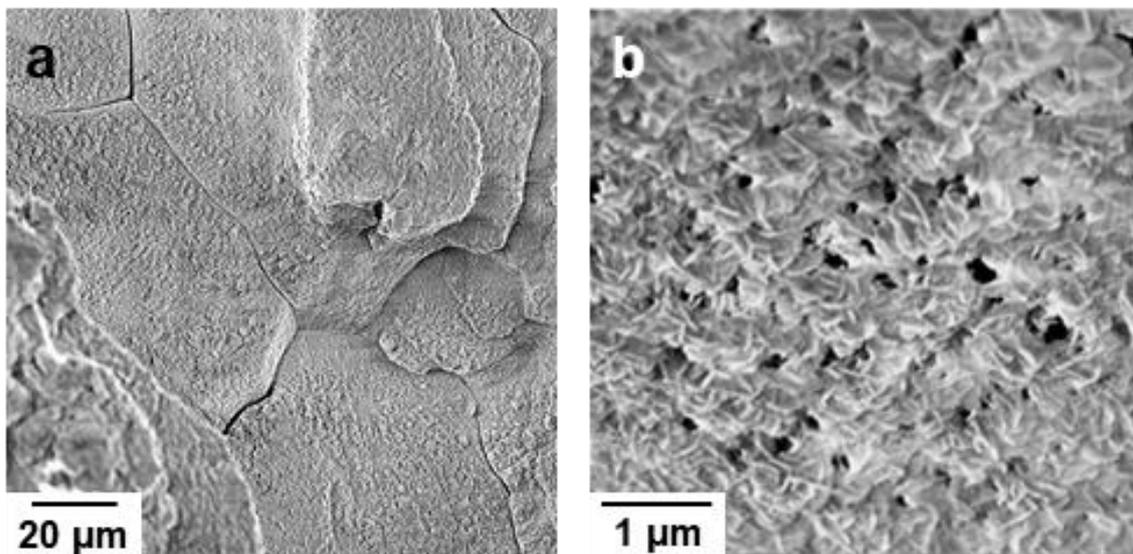
Figure 3. Characterization of the fracture surface. a) overview of the intergranular fracture surface. b) close-up view of the hydroxide formed.

The fracture surface observed by SEM shows all features associated with an intergranular mechanism, as expected for SCC in 7xxx Al-alloys and shown in Figure 3. It is mostly covered with a hydroxide of approx.  $1\mu\text{m}$  in thickness, as determined through a PFIB liftout from the fracture surface (Supplementary Figure 5). This suggests liquid water was condensed within the crack during the test, as the oxide thickness after exposure to  $70^\circ\text{C}$  and 85%RH is only on the order of tens of nm for 7xxx Al-alloys [32].

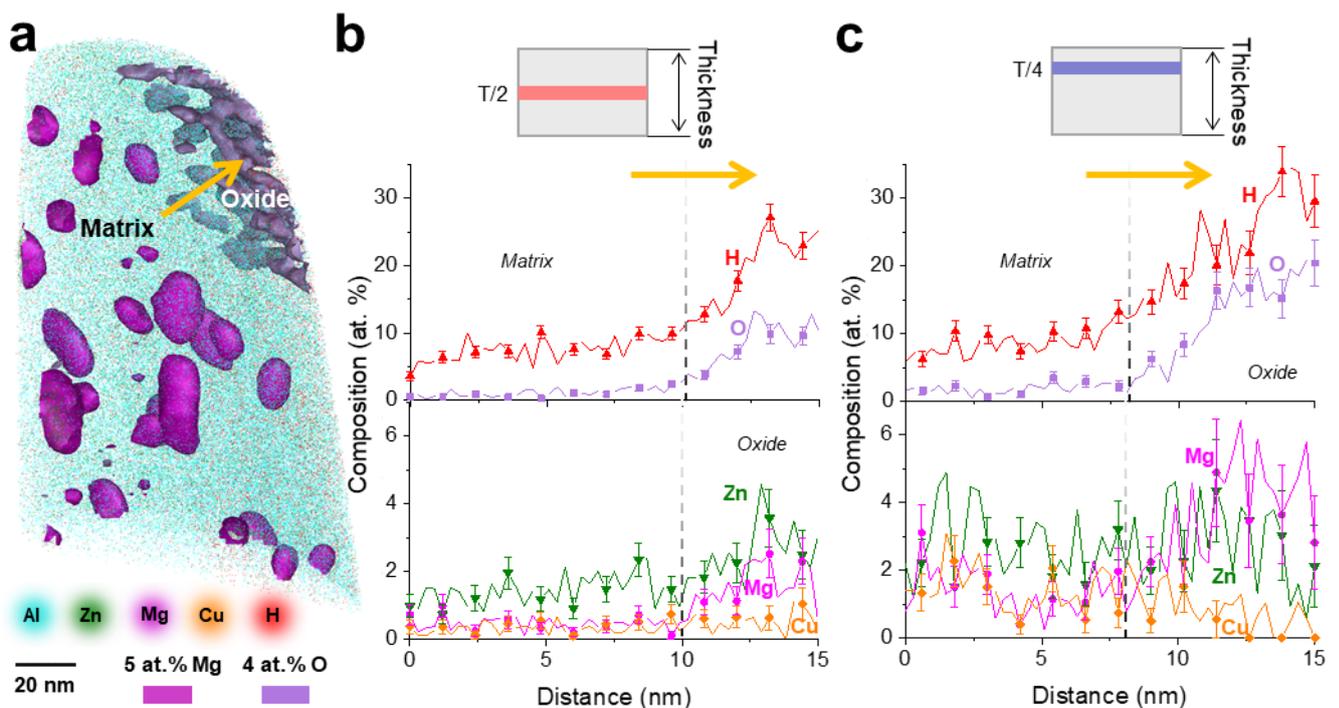
Figure 4. APT characterization of the crack tips. a) APT reconstruction of a crack tip containing a stress-corrosion crack, displayed through an O iso-composition surface. The dataset shown is from the T/2 position. b) Composition profiles taken along the matrix-oxide interface for the T/2 crack tip, measured within a 10 nm ( $\phi$ ) cylinder. c) Composition profiles taken along the matrix-oxide interface for the T/4 crack tip, measured within a 10 nm ( $\phi$ ) cylinder. The error bars correspond to the standard deviation within each of the bins in the composition profiles shown

For both plate positions, we performed APT analyses as near as possible to the stress-corrosion crack tip (Figure 4). The vicinity of the crack is revealed by the presence of an O-rich region highlighted through a set of dark purple iso-surfaces (Figure 4a). Figure 4b–c show composition profiles taken along the matrix-oxide interface for both samples. The oxide is hydrated and enriched in Zn and Mg, and the matrix adjacent to the oxide is also markedly more concentrated in solute compared to the reference measurements shown in Figure 1b.

The composition profiles for both plate positions exhibit only small differences. The average enrichment in Zn, Mg and Cu measured in the matrix adjacent to the oxide (Figure 4b-c) at T/4 is notably higher than at T/2, both in relative and absolute terms, as readily visible in Figure 5. For example, 3.6 at. % Zn is measured at T/4, which is nearly twice the 1.9 at. % Zn at T/2. Zn and Cu follow tendencies consistent with the expected macro-segregation, with T/4 being richer than the alloy's nominal composition, plotted by a dashed line, and T/2 being leaner. Nonetheless, the respective compositional differences are higher than the values calculated with the segregation coefficients for each element [22]. Mg composition within the matrix adjacent to the crack is lower than the nominal in both plate positions, likely due to its preferential oxidation and subsequent loss to the oxide. In addition, matrix  $\eta$ -phase precipitates near the crack tip are lower in Zn, Mg (Figure 6b) and also Cu (Supplementary Figure 6).

Analyses of the crack tips at the two plate positions displayed consistent, reproducible observations (Figure 4). We report on the formation of a Zn- and Mg- rich hydroxide at the crack tip (Figure 4b-c). The matrix adjacent to the oxide is enriched in solute (Figure 5) whereas the nearby matrix  $\eta$ -phase precipitates are leaner in Zn, Mg and Cu (Figure 6b and Supplementary Figure 6). There are also qualitative similarities with measurements performed in another 7xxx Al alloy after SCC in Cl-containing solution [16], suggesting that similar mechanisms are at play. This observation is surprising, as the severity of oxidation/corrosion in NaCl is higher than in hot humid conditions. Upon crack advancement, a fresh surface is exposed and oxidation of the GB, GBPs and nearby matrix commences, triggering the dissolution of nearby matrix  $\eta$ -phase precipitates. A detailed explanation of the possible contribution of oxidation to precipitate dissolution can be found elsewhere [16]. Care should be taken when evaluating the SCC susceptibility of different alloys based on near-equilibrium compositions obtained after the ageing heat treatment.

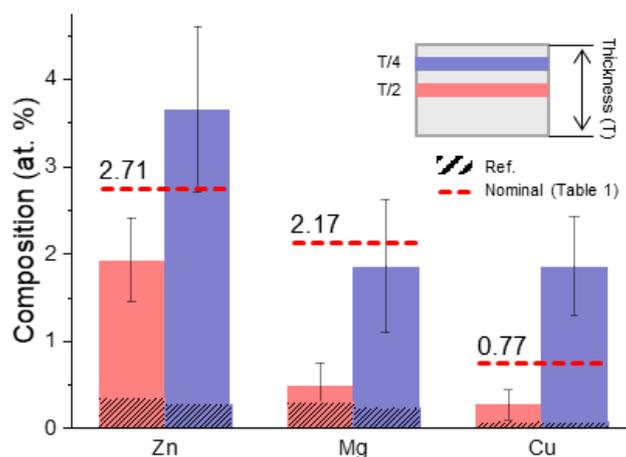
Figure 5. Composition of the matrix adjacent to the oxide for both plate positions. The values shown are an average of two measurements for T/2 and one for T/4. The plot shows an average of the composition in the matrix adjacent to the oxide, shown in Figure 4. The error values correspond to the standard deviation within the matrix adjacent to the oxide for T/4 and between the two measurements for T/2. The nominal composition of the alloy in at. % (Table 1) is shown by a dashed line and the reference matrix compositions (Figure 1) by diagonal line patterned bars. The error values correspond to the standard deviation within the matrix adjacent to the oxide for T/4 and between the two measurements for T/2.

The characterization of the crack tip microchemistry at both plate positions revealed marked differences, with a more pronounced crack tip matrix solute enrichment at the T/4 position (Figure 5). This is presumably caused by the higher total solute content at T/4 (Table 2), which upon strain- and oxidation-induced dissolution of the matrix  $\eta$ -phase precipitates and subsequent diffusion processes would end up near the crack tip. Solute in solid solution in Al can change its electrochemical properties in Cl-containing solutions, especially the dissolution kinetics and the corrosion and pitting potentials [50–54]. Zn increases the dissolution kinetics while Cu lowers them and Mg additions don't have any notable effect. Although corrosion studies performed in Cl-containing solutions may not be directly translatable to oxidation in hot humid air, these can be used to hypothesize. The higher Zn content in solid solution near the crack tip at T/4 (Figure 5) could increase oxidation rates and H production at the crack tip with respect to T/2. Zn incorporation in the oxide would decrease its stability thus rendering its hydration easier, as proposed by Song et al. [55] to explain the activation of Al by Zn, although this was not directly investigated experimentally. A higher concentration of atomic H within the region ahead of the crack might then facilitate crack growth, thus requiring less mechanical driving force to achieve crack advancement. Further, a faster growing oxide could accelerate the increase in local stress intensity — the “wedge effect” — due to the higher crack opening displacement this would induce. The lower  $K_{ISCC}$  measured for the T/4 DCB sample (Figure 2) could therefore be explained through a synergistic effect of both a faster “wedge effect” and an increased H generation.

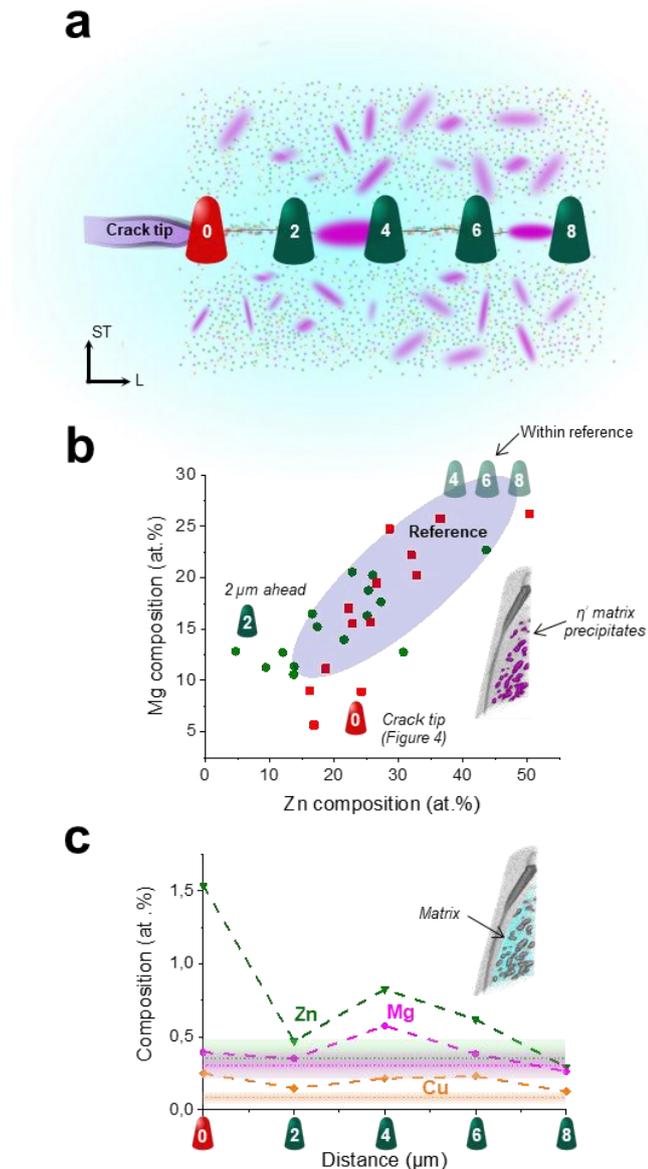
Figure 6. Evolution of the grain boundary ahead of the stress-corrosion crack. a) Microstructure schematic of a typical 7xxx Al-alloy showing the location of the APT analyses at the crack tip and ahead of the crack. b) Compositional evolution of the matrix η-phase precipitates at the crack tip and ahead of the crack. c) Evolution of the matrix composition with the distance to the crack tip. The dotted lines correspond to the matrix reference measurements shown in Figure 1b, for the T/2 position. The graded zones correspond to the standard deviation, also shown in Figure 1b. Note that all datasets were obtained from a single liftout and that datasets at 2, 4 and 6 μm contained part of the same grain boundary ahead of the crack.

The measured increase in solute levels near the crack tip motivated an analysis of the GB region ahead of the crack. Four APT measurements were performed on the T/2 sample spaced by approx. 2 $\mu$ m, as illustrated in Figure 6a. The compositional evolution of the matrix and matrix  $\eta$ -phase precipitates is plotted in Figure 6b–c as a function of the distance to the crack tip. It should be noted that all datasets except the one at 8  $\mu$ m contained a section of the same GB that laid ahead of the main intergranular stress-corrosion crack.

APT analyses of the GB located 2–8  $\mu\text{m}$  ahead of the crack tip (Figure 6a) revealed that the microstructure was modified with respect to reference measurements. The solute content in the matrix was elevated and the matrix  $\eta$ -phase precipitates were leaner than expected (Figure 6b–c), and hence likely less thermodynamically stable than their equilibrium composition. Although other mechanistic explanations are plausible, we propose that strain-induced precipitate dissolution [33] contributes to the partial dissolution of matrix  $\eta$ -phase precipitates. Dislocation activity ahead of the crack can shear precipitates, increasing their

Overall, the evidence presented in Figure 6 and discussed above suggests that, ahead of the crack, there is a solute influx from the matrix  $\eta$ -phase precipitates towards the GB which subsequently diffuse to the crack tip also along the GB. This is further supported by the observed composition gradient ahead of the crack and shown in Supplementary Figure 8a–b. These are measurements of the total solute composition within the grain interiors, including matrix and precipitates. Solute levels reach a minimum 2 $\mu$ m ahead of the crack, and progressively increase further ahead. These fluxes of solutes from the grain interiors could compensate the loss of solutes at the GB associated to the flux towards the crack, driven by the preferential oxidation of Mg near the crack tip triggering diffusion. Interestingly, the distribution for Zn and Cu is similar to that of Mg. The Ellingham diagram [45] suggests that these species are not subject to preferential oxidation compared to Al, even though Zn is incorporated into the oxide (Figure 4). The measured Zn/Cu distribution could be related to e.g. kinetic effects or stress-assisted diffusion towards the stressed region at the crack tip, as reported to occur in a Fe/Zn system and with H in steel [46,47]. Matrix diffusion does not seem to be the preferred diffusion pathway, as one would measure an opposite composition gradient to what is shown in Supplementary Figure 8b, with a higher total solute content closer to the crack tip. Further, solute levels at the GB, plotted in Supplementary Figure 8c, present near constant Cu levels, but Mg and notably Zn present fluctuations, as Zn reaches 1 at. % 6 $\mu$ m ahead of the crack but is reduced to 0.7 at. % at the 2 and 4 $\mu$ m positions. These measurements were based on the same datasets as those used in Figure 6.

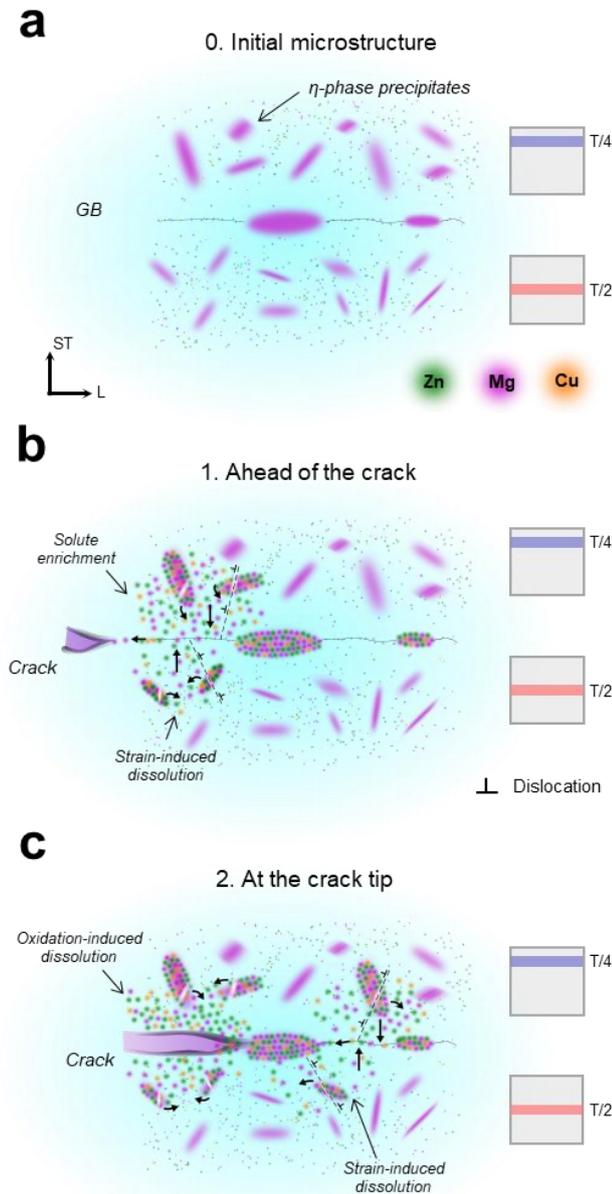
Figure 7. Mechanistic interpretation of the evidence at both plate positions. a) state of the microstructure after the ageing heat treatment, with the sample from T/4 displaying a higher matrix  $\eta$ -phase precipitate volume fraction. b) schematic description of strain-induced dissolution of matrix  $\eta$ -phase precipitates ahead of the crack and its subsequent segregation to the GB and diffusion towards the crack tip. c) comprehensive schematic description of the events at the crack tip. Matrix  $\eta$ -phase precipitates are further dissolved through oxidation-induced precipitate dissolution and the matrix adjacent to the oxide is enriching in solute elements. At the GB,  $\eta$ -phase GBPs oxidize while, concurrently, solutes released ahead of the crack through strain-induced dissolution are diffusing towards the crack tip.

Our interpretation of the compositional alterations both at and ahead of the crack tip is schematized in Figure 7 for both T/2 and T/4 in the bottom and top part respectively. The schematic and the following explanation are structured based on the order of microstructural processes as the stress-corrosion crack progresses.

When the crack is several  $\mu\text{m}$  away, the microstructure is in the near-equilibrium state that results from the ageing heat treatment (Figure 7a). Then, dislocation activity intensifies as the stress-corrosion crack advances, increasing precipitate-dislocation interactions. Some of these matrix  $\eta$ -phase precipitates can be sheared, which may contribute to destabilizing them and favor their dissolution back into the matrix. This is generally referred to as strain-induced precipitate dissolution and is a common microstructural observation after e.g. fatigue [33]. The matrix and  $\eta$ -phase precipitates' composition ahead of the crack would hence be modified (Figure 6). Simultaneously, solutes at the GB diffuse towards the crack tip, following the gradient of chemical potential established by the preferential oxidation of Mg. This drives the solutes released into the matrix ahead of the crack towards the GB, possibly assisted by non-equilibrium segregation facilitated by the vacancies injected during plastic deformation [34] or via the network of dislocations acting as accelerated diffusion paths, i.e. pipes [35]. This can feed into the flux of solutes towards the crack tip, as the GB is replenished from the adjacent matrix, itself replenished by the dissolution of matrix  $\eta$ -phase precipitates. The  $\eta$ -phase GBPs are also undergoing compositional modifications, with the Mg content increasing to above the equilibrium value (Supplementary Figure 7). This hypothesized sequence is depicted in Figure 7b. Figure 7c shows the evolution after progression of the crack tip and oxidation on the freshly exposed surface starts, triggering further dissolution of matrix  $\eta$ -phase precipitates. The microstructure now presents compositional alterations both within the grain (Figure 6) and at the GB (Supplementary Figure 7). The solutes released by the matrix  $\eta$ -phase precipitates subsequently diffuse towards the growing oxide, thereby enriching the matrix in Zn and Cu as Mg is preferentially oxidized (Figure 4), thereby altering its electrochemical behavior. This will be referred to as oxidation-induced precipitate dissolution, and was recently reported to be occurring during SCC of a 7xxx Al-alloy [16].

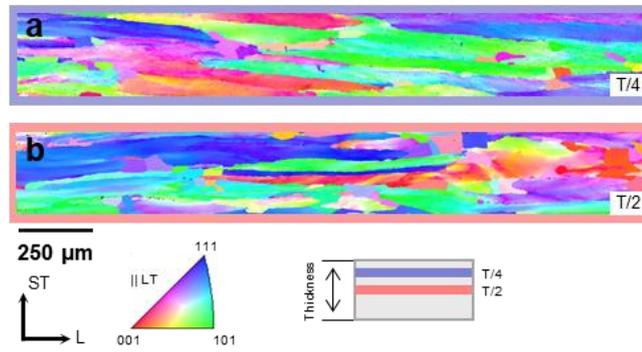
Supplementary Figure 1. Representative regions of the 2.1 x 0.95 mm EBSD scans for a) T/4 and b) T/2.

We performed 2.1 x 0.95 mm EBSD scans to characterize the grain structure around the stress-corrosion cracks in the ST-L orientation at each plate position and determine its possible influence on crack propagation (Supplementary Figure 1). Grain size and recrystallized fraction are similar in both samples but the T/4 position presents flatter grains, as shown by an increased aspect ratio (Supplementary Table 1). Supplementary Figure 2 presents {111} pole figures from both samples, with the T/2 position presenting the stronger texture (Supplementary Table 2).

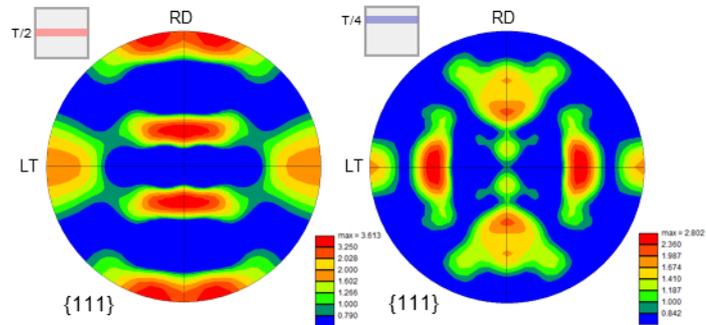
Supplementary Figure 2. {111} pole figures for the two plate positions.

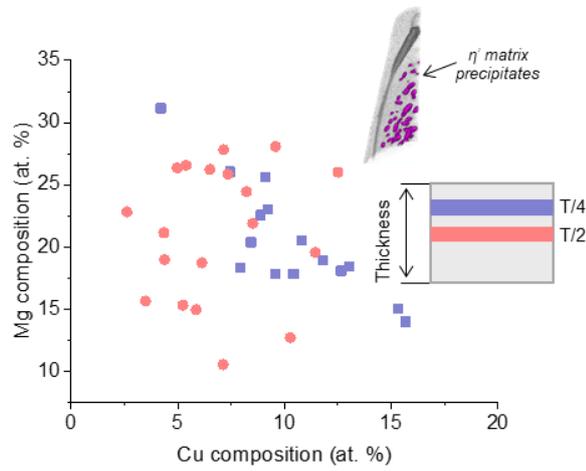
Supplementary Figure 4. Compositions of the matrix  $\eta$ -phase precipitates within the grain interior at both plate positions. 2 datasets for each plate position are shown and each data point corresponds to an individual matrix  $\eta$ -phase precipitate.

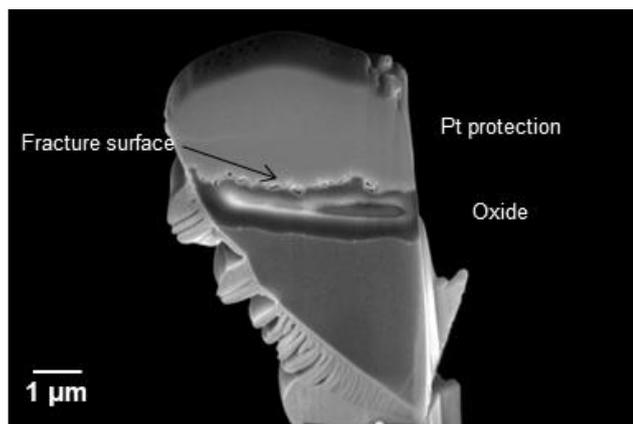
Supplementary Figure 5. PFIB liftout from the fracture surface showing the thickness of the oxide layer.

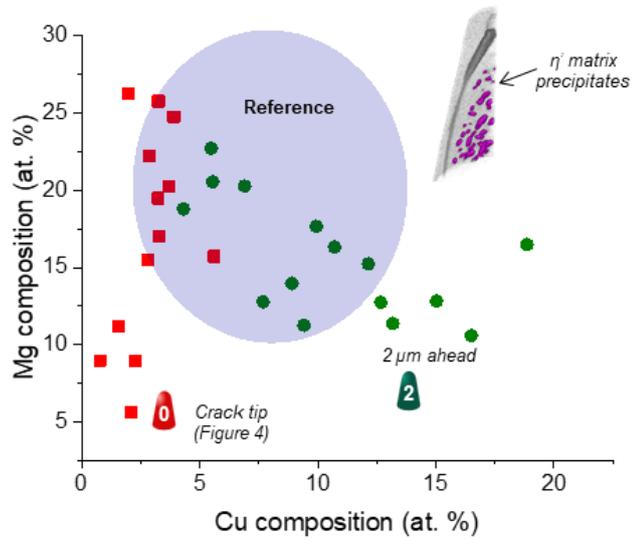
Supplementary Figure 6. Compositional evolution of the matrix  $\eta$ -phase precipitates at the crack tip and ahead of the crack

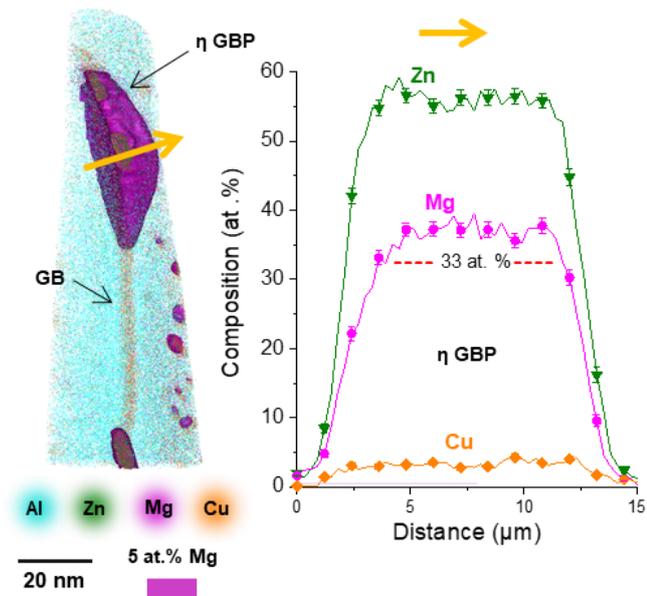
Supplementary Figure 7. APT reconstruction from  $4\mu\text{m}$  ahead of the crack showing an  $\eta$ -phase GBP with an elevated Mg composition.

Interestingly, an  $\eta$ -phase GBP in the dataset 4  $\mu$ m ahead of the crack was found to contain 37 at. % Mg, higher than the 33 at. % equilibrium composition of the  $\eta$ -phase (MgZn,

Cu, Al)<sub>2</sub>), as shown in Supplementary Figure 7. An η-phase GBP with increased Mg content ahead of a stress-corrosion crack was also recently reported in another 7xxx Al-alloy [16].
