# Study of polystyrene based scintillator ageing in the DANSS experiment

**ABSTRACT:** DANSS is a spectrometer of reactor antineutrino based on plastic scintillator. The sensitive volume of the detector is made of 2500 polystyrene based scintillator plates with wavelength shifting (WLS) fiber readout (strips). We present a study of the strips light yield during 6.5 years of DANSS continuous running. Overall ageing at the rate  $0.55 \pm 0.05$  (syst.) % per year is observed that is considerably smaller than in other similar experiments. We also observe the WLS fiber attenuation length shortening at the rate  $0.26 \pm 0.04$  (stat.) % per year.

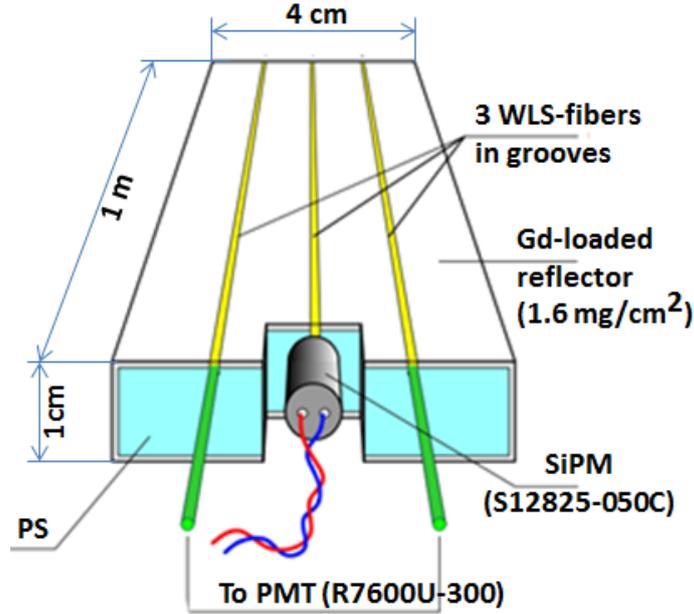
**Figure 1.** Scintillation strip layout.

The detector sensitive volume is built from scintillator plates (strips) which were extruded from polystyrene by the Institute of Scintillating Materials, Kharkiv, Ukraine. The strip design was developed especially for this experiment with very specific material composition and manufacture procedure [10]. The core plastic is doped with 1% PPO (2,5-Diphenyloxazole) and 0.03% POPOP (1,4-bis(5-phenyloxazol-2-yl) benzene) fluors. The surface is covered by about  $\approx 0.3$  mm co-extruded diffuse reflection layer. The layer consists of polystyrene with 18%<sub>wt</sub> admixture of rutile TiO<sub>2</sub> and 6%<sub>wt</sub> of gadolinium oxide Gd<sub>2</sub>O<sub>3</sub>. Gadolinium has natural isotope composition and is used to capture neutrons from the inverse beta-decay after their moderation. The final gadolinium density is about 1.6 mg/cm<sup>2</sup>, which corresponds to  $\sim 0.35\%$ <sub>wt</sub> with respect to the whole detector body. The layout of the strip is shown in Figure 1. The strip has 1 m length, 40 mm width and 10 mm thickness. There are three grooves on the top surface of the strip with wavelength shifting (WLS) fibers Y-11(200)M by Kuraray [11]. The fibers are glued into groves with a two component siloxane based optical gel from SUREL SUREL-SL1 (St. Petersburg, Russia) [12]. The central fiber is read out by a SiPM S12825-050C by Hamamatsu. Two side fibers from each of the 50 neighbor strips are collected into 100-fiber bundles and led to a conventional PMT R7600U-300 by Hamamatsu. The opposite ends of the fibers are polished and covered by reflective paint “Silver shine” M415001K00250 by Manoukian Argon (Italy). The strips are put in rows of 25 each. There are 100 rows, which form a cubic meter of the sensitive volume of the detector. Strips in adjacent rows are perpendicular to each other. The strips are supported by copper plates, which serve as an inner layer of the passive shielding. The copper layer is 5 cm thick on average. The aim during the assembly was to have most of the weight residing on the copper frame, though there is some sag of the strips in their middle and some touching between the strips could not be excluded. The outer part of the shielding is assembled from 8 cm of borated polyethylene, 5 cm of lead and another 8 cm of borated polyethylene. The shielding significantly decreases both gamma and neutron backgrounds, making radiation doses in the strip location well below common room conditions. Three centimeter thick scintillator veto counters cover the detector outside the shielding on all sides with the exception of the bottom and serve for tagging muons. The front-end electronics are placed on two sides of the cube in a slit between copper and borated polyethylene. The electronics are cooled by a chilled water cooling system, providing a stable temperature for the central part of the detector. Unfortunately, the temperature at the SiPM location varies from 18 °C for top and bottom rows to 23 °C for middle rows. DANSS data acquisition system (DAQ) is based on 64-channel, 12-bit, 125 MSPS waveform digitization modules (WFD) [13], which sample analog signals from photodetectors in 512 ns windows.

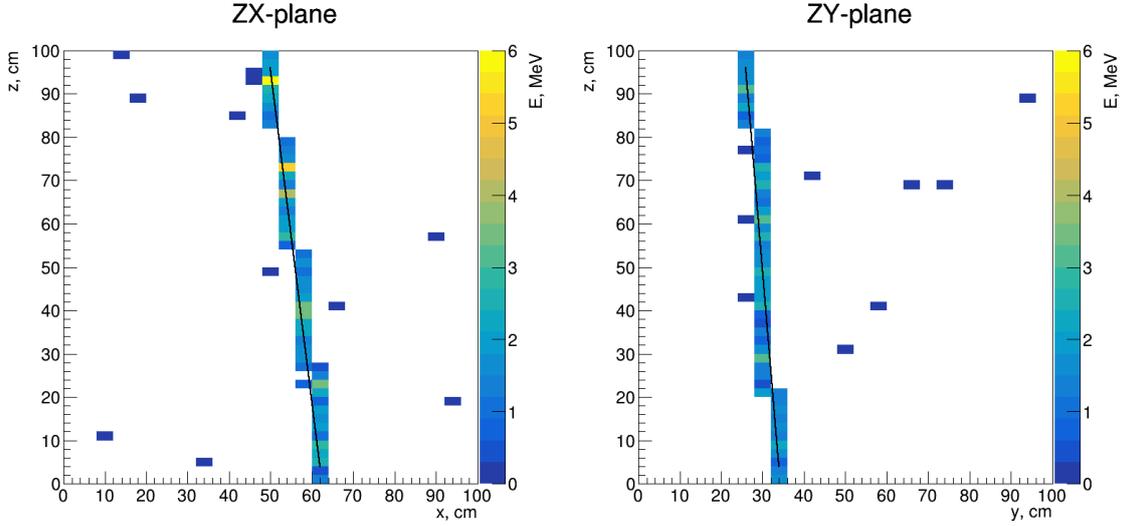
selected event is shown in Figure 2. A hit energy is shown by a color and the line corresponding to the track is shown also. Dark blue rectangles show low energy hits, produced by SiPM noise.

**Figure 2.** An example of selected muon event. The color scale corresponds to strip energy deposit. A black line shows muon track position reconstructed by its ends.

Though the detector has notable overburden, about 40 atmospheric muons pass each second through the detector [15]. Energy deposit from close to vertical muons is used as a standard candle. We start with selection of triggers with vertical muons. The event should have number of hits in the above 90. This effectively selects events with muons passing through the most of the detector. Track coordinates in the lowest and the highest 8 planes are calculated by averaging hits with a weight proportional to their energy deposit. A muon track is defined as a line connecting the points with these averaged coordinates. In order to select vertical muons only events with distances below 20 cm in the horizontal plane between these points are selected. So the tangent of the track zenith angle is below 0.2 and the difference between lengths of track in a strip is less than 2%. An example of a

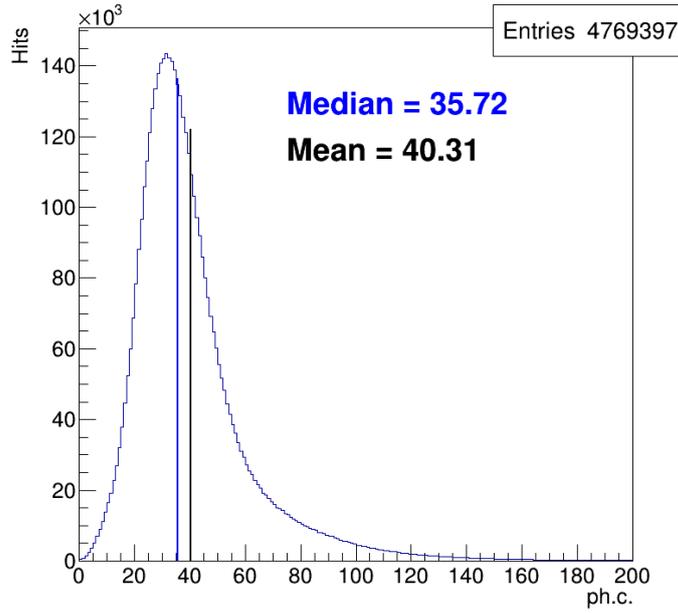
**Figure 3.** An example of number of photo carriers per hit distribution.

The whole data was splitted into 100-files chunks, which correspond to approximately 2 days of data taking. A distribution of number of photo carriers per hit for all hits in some data chunk is shown in Figure 3. Median value is used in the analysis as a measure of the light yield (LY).

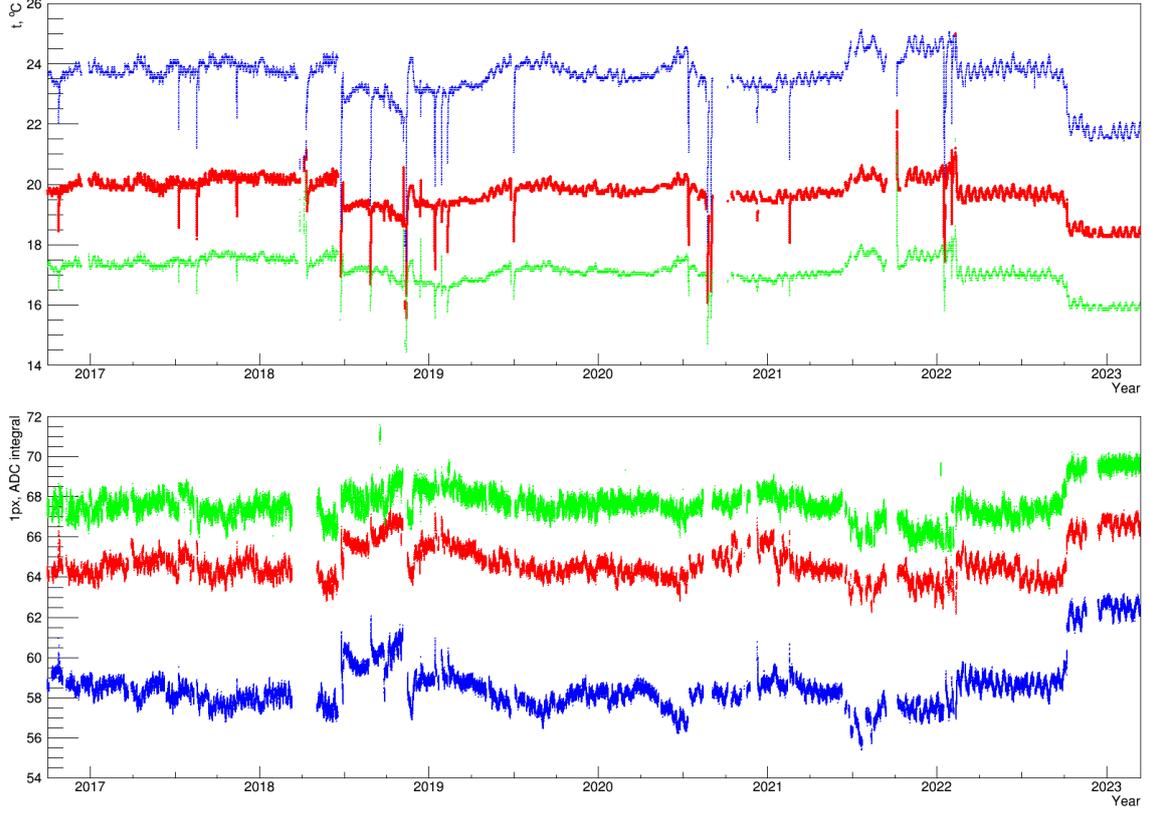
**Figure 4.** Temperature dependence as a function of calendar time (the top panel). Different colors show 3 sensors placed in the center (blue), right top corner (red) and left bottom corner (green) of the "Y" readout plane. The calendar time dependence of the single pixel signal (the bottom panel). The same colors are assigned to SiPMs close to the corresponding temperature sensors. To avoid overlap the red graph is shifted up by 5 units and the green one by 10.

independent slow monitor system every 5 minutes and is written separately from the main DAQ data files. Graphs of the temperatures are presented in Figure 4 (top). At the bottom part of this figure single pixel signal dependence of the nearby SiPM is given. A clear anticorrelation is seen.

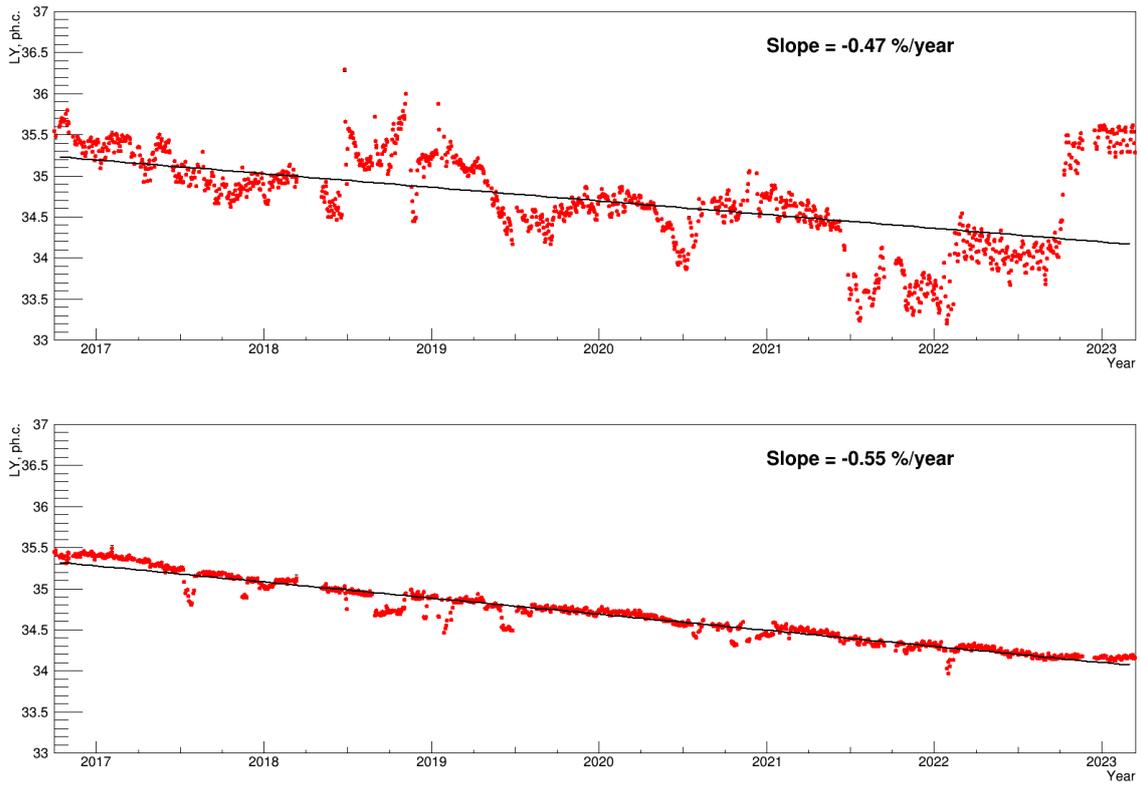
**Figure 5.** Light yield dependence over calendar time without the temperature correction (top) and with the correction according to the equation (4.1)(bottom). Statistical errors only.

The data used in this analysis is taken in the form of ph.c., so variation in the single pixel signal and crosstalk due to temperature is already taken into account, but changes in PDE are still not compensated. This compensation is done in a simple linear approximation based on the single pixel signal measured for each SiPM in each data file. In this approximation the corrected value of the signal is given by an equation:

where  $S$  is a number of ph.c., upper indexes correspond to event number ( $i$ ), file number ( $j$ ) and strip number ( $k$ ).  $A$  is a single pixel signal and subscript "avg" denotes its average over all files.  $\alpha$  is a correction coefficient common for all SiPM channels. The value of  $\alpha = 0.85$  corresponds to the minimum of  $\chi^2$  deviation from a linear fit to LY over time dependence. The LY dependence over time is shown in Figure 5. The top panel shows LY without the temperature correction. The corrected result is shown at the bottom. It is seen that some uncompensated effects are still present. Nevertheless the LY decrease with time is clearly seen.

Statistical only errors are shown in Figure 5. In order to estimate systematical errors the detector was split into 50 sections of 50 neighbor strips each (5 horizontally strips to 10 rows of the same direction). Annual LY decrease was calculated in these sections. The distribution of the results is shown in Figure 6. RMS of this distribution gives a good estimate of the systematic error, so the ageing of the whole detector is  $0.55 \pm 0.05(\text{syst.}) \%$ /year.

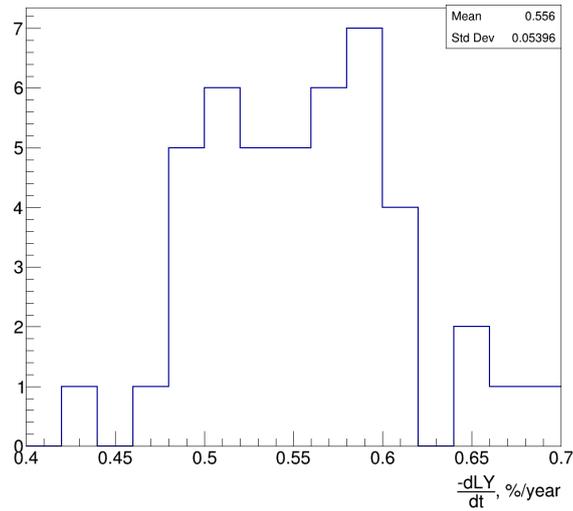
**Figure 6.** Light yield decay distribution for sections of the detector.

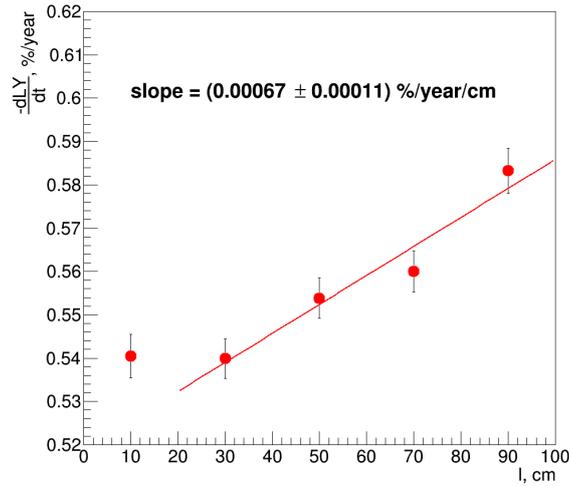
**Figure 7.** Light yield decrease dependence over the length along the strip. The line presents the linear fit in the range  $20 \div 100$  cm.

An observed decrease of the LY could have several reasons in addition to the degradation of the scintillation material. They include ageing of WLS fibers, optical gel used to glue fibers and light receivers<sup>1</sup>. We can not separate these factors with an exception of WLS fiber light attenuation length decrease, which can be seen as a larger ageing effect for longer distance along the strip. The LY decrease dependence over the length along the strip is shown in Figure 7. A hint of ageing effect increase with the distance to a SiPM is seen. At moderate distances from SiPMs the light attenuation is described by an exponent with the attenuation length  $L_{att} = 3.9$  m. The observed increase in the ageing effect with the distance could be translated into the annual decrease of the attenuation length with a formula:

where  $\frac{1}{LY} \frac{\partial LY}{\partial t}$  is the relative annual decrease of the LY and  $l$  is the length from muon track to SiPM. The measured WLS attenuation length decrease, calculated from a linear fit in the range 20 ÷ 100 cm shown in Figure 7, is  $0.26 \pm 0.04(\text{stat.})$  %/year.
