Wear Behavior and Microstructure of Thermally Sprayed NiCrBSiFeC and Composite NiCrBSiFeC-WC(Co) Coatings

Abderrahmane Abderrahmane, Mohamed Gaceb, Mohammed Cheikh, Sabine Le Roux. Wear Behavior and Microstructure of Thermally Sprayed NiCrBSiFeC and Composite NiCrBSiFeC-WC(Co) Coatings. Materials Science-Medziagotyra, 2021, 27 (2), pp.175-183. 10.5755/j02.ms.24478. hal-03149468

In this work, a study was carried out on the friction and wear behavior of flame thermal sprayed NiCrBSiFeC-WC(Co) composite and NiCrBSiFeC coatings subjected to severe wear conditions. For this purpose, flame remelted samples were tested in reciprocating wear conditions based on a cylinder-on-flat configuration. The wear assessment of the coatings was achieved using scanning electron microscopy (SEM) and 3D optical profilometry. The microstructure and the mechanical properties of the coatings were investigated using SEM, EDS and XRD techniques as along with indentation tests. The tribological behavior of the substrate and the coatings was successfully studied thanks to wear tests conducted on an adapted multi test apparatus. The results show that both NiCrBSiFeC and composite coatings induced a significan

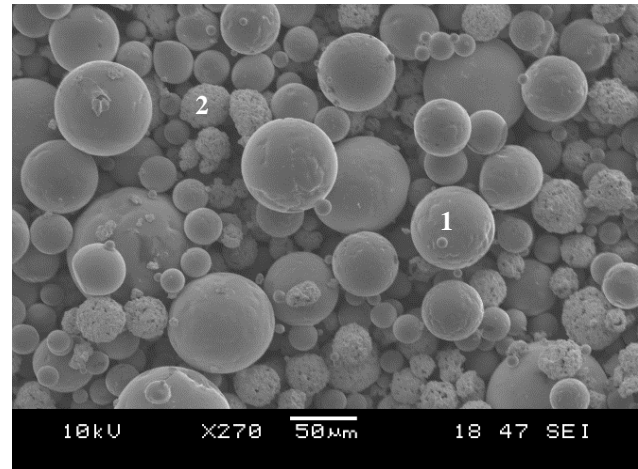
Fig. 1. SEM morphology of a mixture of the as-received powders M30C: M (1), C (2)

manufactured by Oerlikon Metco Company, its brand is Woka 3203. The size of the powder particles is principally in the range of 20 to 125 μm for the NiCrBSiFeC alloy and 20 to 53 μm for the WC(Co) powder. As the SEM micrograph (Fig. 1) shows, the particles for both powders are essentially spherically in shape.

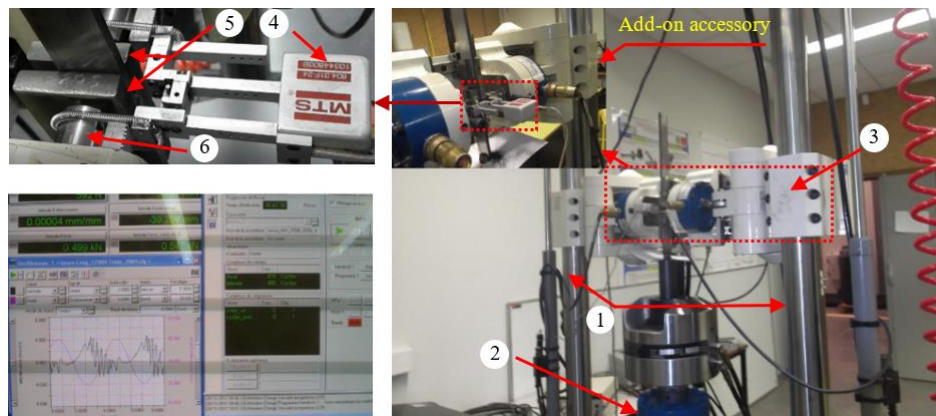
Fig. 3. Wear test machine including the add-on accessory and the monitoring software

execution. The adapted equipment is a device that allows a conventional fatigue machine to be adapted as a tribometer to perform sliding of a reciprocating specimen under a stationary pin. This device adds a second axis to a usual fatigue machine in the form of an add-on accessory. The apparatus can also be used as a fretting-wear machine or a fretting-fatigue machine. This device is supported by a crosspiece (3: white), which is attached to the two columns (1) of a standard fatigue machine. Several pin shapes may be used with this device. The pins are fixed in the supports (6) and allow the specimen (5) to be pressed with a perfect symmetry in the form of a pinching motion. In the tribological configuration of the device, the specimen (5) is driven by the fatigue machine actuator in a vertical alternative movement. The friction force is measured using two load cells incorporated in the fatigue machine (2). The coefficient of friction (COF) is recorded in situ by means of acquisition software (Fig. 3) and the average COF is evaluated in the steady state zone. The wear depth corresponds to half of the measurement given by the extensometer (4). Details of the apparatus are reported elsewhere [11].

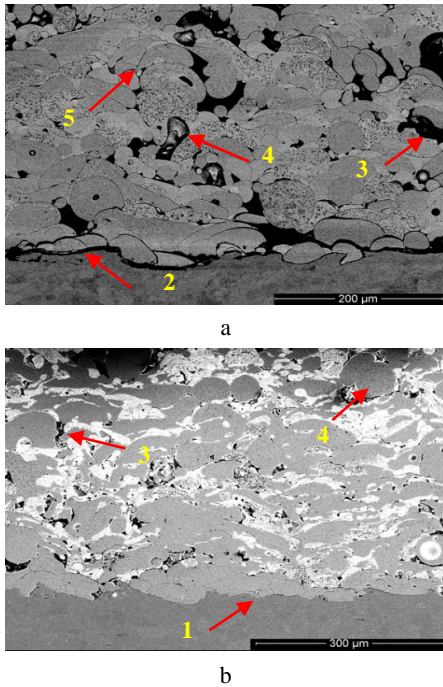
Fig. 4. SEM Comparative microstructure of as-sprayed coatings: a–NiCrBSiFeC; b–NiCrBSiFeC-WC(Co), the arrows indicate: 1–substrate-coating interface; 2–oxides; 3–pore; 4–unmolten particle; 5–splat boundary.

From the micrographs presented in Fig. 4 and Fig. 9, the layers of the as-sprayed coatings show a general lamellar structure with a few pores, oxides, and unmelted particles.

Individual splats are well recognized, and small sized scattered precipitates can be clearly seen in almost all splats of the NiCrBSiFeC and the composite coatings. This has also been discerned in previous works [3–5, 13, 16]. The coating-substrate interface and splats boundaries are very clear and the substrate roughness profile stemming from surface preparation was preserved. This gives evidence that the coating bonding to the substrate and between splats are both essentially mechanical. In addition, single metallic (grey region) and cermet (white region) splats can clearly be observed in the composite coating. Moreover, the latter present less porosity and more flattened splats than the NiCrBSiFeC coating. The low porosity is thought to be due to the small size WC(Co) particles that can be easily inserted into voids between the metallic particles thereby increasing the density.

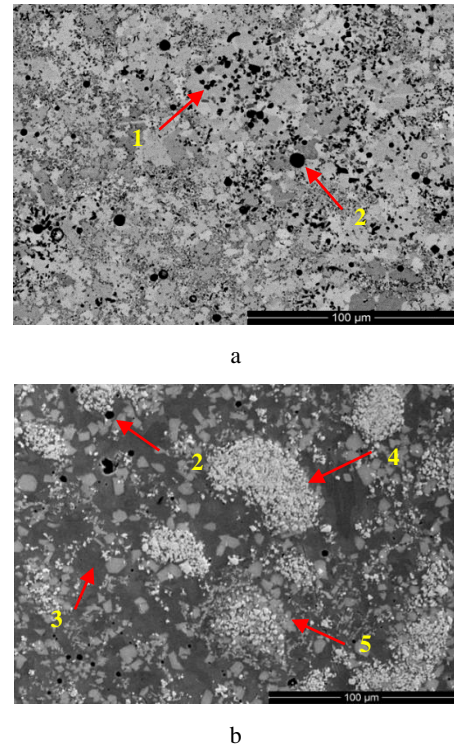
Fig. 5. SEM Comparative microstructure of the remelted coatings: a–NiCrBSiFeC; b–NiCrBSiFeC-WC(Co). The arrows indicate: 1–blocky precipitates; 2–rounded pore; 3–matrix; 4–unmolten WC carbides; 5 molten WC carbides

As illustrated in Fig. 5–Fig. 7 and Table 3, the splats boundaries are completely eliminated and the surface roughness has intensely decreased for the two coatings NiCrBSiFeC and NiCrBSiFeC-WC(Co) after remelting compared to the as-sprayed coatings.

The two coatings exhibit practically almost pore-free, nanoscale grained and homogenized microstructure characterized by coarser well-dispersed precipitates, as well as small isolated rounded pores. This is in agreement with previous studies [9, 12–16]. In addition, the composite coating shows molten (white) and unmolten (light grey) WC carbide particles well dispersed in the matrix.

It can obviously be noticed from Fig. 6 a that the boundary between the coatings and the substrate has totally disappeared, evidence of good adhesion.

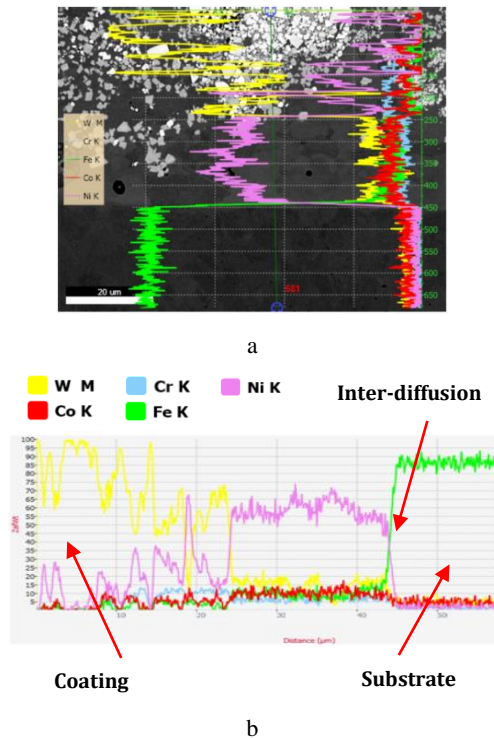
Fig. 6. SEM-EDS line scan profiles at the substrate-coating interface (green line) of the remelted NiCrBSiFeC-WC(Co) coating

SEM scan line analysis (Fig. 6 b) revealed the existence of a transition layer between the substrate and the remelted coatings. This is seemingly due to inter-diffusion phenomena occurring between the coating at its liquid state after remelting at high temperature and the substrate. The transition layer mainly contains Ni and Fe elements and is about 2.4 μm thick, evidence that the metallurgical bond has been successfully established. This is in line with previous studies [5–8, 16–18].

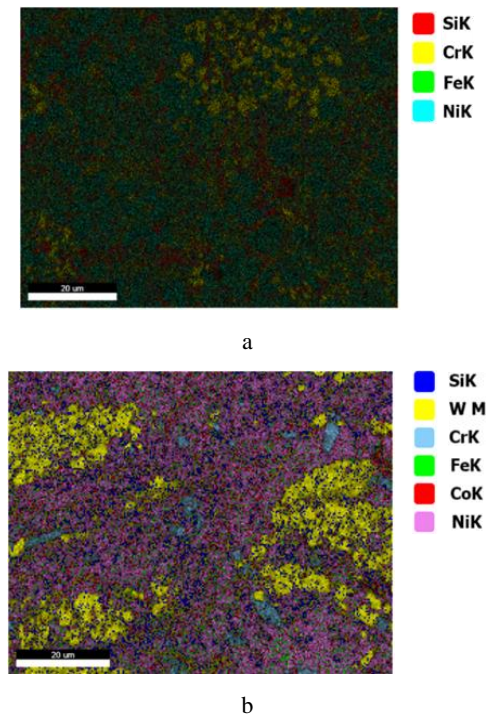
Fig. 7. SEM/Element overlay cartography of remelted coatings. Left: NiCrBSiFeC; Right: NiCrBSiFeC-WC(Co)

The elemental distribution in the composite NiCrBSiFeC-WC(Co) coating displayed in Fig. 7 b clearly shows that the cobalt attached to its original WC(Co) particle in the as-sprayed coating is uniformly redistributed throughout the microstructure after remelting. It is thought that the cobalt was dissolved in the Ni-based liquid alloy during the melting process because of its low melting temperature that can be reached during the melting process unlike the WC tungsten carbides. Accordingly, the resulting composite coating can be identified as WC carbide in a matrix of Ni-based alloy and Co. In addition, well-distinguished zones can be observed in both coatings. Based on elements' color distribution these obviously correspond to silicides, tungsten carbides and chromium compounds.

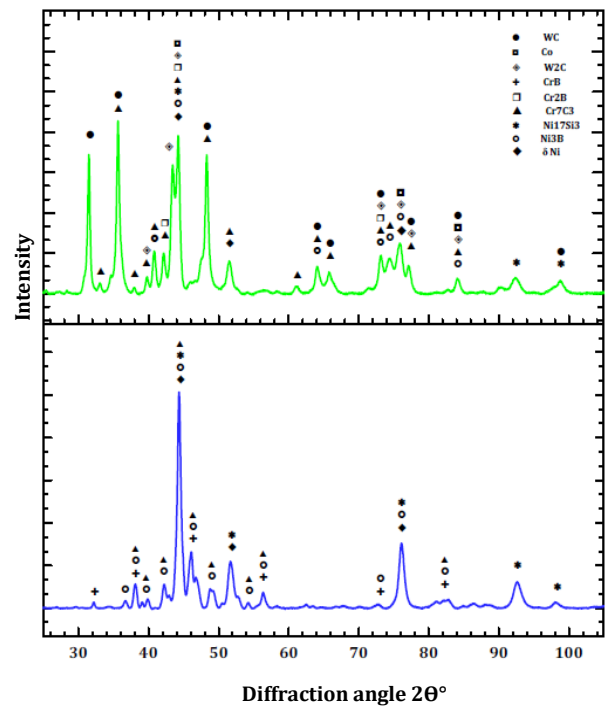
Fig. 8. XRD spectra of remelted coatings. Top: M30C; Below: NiCrBSiFeC

Besides, it is noticed that the chromium boride detected in the composite coating is Cr₂B [13]. The W₂C is obviously the result of WC decarburization at high temperature [2, 5].

As portrayed in XRD pattern (Fig. 8), it can be noticed that the coatings clearly exhibit broad peaks with humps, which are more expanded in the composite. This is more likely associated with nanocrystalline matrix phases resulting from the high cooling rates related to thermal spray coating process [2, 13, 15].

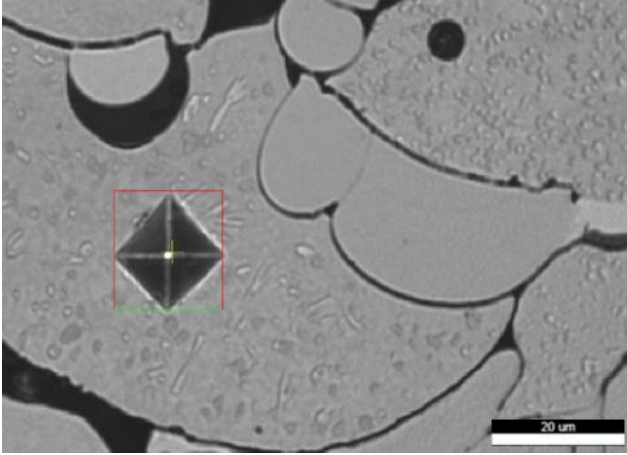
Fig. 9. Optical micrograph of an indent impression of as-sprayed NiCrBSiFeC coating under a load of 100 g

as-sprayed coatings while surface hardness is higher in remelted coatings, which is in agreement with reported results [5, 9, 23]. The high surface hardness of the remelted coatings could be mainly due to their high density owing to the reduction in porosity and enhancement of the coating cohesion as a result of the high temperature (1200–1500 °C) reached during the melting process [3, 9, 16]. The greater microhardness of the as-sprayed coatings may be due to their finer microstructure [5, 12, 15] (Fig. 9).

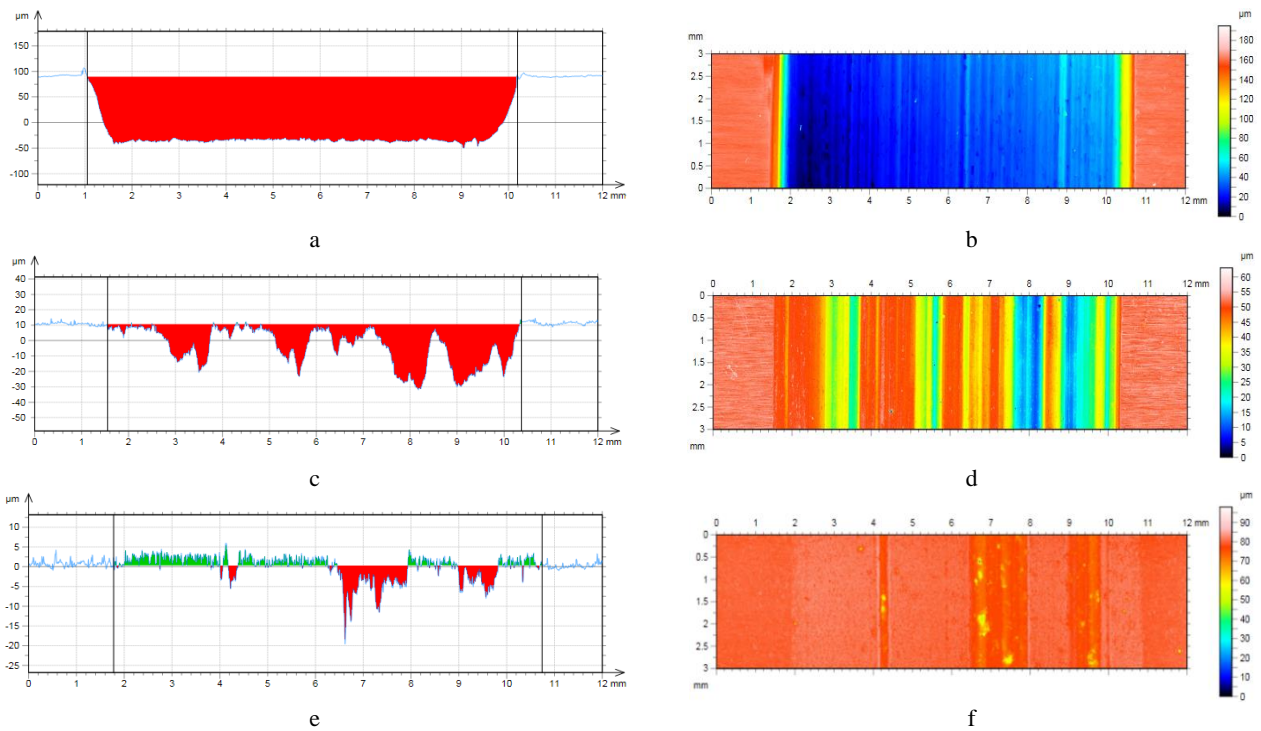
Fig. 10. 3 D non-contact surface mapping with cross section of the wear scars (Right) and wear track profiles of remelted coatings (Left). a, b – substrate; c, d – NiCrBSiFeC; e, f – NiCrBSiFeC-WC(Co)

3D profilometry and SEM investigations of the wear tracks on the substrate and the coatings suggest that several wear mechanisms, promoted by the reciprocating dry sliding had occurred simultaneously. As shown in Fig. 10 b, two-body abrasive wear occurred in the substrate, characterized by deep grooves parallel to the direction of sliding resulting from the relative motion between a soft surface (substrate) against a counterpart with harder asperities (pin). Consequently, a large fluctuation in COF (0.7–0.95) was induced (Fig. 12 a). The small black spots that can be seen in the figure are thought to be due to low oxidation. For the NiCrBSiFeC coating (Fig. 10 d and Fig. 11 a and b), several macro and microgrooves parallel to the sliding direction related to the abrasion mechanism can be observed. In addition, a significant adhesion layer is obviously visible, which may have accumulated on both sliding surfaces by plastic deformation and flattening of the debris under continuous sliding [3,14,23]. The high mutual solubility of the Ni (coating) and the Fe (pin) contribute considerably to the development of this phenomena. Thereby, the adhesion layer is a result of material transfer from the counter-body which is mixed to coating debris and oxidized during the wear process to form a thin tribolayer [3, 23, 25]. This latter smoothed the worn surface and exerted a protective function to the coating, inducing a significant reduction in friction and wear (Table 4). As a result, a short running-in stage and a very stable COF were recorded for the NiCrBSiFeC coating (Fig. 12 b). Fig. 11 .b also shows some voids related to micro-porosities probably revealed by the wear process. Some of these contain indeed piled up debris inside. For the composite coating, wear particles agglomeration phenomenon is well observed. The smaller wear particles have linked together and formed a larger single pile. Particle agglomeration had occurred simultaneously in confined locations at the top and bottom edges of the wear area. Since the sliding is performed in the vertical direction, some fragments of debris piles were subsequently detached by gravity, trapped in the contact surface, and then partially embedded in the pin surface, thus acting as fixed indenters. As a result, large and shallow wear marks are clearly visible on the surface of the coatings (Fig. 10 f and Fig. 11 c and d) which is a sign of two-body abrasive wear mechanism [27]. The width of the mentioned wear marks are in the range of 258 μm to 1.58 mm, which may give an indication of the size of the debris piles. Some craters can be observed on the worn surface, mostly on the matrix and apparently bigger within the wear marks, which suggests that a part of debris (or agglomerated debris) remain free to roll between the two mating surfaces and may be the basis of a three-body abrasion wear mechanism [12, 27].

(Fig. 12 c). The formation of a microfilm within the big marks and covering a large area of the wear track was also displayed (Fig. 10 f and Fig. 11 c). It is clearly indicated by the green area above the surface of the wear track (Fig. 10 e). This is a sign of tribo-oxidation mechanism, as reported in several previous research works [4, 10, 22, 28].

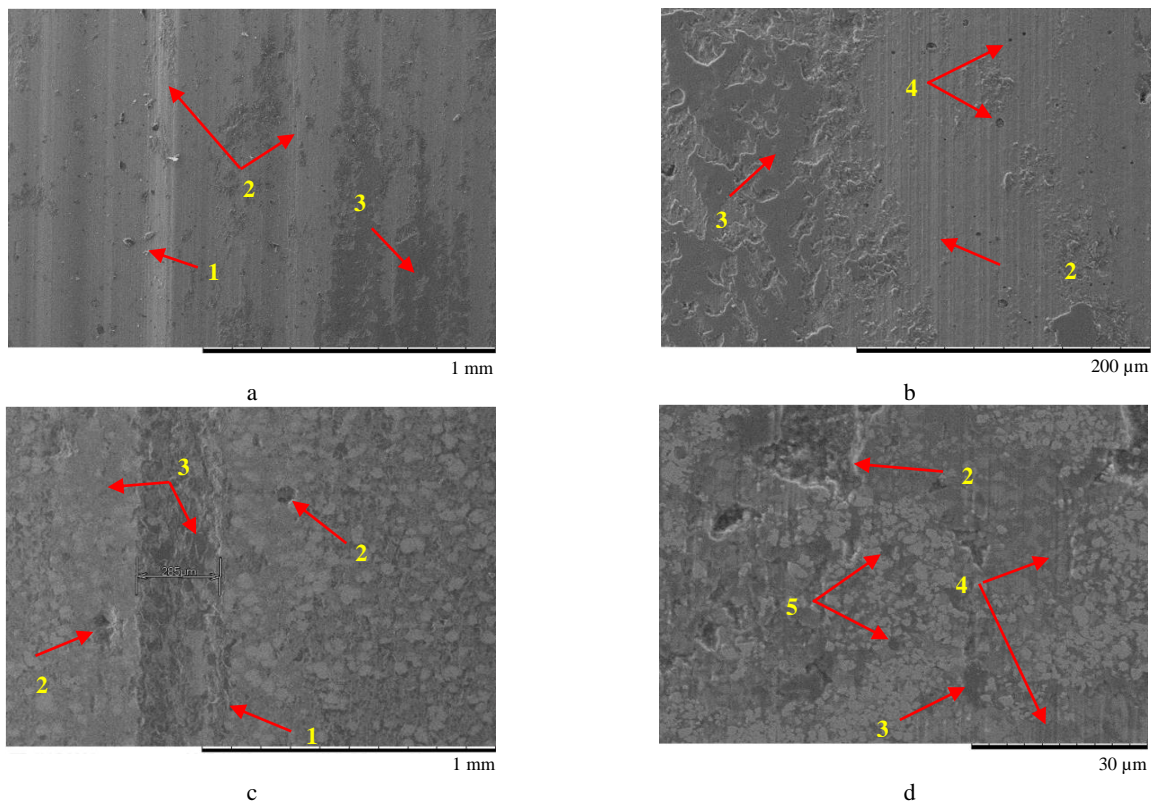
Fig. 11. SEM images of the worn surface of the remelted coatings: a, b – NiCrBSiFeC (1 debris; 2 grooves; 3 transferred layer; 4 micro-porosities); c, d – NiCrBSiFeC-WC(Co) (1 wear mark; 2 craters; 3 microfilm; 4 microgrooves; 5 micro-pits)

Some of these debris may be the results of the pulling out of the reinforcement phase. The craters are also visible in the counterpart supporting the idea of three-body wear mechanism. Due to this combined abrasive wear, the running-in stage was more extended and a large fluctuation in the COF is evident for the composite coatings (0.5 – 0.7)

In contrast to the NiCrBSiFeC coating, no material transfer to the counter-body was detected. At high magnification (Fig. 11 d), it can be clearly seen that microgrooves are well noticeable on the matrix but interrupted in the WC carbides zone.

These may indeed have been generated by the hard carbides of WC previously extracted more likely by fatigue wear mechanism due to the alternative sliding [17], and which can become trapped between the sliding surfaces and cause the wear of the matrix. Micro-pits related to the pulled out carbides are obvious on the examined worn surface. Such phenomenon is not perceived in the NiCrBSiFeC coating.

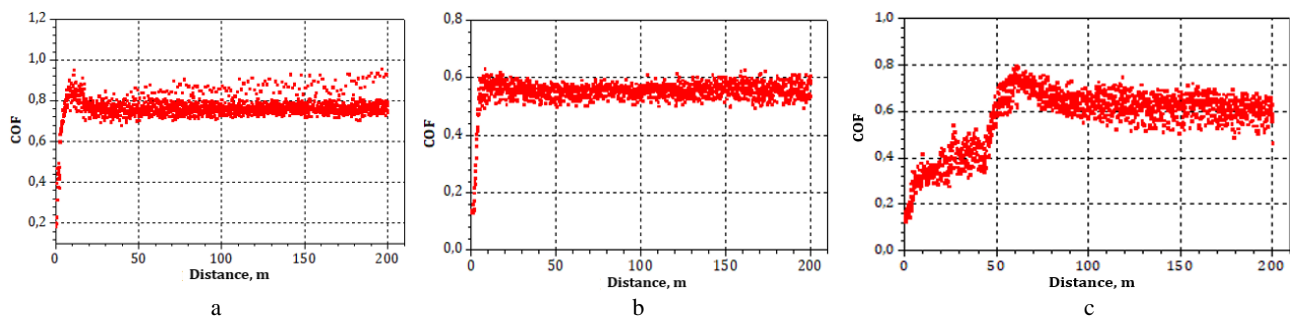
Fig. 12. Coefficient of friction vs. sliding distance plots of the substrate and remelted coatings: a – substrate; b – NiCrSiBFeC; c – NiCrBSiFeC-WC(Co)
