A new experimental snow avalanche test site at Seehore peak in Aosta Valley (NW Italian Alps) – Part II: Engineering aspects

A new experimental snow avalanche test site at Seehore peak in Aosta Valley (NW Italian Alps) – Part II: engineering aspects

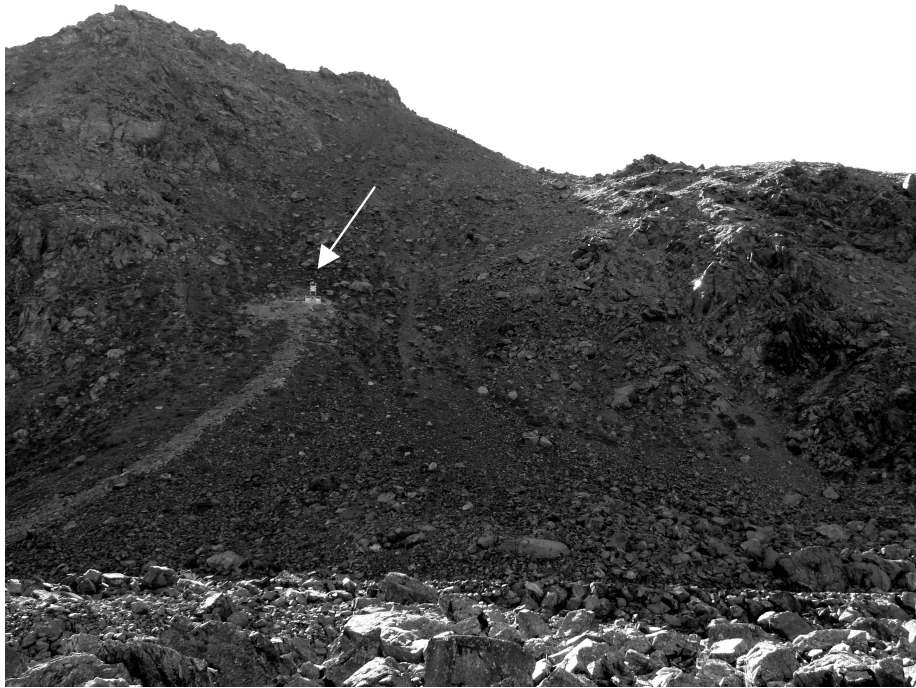
Figure 2: Frontal view of the test site in summer. The arrow marks the obstacle position.

Close to the location of the instrumented obstacle the following types of coverage were observed (see Figure 2):

The obstacle and the measurement systems rest on a concrete slab 3 m long by 3 m wide and 0.6 m thick, placed approximately in the position shown in Figure 2. They were designed to resist the impact of avalanches running along the path and to measure velocity and impact forces. The foundation was embedded so that it emerges only 0.6 m from the natural slope. Gabions filled with material readily available on site were used to support the excavation; this choice helped to minimize the environmental impact, also reducing the amount of concrete to be cast in place (Figure 3).

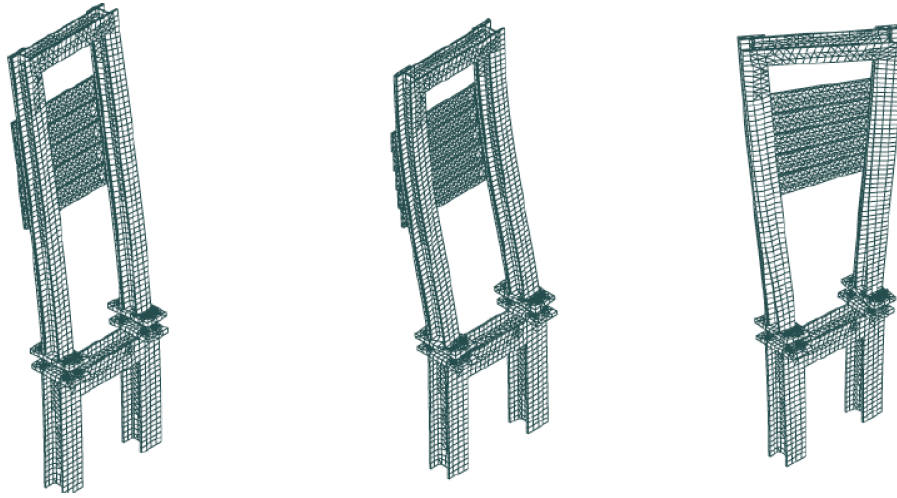
Figure 7: First three modes of vibrations, corresponding to the lowest frequencies, obtained through a numerical simulation.

In particular, experimental modal analysis has been performed in order to assess the dynamic properties of the obstacle and to validate the results obtained from numerical analyses (Figure 7), performed with the finite element code ADINA (ADINA R&D, Inc. (2012)).
