Krzysztof SZWAJKA, Tomasz TRZEPIECIŃSKI

THE INFLUENCE OF MACHINING PARAMETERS AND TOOL WEAR ON THE DELAMINATION PROCESS DURING MILLING OF MELAMINE-FACED CHIPBOARD

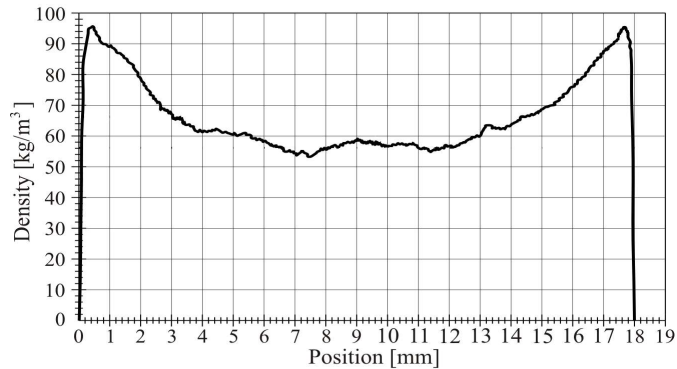
The measurement of the density profile through the chipboard thickness (fig. 1) was carried out using a GreCon DA-X instrument. The density in the middle part of the thickness was about 85% of the density near to the outer surface layer.

Fig. 1. Density profile through the thickness of the chipboard measured using a GreCon DA-X instrument

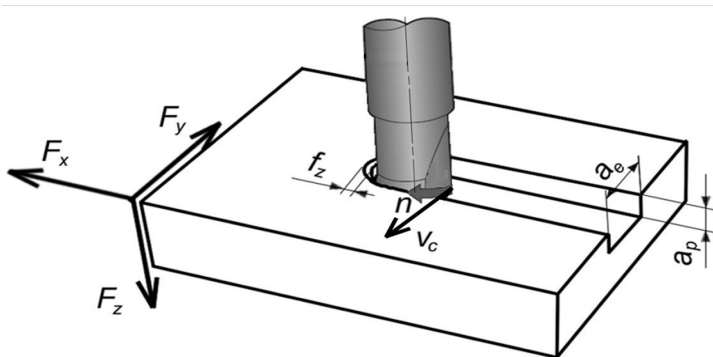
The main objective of the research on the milling process using a high-speed steel tool was to determine the effect of the cutting speed on the cutting tool life. To determine the durability of the cutting tool a geometric criterion was used. As a wear factor the maximum wear of the tool flank VB_{\max} was adopted. It was decided to determine the influence of the basic cutting parameters (cutting speed, feed rate) on the chipboard surface quality and the value of the signals of the forces occurring in the machining process, i.e. F_x , F_y , F_z (fig. 2).

Fig. 2. Distribution of force components F_x , F_y , and F_z in the milling process: a_e – width of milling, a_p – depth of cut, f_z – feed per tooth, n – rotational speed of the milling cutter, v_c – cutting speed (prepared on the basis of Jemielniak [1998])

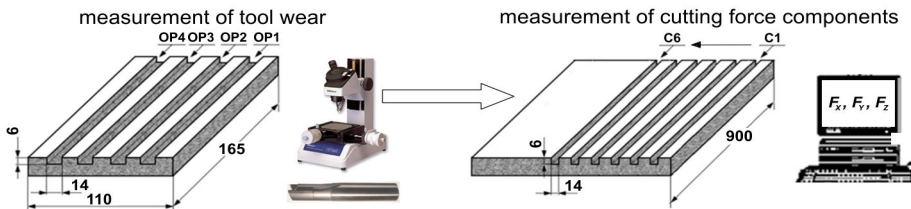
Before starting the first milling operation using a new tool at $f_n = 0.2$ mm, the registration of force signals was carried out during one cut (OP1 (fig. 3)). Then, the cutting force components were measured during six cuts (C1-C6 in fig. 3). After the end of each operation consisting of six cuts tool wear was measured. The investigations of tool wear (after one cut) and cutting force components (CFC) during six cuts were carried out on one workpiece. After the registration of cutting forces the tool was dismantled from the spindle and wear was measured. Next, the measurements of cutting forces and tool wear were repeated at $f_n = 0.5$ mm and $f_n = 0.8$ mm on a new workpiece, starting with a new tool. An algorithm for experimental procedure is shown in figure 4.

Fig. 3. The research method consisted of milling parallel grooves and registration of the cutting forces; tool wear was measured after the end of each operation consisting of six cuts

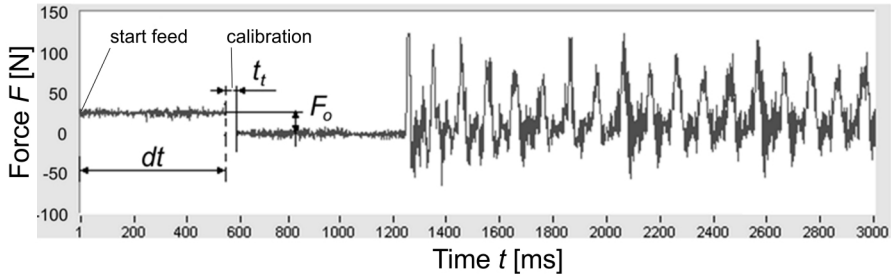
disturbances can be eliminated or reduced by the use of signal taring [Jemielniak 1998]. The method of signal taring of force signals is presented in figure 5. An analysis of the values of the signals started when the feed was turned on by the machine's control system.

Fig. 5. Scheme of signal taring for reducing the disturbances in signals recorded by the industrial piezoelectric sensor

After buck-off at time dt , the average force F_0 acting on a sensor at time t_t was determined. The average force evaluated was taken as a reference value ($F = 0$). The duration of dt should be long enough to stabilise forces during tool input. However, the sum of time dt and t_t must be shorter than the time of tool input. The cutting force value was evaluated as the difference between the measured force value and F_0 force value.

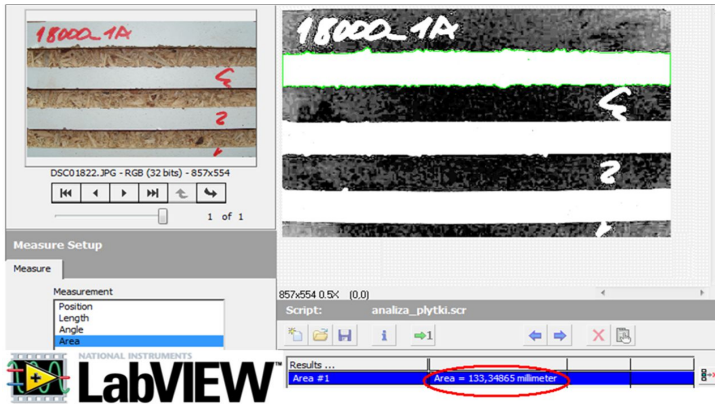
The maximum wear of the tool flank VB_{\max} was adopted as a criterion of wear. According to ISO 8688-1:1996 [ISO 1996] the limit value for this wear factor in the case of high-speed steel tools had the value $VB_{\max} = 1$ mm. In the next stage of the results analysis, in order to determine the effect of wear of the blade, feed and cutting speed on the surface texture, it was decided to analyse the quality of the edge of the chipboard. Based on the digital images of the machined surface obtained during the process of the registration of digital signals of forces, an image analysis of the machined surface was carried out. The digital images were uploaded to a computer, and then subjected to digital post-processing to determine the area of delamination with the Vision Assistant application in the LabView environment (fig. 6).

Fig. 6. View of the LabView environment for image analysis of delamination

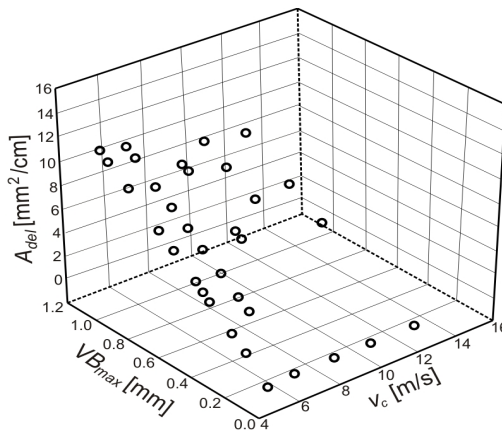
With increasing wear of the tool flank VB_{max} , cutting speed v_c had a dominant effect on the delamination factor. Increasing tool wear caused an increase in the area of delamination (fig. 7).

Fig. 7. Effect of VB_{max} and v_c on the value of area of delamination A_{del}

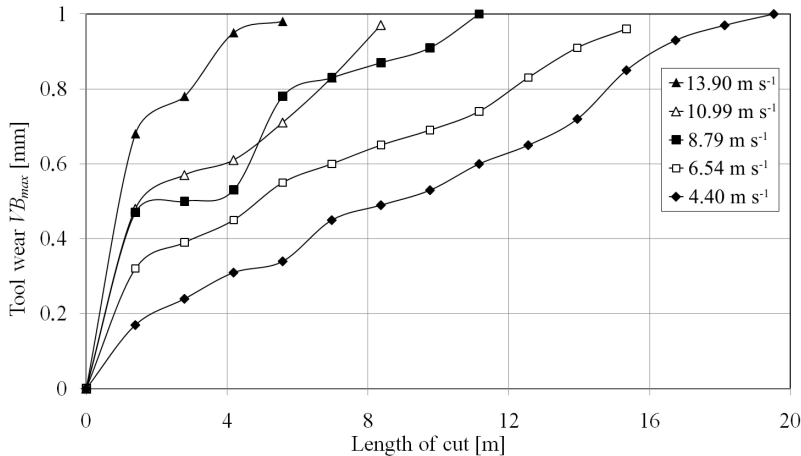
Figure 8 shows the variation of wear of the tool flank VB_{\max} as a function of length of cut l_s for five tests carried out with different cutting speeds (see table 2). There was a clear impact of cutting speed on the length of tool life and this relation was manifested as a decrease in tool life with increasing cutting speed. For example, the milling cutter machining at $v_c = 13.9$ m/s after a cutting distance of about 6 metres reached an assumed value of tool flank wear $VB_{\max} = 1$ mm, and the allowable tool wear of the milling cutter operated at low cutting speed $v_c = 4.4$ m/s was reached after about 20 metres. Moreover, a rapid increase in tool wear was observed in the initial period of tool operation ($l_s = 0-2$ m) as cutting speeds increased.

Fig. 8. Variation of tool wear as a function of cutting distance (for five tools), $f_n = 0.5$ mm

- There was a clear relationship between the cutting speed and the length of tool life under the cut. In the initial period of tool operation, in the cutting length range of 0-2 m, with increasing cutting speed a rapid increase in tool wear was observed as a function of cutting length.

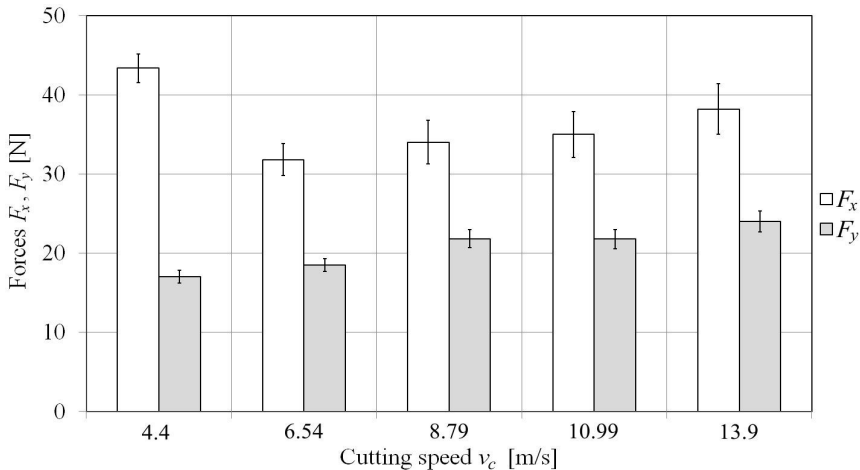
Fig. 9. Effect of cutting speed v_c on the value of forces F_x and F_y

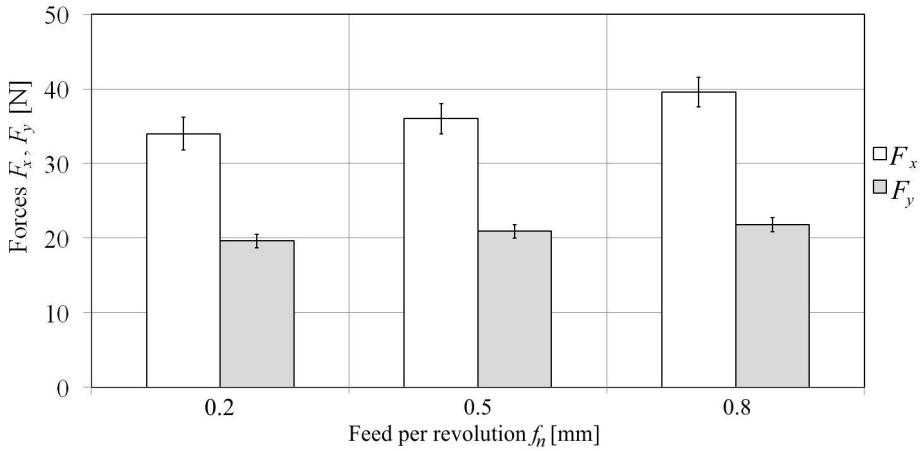
Fig. 10. Effect of feed per revolution f_n on the value of forces F_x and F_y

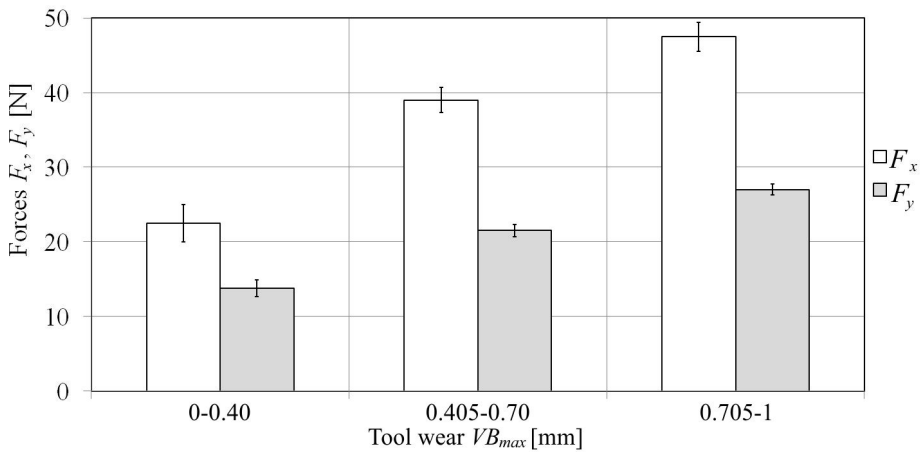
Fig. 11. Effect of wear of the tool flank VB_{max} on the value of forces F_x and F_y

- An increase in the value of the cutting force component was not proportional to the increase in the wear of VB_{\max} . The largest increase in signal amplitude associated with an increase in tool wear was observed for the F_x component of cutting force.

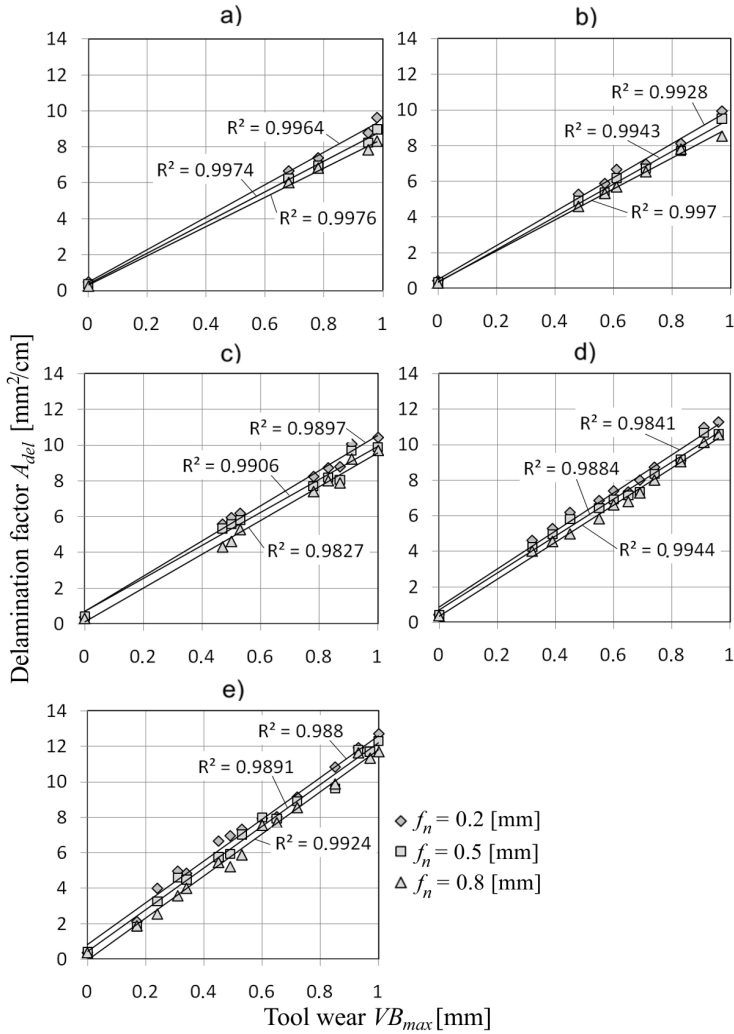
Figure 12(a-e) presents the relationship between the delamination factor A_{del} and tool wear VB_{max} . A reduction in the cutting speed increased the area of delamination, leading to an increase in the value of the A_{del} factor. The same conclusion was drawn by Gaitonde et al. [2008b], who has found that by employing a higher cutting speed it was possible to reduce the tendency to delaminate during drilling.

Fig. 12. Dependence of the delamination factor A_{del} vs. tool wear for different cutting speeds: $v_c = 13.19$ m/s (a), $v_c = 10.99$ m/s (b), $v_c = 8.79$ m/s (c), $v_c = 6.59$ m/s (d) and $v_c = 4.40$ m/s (e)

To summarize, both a change in cutting speed and tool wear had a statistically significant effect on the area of delamination. However, a change in feed per tooth had no significant effect ($p = 0.092$). There was no statistically significant synergistic effect on the products of the parameters analysed on the value of the factor A_{del} .
